*Re: Focus: Traffic
Additional Comment & Expert Review Regarding Development Proposal for Bishop Tube site by
Constitution Drive Partners*

To: Maya van Rossum, the Delaware Riverkeeper
From: Mark L. Stout
Project: Bishop Tube development
Subject: Traffic and accessibility analysis, preliminary report
Date: 24 June 2019

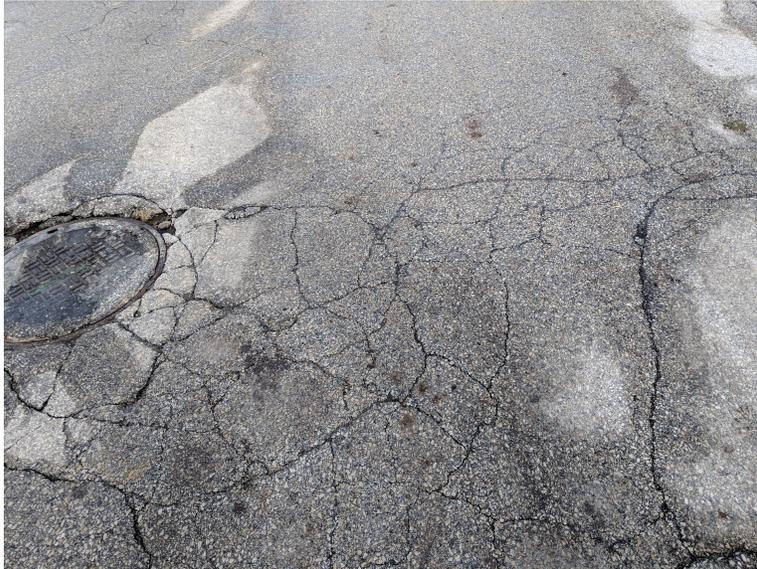
The pavement on Malin Road south of the overpass appears to be in overall fair to poor condition. There is evidence of alligator cracking (figure 1), delamination (figure 2), and failure at the edge of the pavement (figure 3). There is some curbing, but no sidewalk.

Figure 1, Malin Road, alligator cracking

The ARRO letter makes no reference to the requirement that the developer meet township construction standards (§175-34) or other relevant standards. In this regard, we are concerned that a mere resurfacing of Malin Road could well lead to early pavement failure.

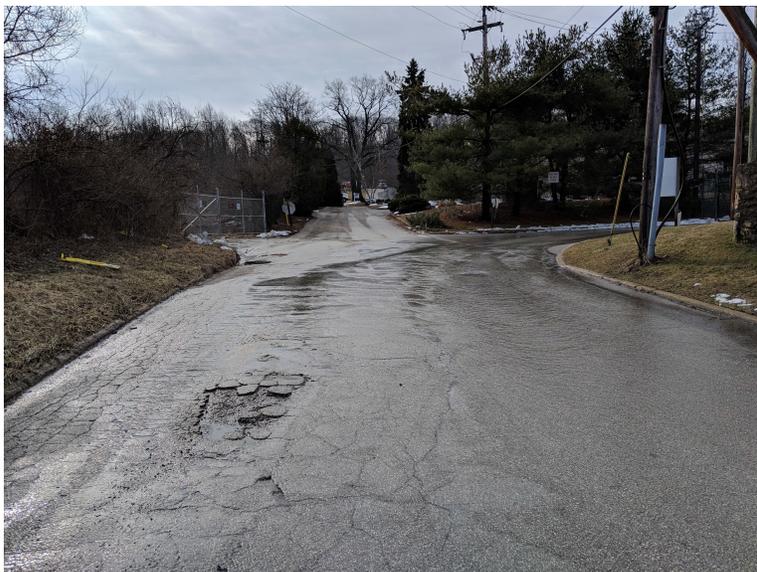
Figure 2, Malin Road, pavement delamination

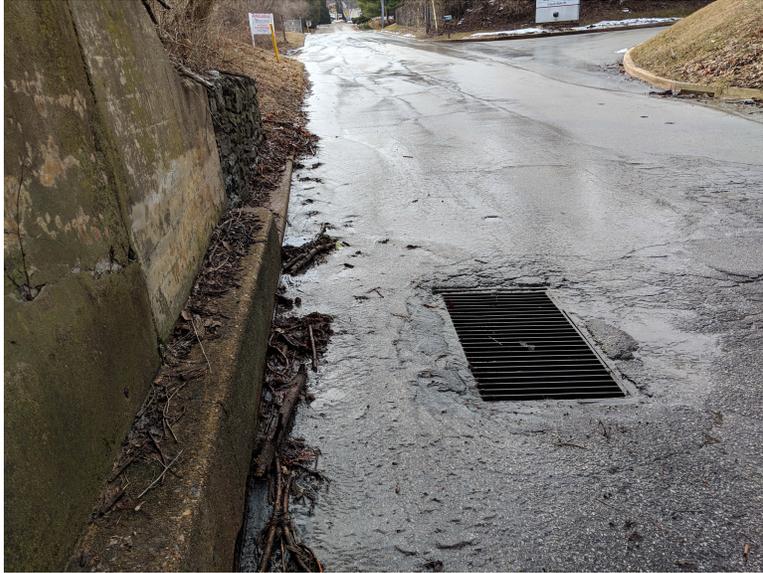
There is some underground drainage on Malin Road, as evidenced by two drainage inlets at the low point near the overpass (figures 4 and 5) and one inlet uphill on the south side. However on a field visit during a spring day with runoff from snowmelt we observed sheet flow from the elevated portions of the road on the south side (figure 6) and ponding at several points (figure 7).

Figure 5, Malin Road, drainage inlet

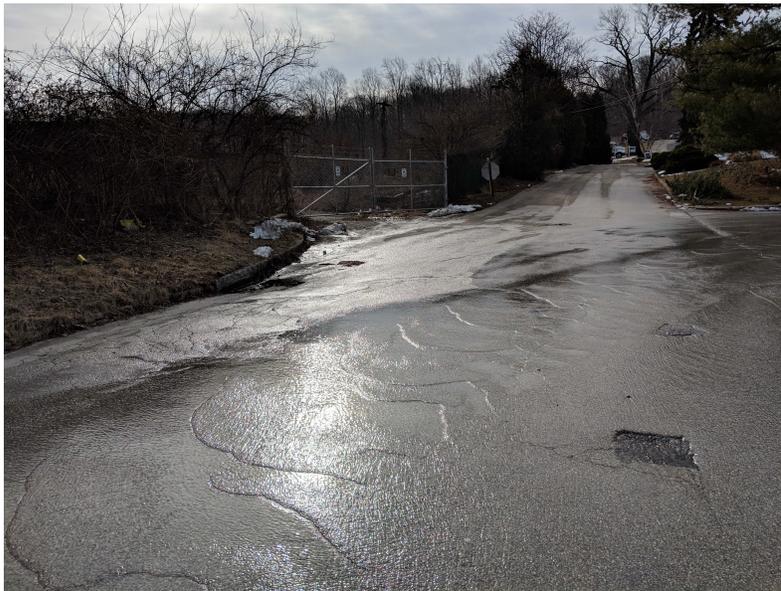
Figure 6, Malin Road, sheet flow

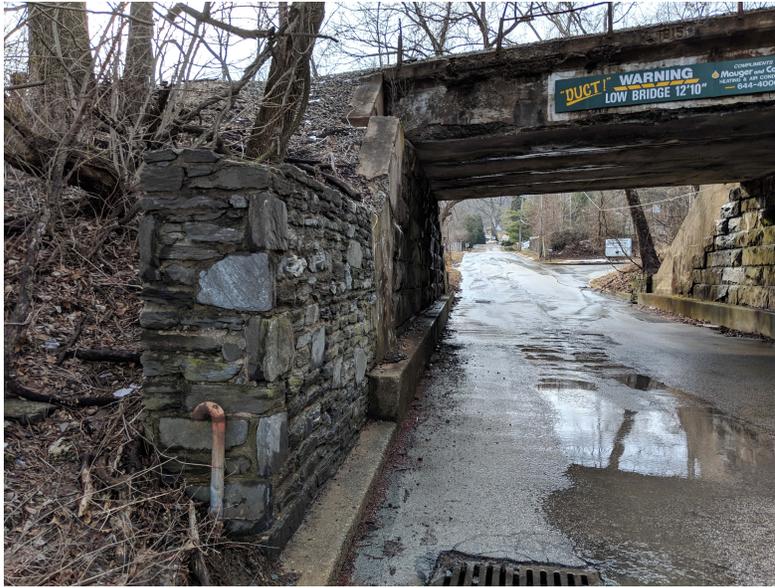
Figure 7, Malin Road, ponding

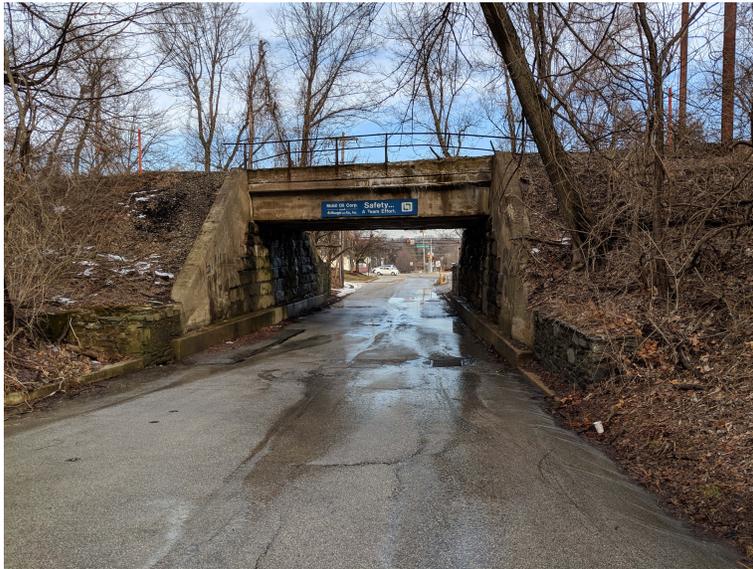
In addition, we note that the south side of the overpass offers an easy route for anyone wishing to climb from the roadway to the railroad tracks (figure 8). Given the potential for youth of varying ages living in the proposed development, this should be considered an “attractive nuisance” for public safety purposes.

Figure 8, potential climbing routes from Malin Road to the railroad tracks

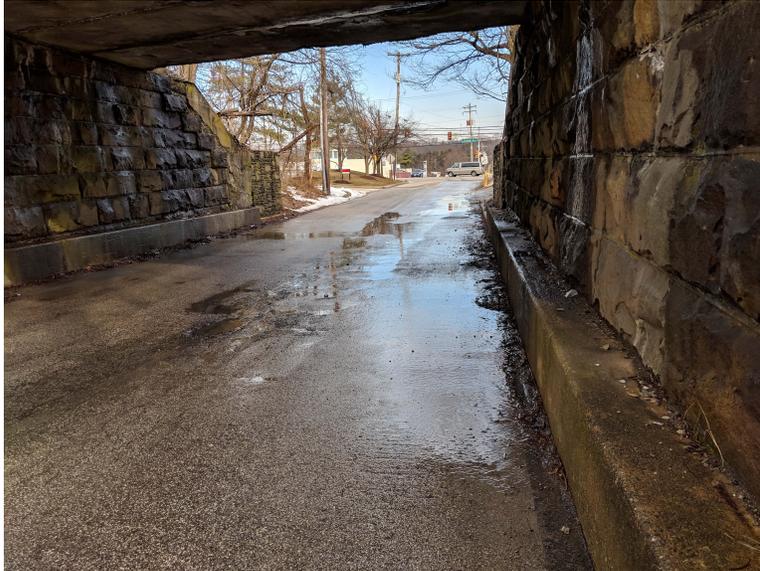
Second, the Plan appropriately calls for a pedestrian walkway protected by a Jersey barrier and railing under the overpass (Sheet 24). In order to keep the existing concrete curb (figure 15) in place (presumably for structural reasons), without reducing the cartway width even further, the design in the Plan would build the walkway over the curb, at a height approximately 32" above the surface of the road (figure 16). This raises design issues for accessible ramps between grade level and the level of the walkway and for a safe railing system in the underpass.

Figure 15, concrete curb in overpass

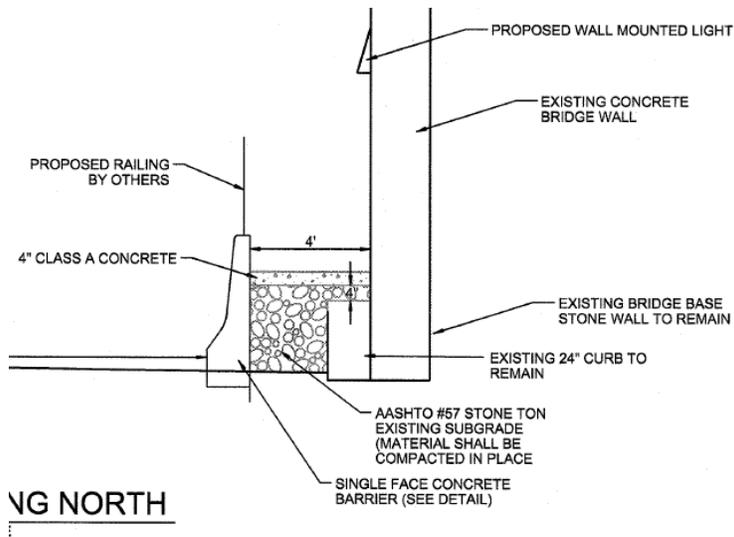
Figure 16, underpass walkway design, excerpt from Sheet 24, Revised Preliminary Land Development Plan

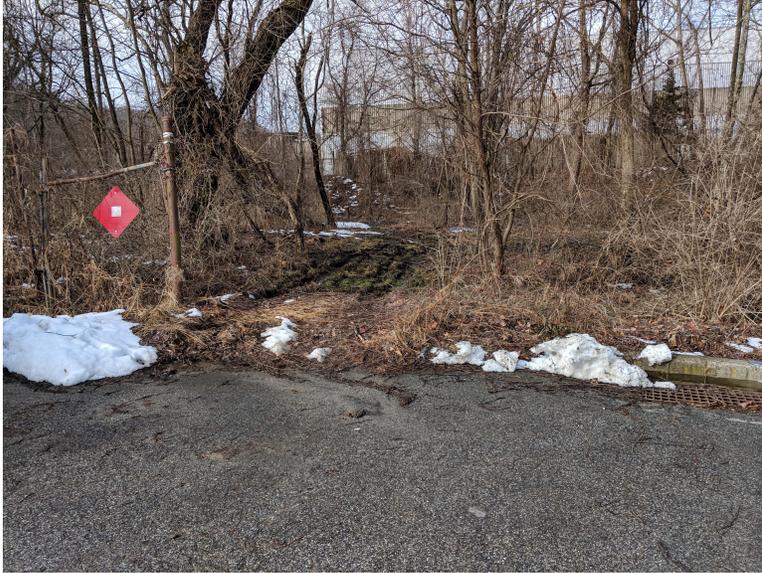
3. The proposed EAR was observed to be in a wetland area with a stream running through the area as well as runoff from the roadway (Village Way) funneling into the stream (figures 17, 18, and 19). A wetland delineation line is shown on Plan Sheet 5. Stream encroachment and wetland impacts would be serious issues for any construction in this area.

Figure 17, looking from Village Way to route of proposed Emergency Access Road

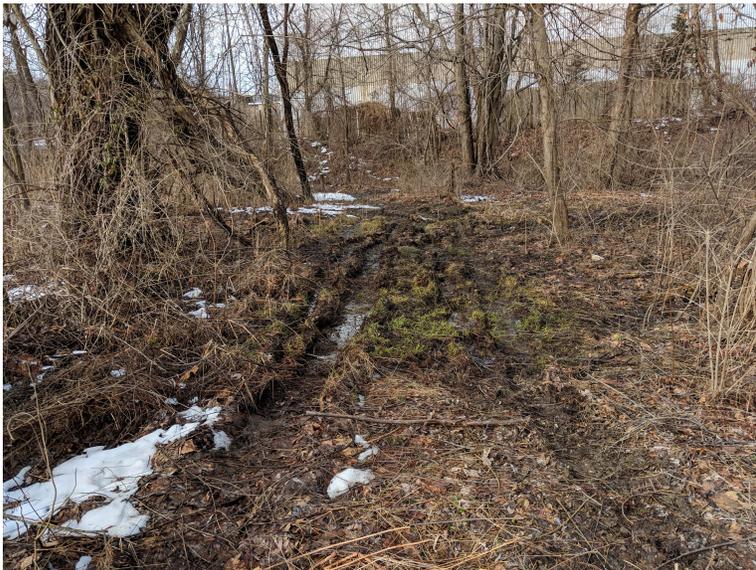
Figure 18, route of proposed Emergency Access Road – note marshy terrain

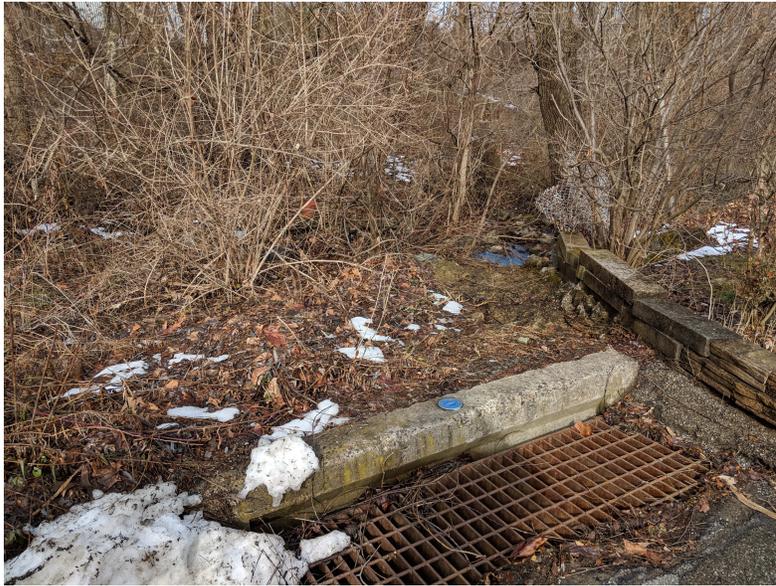
Figure 19, runoff from Village Way draining toward Bishop Tube property
