**Field-Truthing and Monitoring of the Proposed PennEast Pipeline,
FERC Draft EIS, Docket No. CP15-558**

September, 2016

Prepared by: Delaware Riverkeeper Network

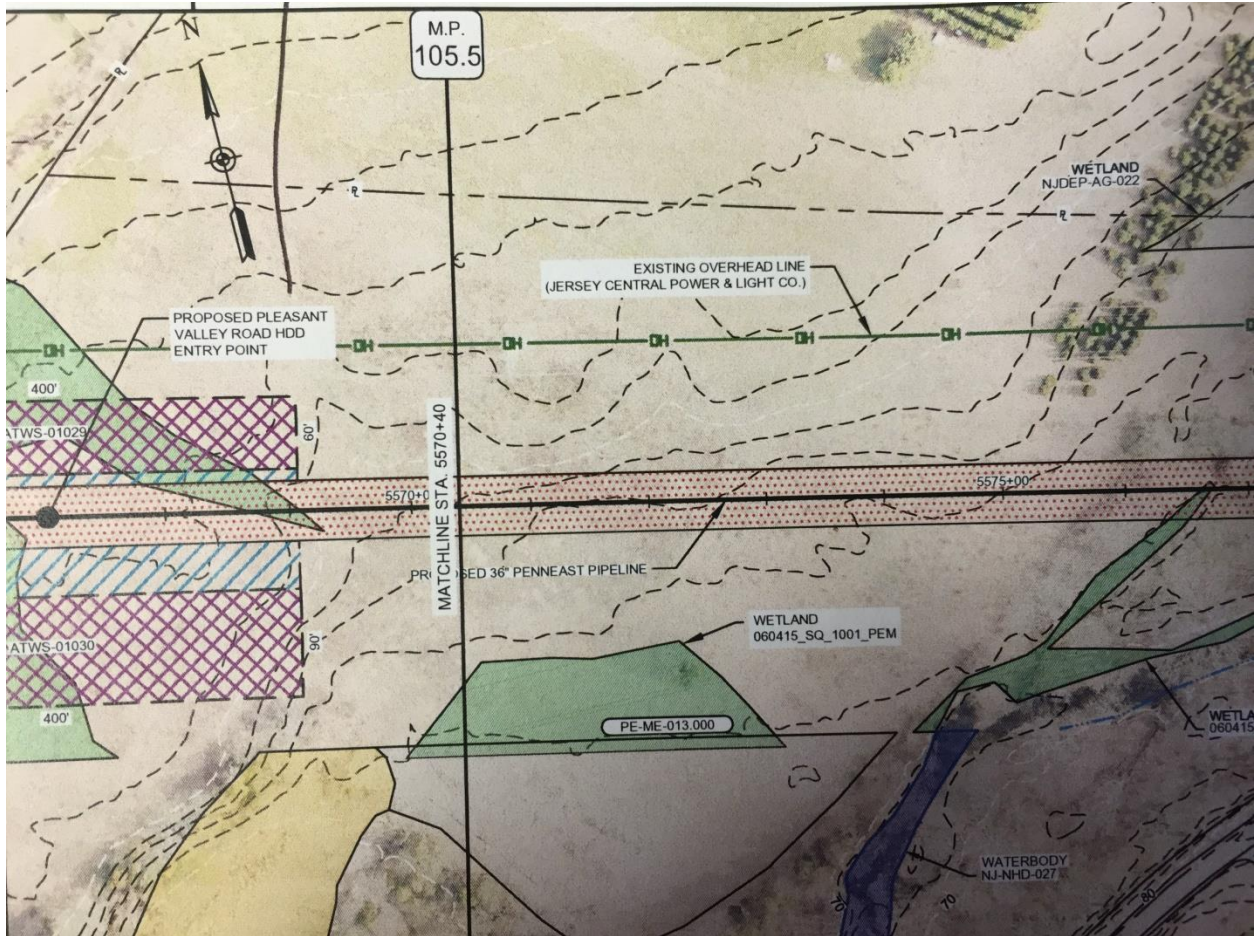
Figure 1. Penn East Alignment Drawing 000-03-01-212 Revision D. Illustrating an HDD entry work space within a wetland

HDD long borings should be considered and analyzed for feasibility for each and every waterbody crossing along the route to reduce impacts to sensitive habitats.^{vi} However, in some instances, HDD entrance and exit points which often require large land clearings and impacts to soils are proposed by PE to be located in sensitive wetland and forested habitats. This practice is another indication that avoidance and minimization is not fully being considered for wetlands and waterbodies and the most technological advanced measures and proper citing of HDD are not being considered. For example, in Mercer Co. New Jersey, a horizontal directional drill (HDD) is proposed under Pleasant Valley Rd. and an adjacent stream and wetland complex (between MP 105.5 and 106.0) (see figure 1). However, in this instance, the HDD entry point is proposed to be located at MP 105.4 and within a large PEM wetland complex (1002-PEM and 1001-PEM). According to alignment sheets, that HDD entry point in the wetland would require temporary work space on either side of the permanent ROW in addition to a 400' by 90' and 400' by 60' ATWS on either side of the permanent ROW within the wetland. It would be less impactful to extend the HDD entry point westward away from the waterbody or forest to reduce impacts and to encourage longer HDD borings to better avoid impacts from open cuts.

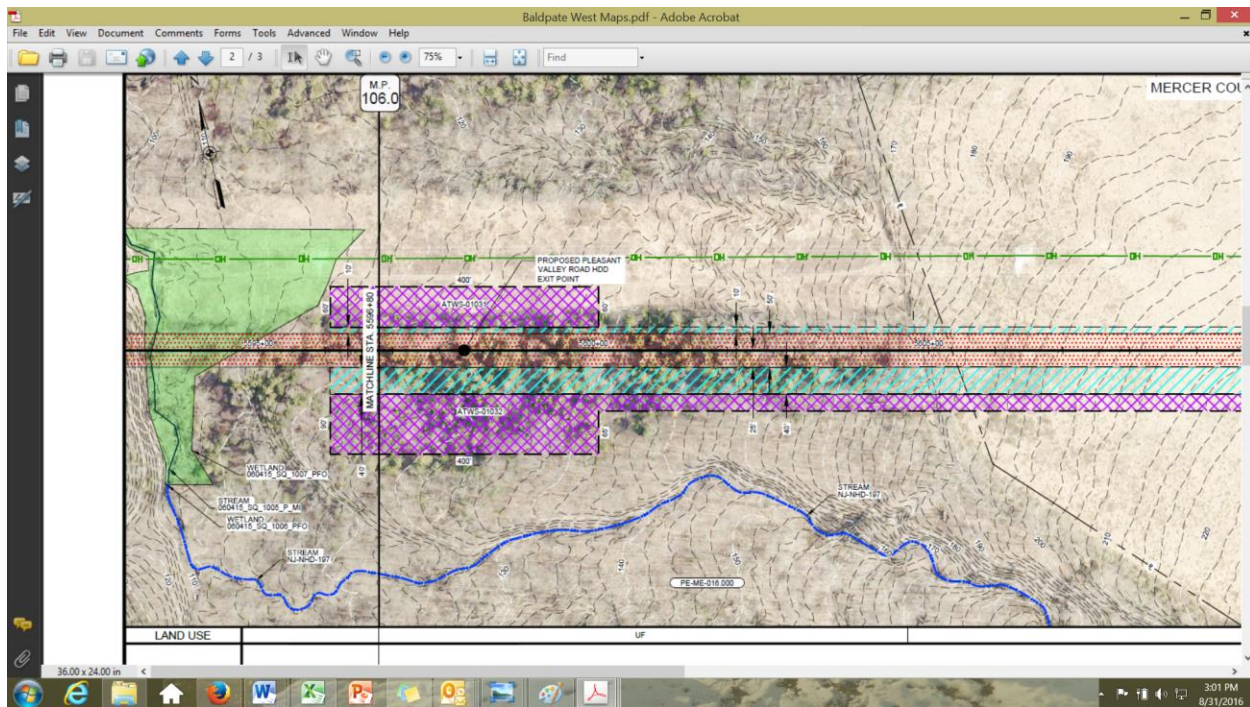
Figure 2. Penn East Alignment Drawing 000-03-01-213 Revision D. Illustrating an HDD exit work space adjacent a wetland and parallel a stream. Mature trees also appear to possibly located in this reach though faded alignments are provided by PE which make land use determination difficult.

The exit point for this same proposed HDD section is proposed just adjacent another wetland complex and just north of and paralleling a stream (see figure 2). The faded aerial overlays that are provided by Penn East in alignment sheets are unclear but it appears mature trees may be cut for this HDD exit point. Again, it would be less impactful to extend the HDD to a location where already impacted land would not be harmed since technology is feasible to drill for longer segments, thereby reducing impacts. An HDD should be required in this MP area to minimize harm to the point pleasant wetland and stream complex but the citing for the exit and entrance points is inappropriate yet it has been deemed acceptable impact by FERC.

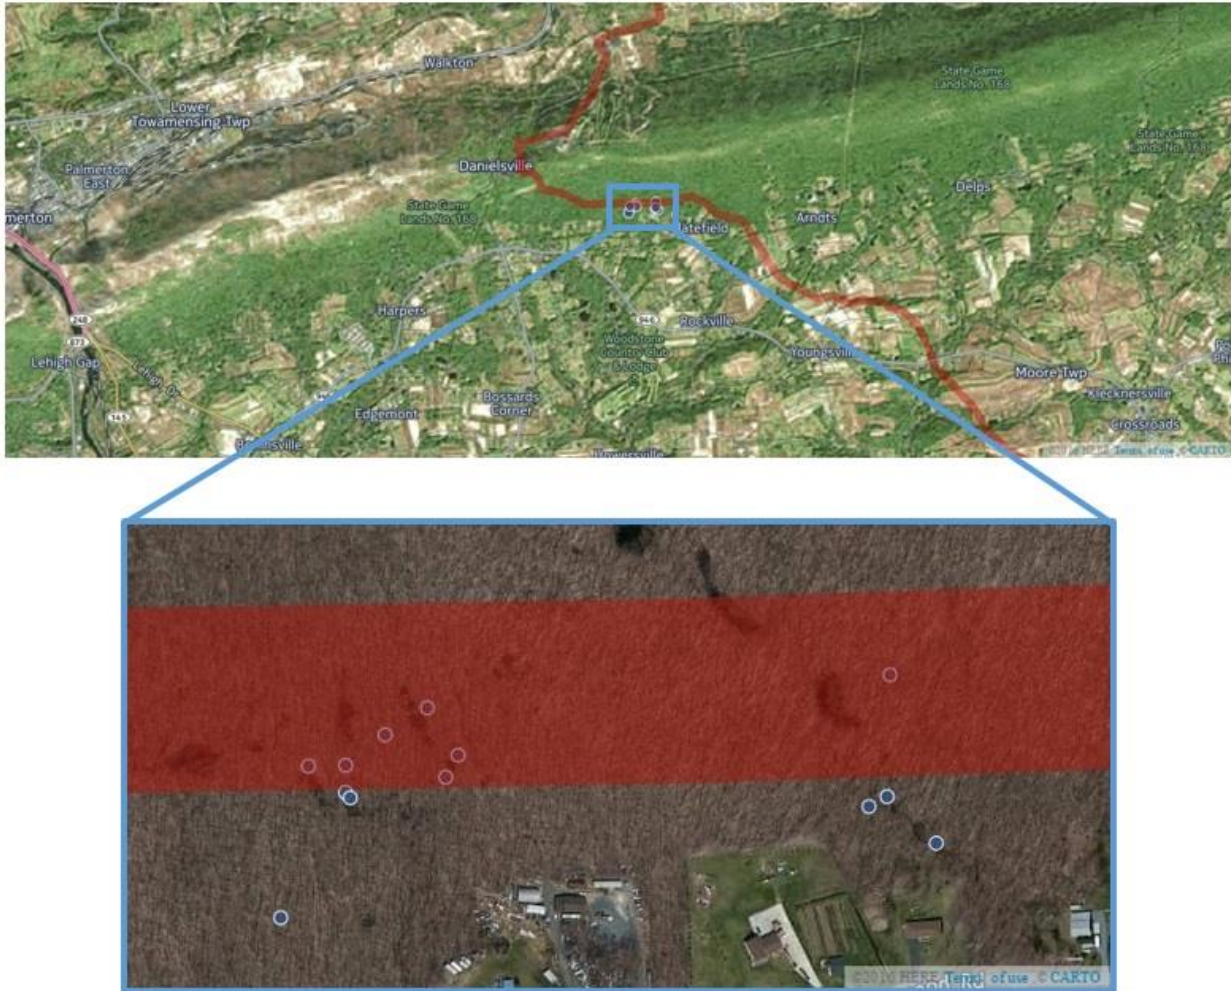
Figure 3: Vernal pools and groundwater seeps along base of Blue Mountain. Note red line depicts pipeline route with 400 ft. survey area. Herpetologists recommend 1,000 ft buffer of upland to protect vernal pool species.

sheets (Revision D) that showed there were only three vernal pool habitats present in this area of the route. (072415_JC_1001_VP, 072415_JC_1003_VP, 72415_JC_1002_VP on Figure 3 Sheets 129 and 130, PE wetland delineation map). When DRN assessed and walked this section of pipeline, it was clear vernal pool habitats were missed even in areas that PE has noted as being surveyed. DRN documented 12 vernal pools or potential vernal pool complexes and groundwater seeps and depressions that may serve as habitat along this same area of the pipeline route (see Figure 3). Table G-11 of the DEIS notes only two vernal pools in this area at MP 52.4 and MP 52.6 and both are forested yet an open cut (25 feet and 67 feet) is the crossing type PE is proposing. One stream, an UNT to Indian Creek at 52.4 is documented by PE on Table G-7. No groundwater seeps or springs have been documented by PE in this area. This is not protective of the vernal forested pool habitats that obligate and facultative vernal pool species require and it also does not include or map all vernal pools and groundwater seeps that were present in this reach of the proposed route. Table G-11 in the FERC EIS and the wetland delineation maps provided by PE are also not consistent.

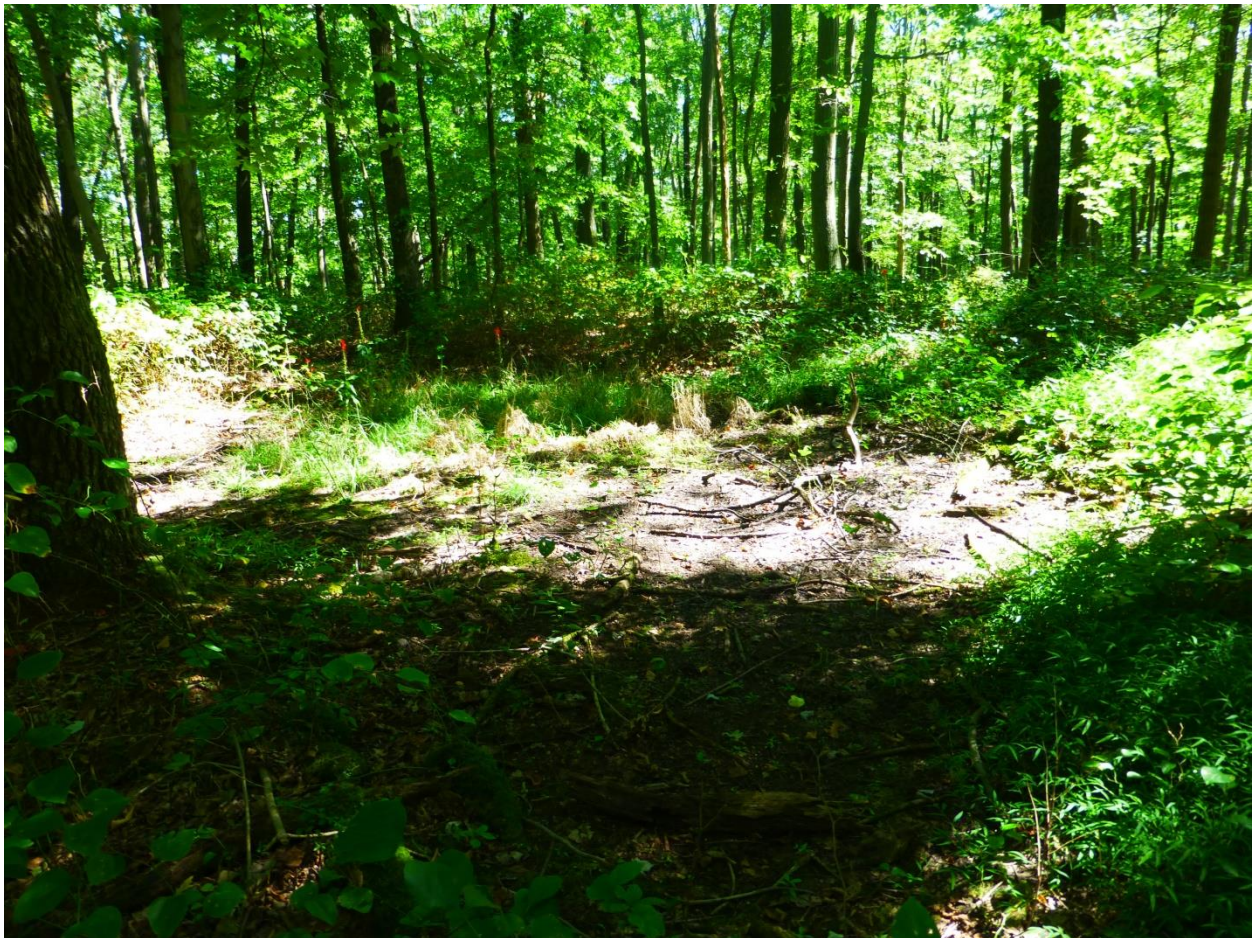
Figure 4. Note depression, stained leaves, cardinal flower in bloom and ground indicative of forested vernal pools

Though these photos were taken during the dry season on August 29, 2016, it is evident that they likely serve as wetland vernal pool areas during the vernal pool season.

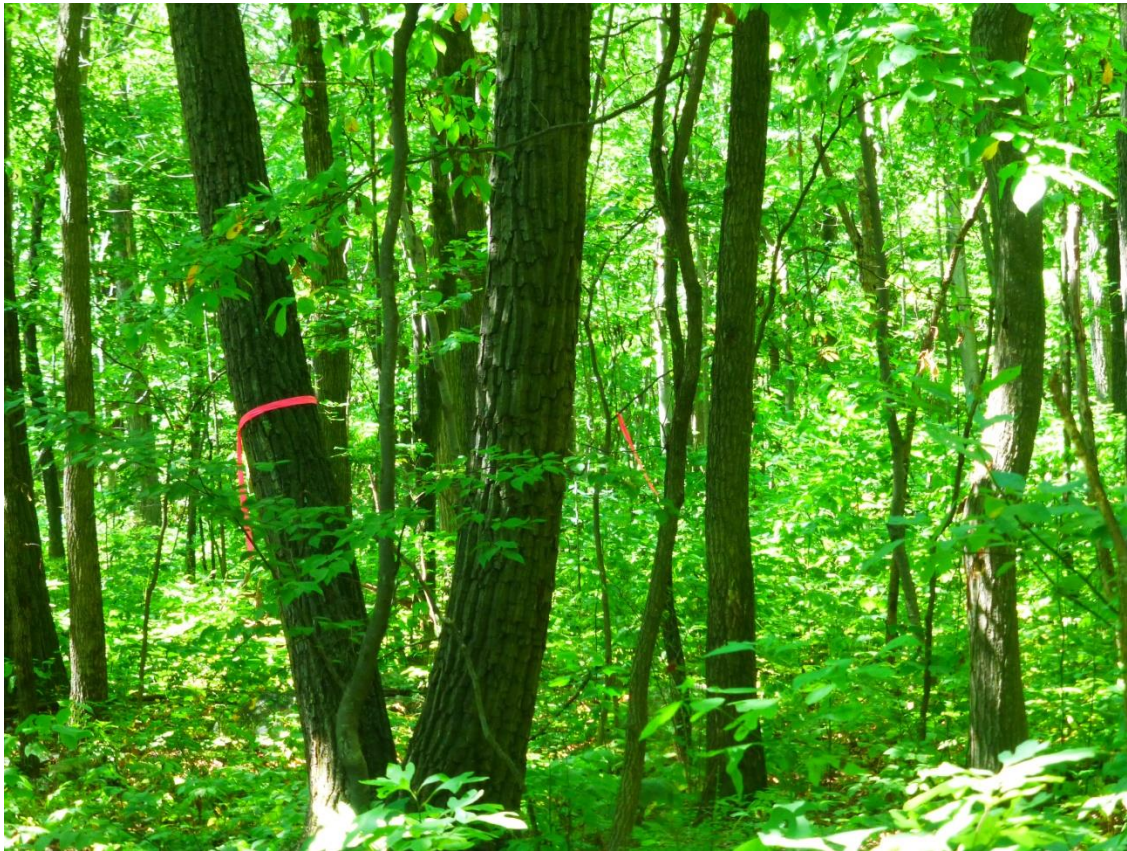
confirm with any precision in the field the accuracy of the wetlands depicted on the applicant's drawings".^{ix} DRN observed this same spotty and often completely missing flagging or non-existent flagging along the pipeline routes that were assessed – even in areas where PE stated the route had been surveyed. When we did observe flagging, it looked relatively new, like here in the case on SGL 168 yet there were very little flags present along the route and flagging was only in proximity to an easy access point.

Figure 11: Two of approx. 8 pink survey flags noting the pipeline center route along an area marked as “surveyed by PE” on SGL 168. Note flagging looks new so it is unusual that not more flagging is present throughout the SGL proposed route. None of the wetlands or vernal pool areas were flagged. On the top of Blue Mountain only 4 new pink flags were noted while no flagging was present along the steep slope away from the Appalachian Trail. Photo taken August 29, 2016.

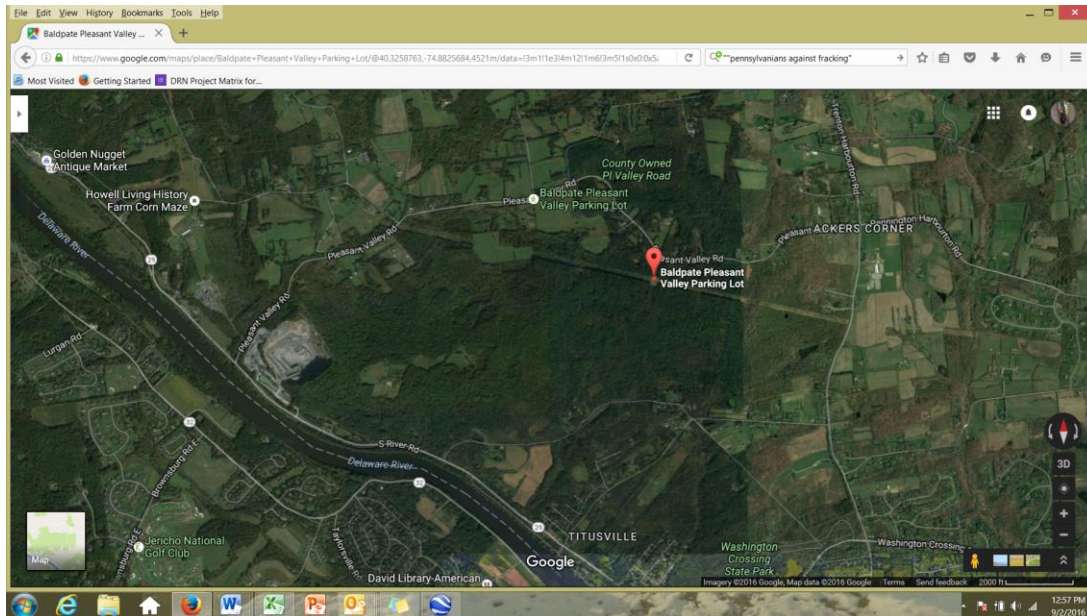
Figure 12: DRN walked west from the Access Pleasant valley road parking area on July 30, 2016 and documented within 0.5 miles one obvious intermittent stream missing from PE wetland and alignment sheet maps. Shagbark hickories and other important mature trees that provide refuge for bat species were documented. Invasive plants were documented along existing JCP&L ROW that would be exacerbated and spread with a new ROW.

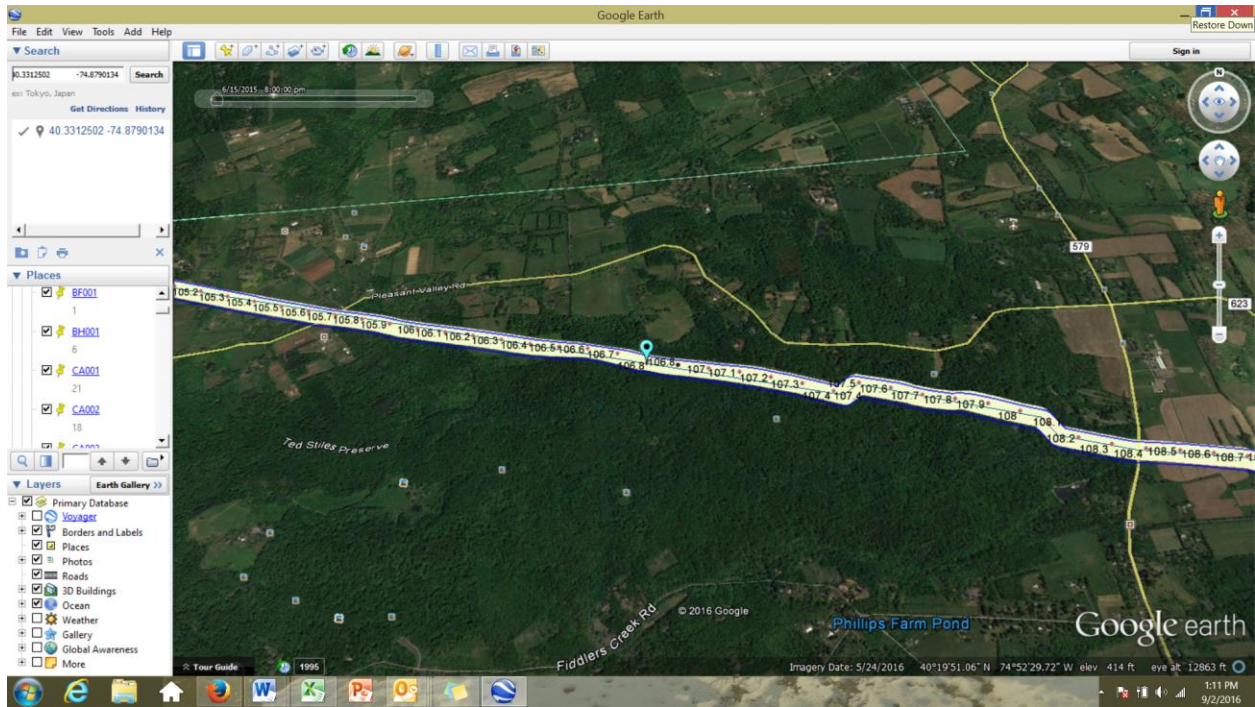
Figure 13. Approx. location of the intermittent stream within proposed ROW corridor on Ted Stiles Preserve at Baldpate Mountain not mapped by Penn East

This Mercer County Public Park has over 12 miles of marked trails for hiking, horseback riding, mountain biking, and trail running. According to the DEIS and PE alignment sheets, this area had been surveyed by PE. No flagging was observed during ground-truthing for the pipeline center line, or any of the wetlands or streams along the proposed pipeline route we encountered as late as July 30, 2016. An intermittent stream was not delineated on the PE alignment sheets nor was there flagging present to note this water feature despite the fact that the stream is delineated on state freshwater mapping layers available to the public. Table G-6 in the DEIS also does not list this stream as a waterbody to be cut.

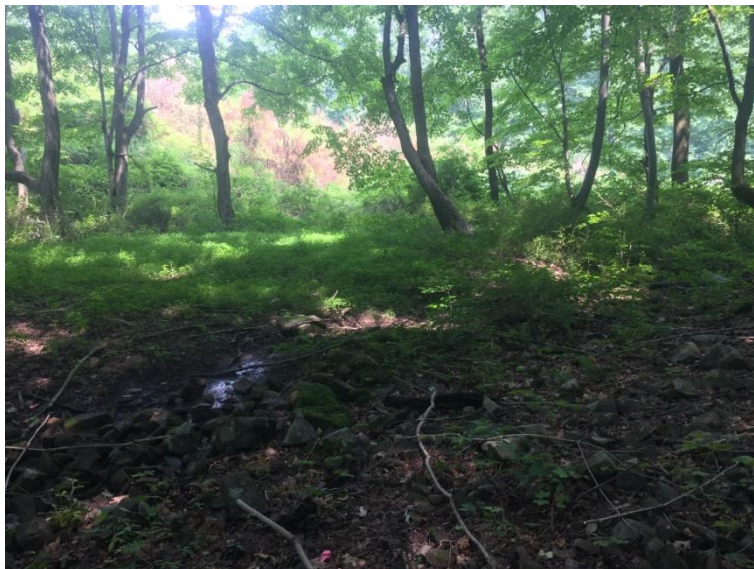
Figure 15. Intermittent stream undocumented in the DEIS mapping and Table G-6 that DRN documented along the pipeline corridor. Note abundance of invasive Japanese stiltgrass encroaching and advancing into the mature forest spreading inland into the forest from the existing ROW. Photo taken facing the existing ROW.

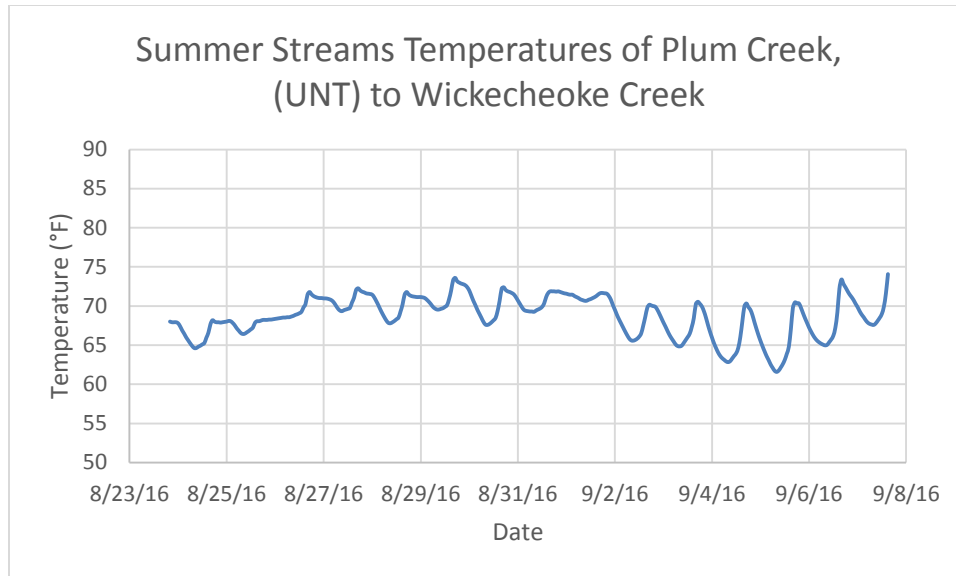
Figure 16: Stream temperatures for UNT to Wickecheoke Creek (Plum Creek) (MP 95.1)

The temperatures observed in Plum Creek, an UNT to Wickecheoke Creek, a C1 stream (FW2-NTC1) in New Jersey (located at MP 95.1) indicates conditions that groundwater seepage is assisting to help sustain and cool this important C1 tributary. This area of the stream is in the very headwaters and upstream of a large pond that eventually continues downstream to feed the Wickecheoke Creek. The temperatures range from 61.6°F to 74.0°F, with a mean of 68.7°F. The conductivity of Plum Creek on 9/7/2016 was 270 uS/cm and on In addition this stream, is currently private and preserved farmland and native plant meadows with a healthy forested riparian buffer along the stream. The PE is proposing to cut down mature trees and cut across this stream using a dry crossing and the construction period is estimated to be July 16 – September 30. However, if the proposed pipeline ROW crosses the stream at this location, it would impact and likely alter groundwater flows. Furthermore, Table G-6 in the DEIS lists 10 pipeline cuts across the Wickecheoke watershed proposed just for the Penn East pipeline alone. Most cuts are proposed to be dry crossings conducted 7/1 to 9/30 or 6/16 to 9/30 with the exception of one bore at MP 96.8. Table G-8 at MP 95.3 lists a waterbody as UNK. Despite multiple cuts across these watersheds, FERC fails to require any other measures to ensure cumulative impacts for these cuts is adequately monitored or considered on a sub-watershed or a larger watershed context.

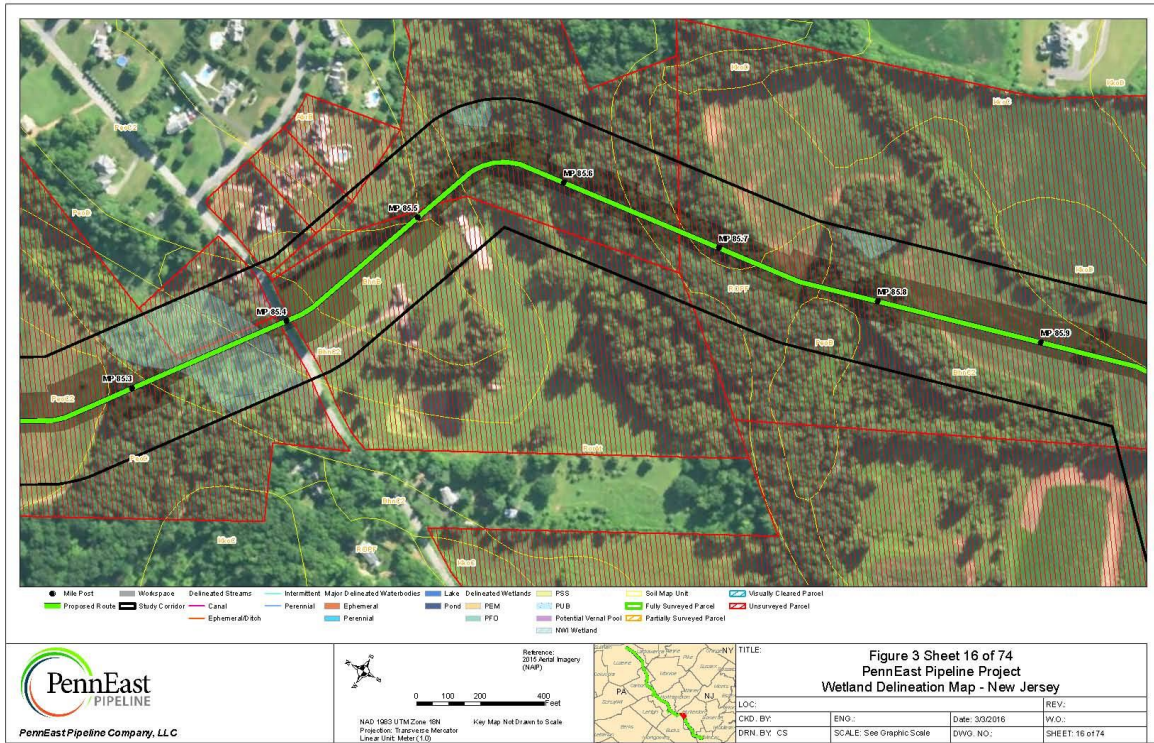
The crossing lengths identified by PE appear inaccurate and photos below indicate more disturbance of PFO depending on the alignment. The DEIS lists for this wetland complex the PFO is only 1 ft., the PSS 227 ft., and the PEM 79 ft. With some mature trees being present in the wetland, a 1 foot PFO estimate does not adequately account for the large trees likely to be cut. But no alignment sheets are updated for this deviation of the pipeline route in the DEIS plus alignment sheets included do not have MPs delineated like earlier versions which makes it difficult to cross reference waterbody crossings with MPs in the field esp. since so much of the areas have not been flagged by PE in the field. Without updated alignments sheets which FERC states only need be provided before construction, field visits and independent reviews cannot easily be provided by the public for a thorough review of ATWS or TWS which may be included at this crossing. Landowners on deviations also do not appear to have access to the alignment sheets at this time either. This inadequacy of mapping in the draft EIS is a gross omission by FERC. The map below is from the wetland delineation report for this wetland and stream (MP 85.3 to MP 85.4) which does not provide detailed construction plans as the alignments do (these maps were obtained from the DRBC website not the DEIS). Note the unsurveyed field parcels here by PE (red hatch). These delineation maps were not part of the DEIS volumes provided by FERC which indicates another missing piece and data source that is not readily accessible nor made available at all to the public and community reviewing the DEIS.

Figure 18: Wetland delineation maps not part of DEIS package

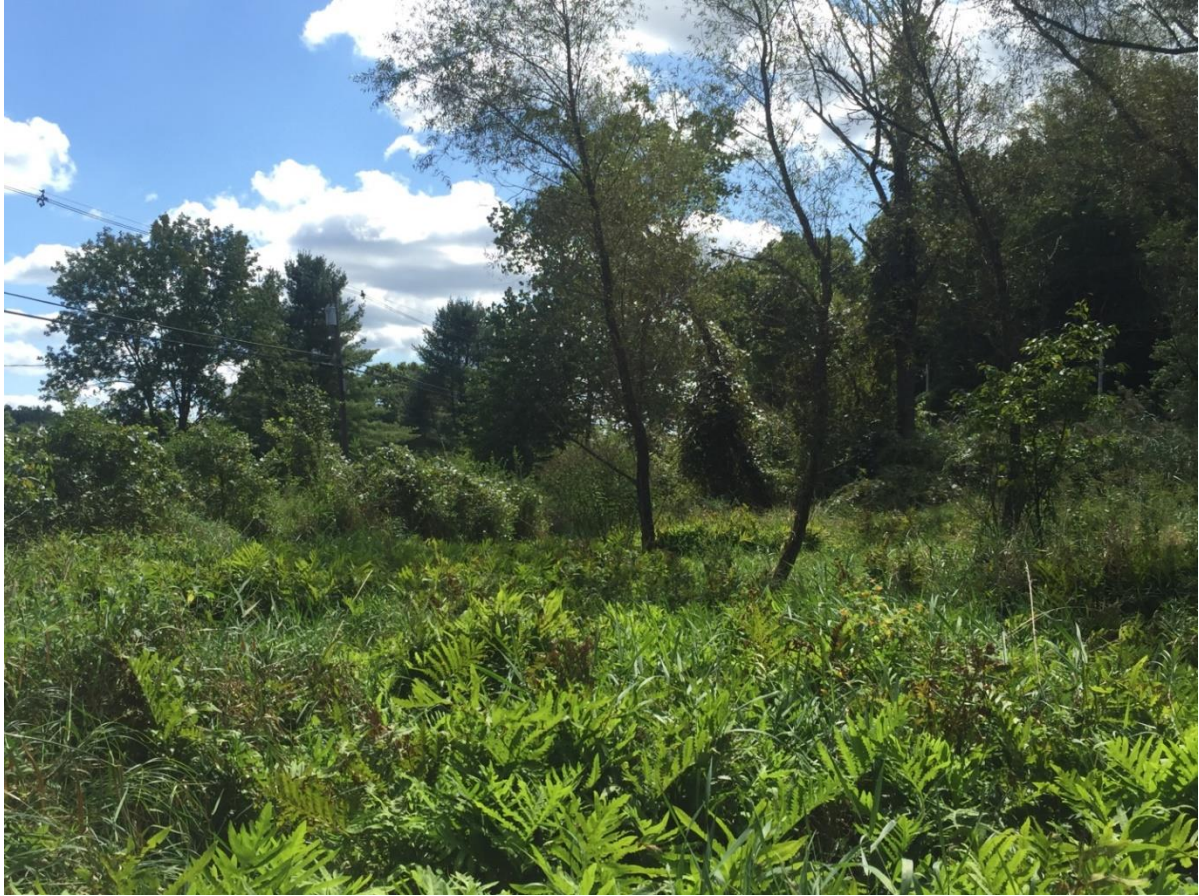
Figure 19. Wetland and stream complex that could be cut by PennEast pipeline around MP 85.3-84.4. The crossing widths (1 ft.) PE provides per wetland type especially related to PFO do not appear comprehensive from observations in the field. Photo taken August 12, 2016.

Some of the native plant species in the wetland or shading the wetland observed (not all identified here) include cattail, sensitive fern, wool grass, bull rush, golden rod, jewelweed, deer tongue, and ironweed. Mature trees and shrubs within the wetland or shading the wetland and along the streambank that would be cut include: red maple, willow, oak, dog wood, and witch hazel. Invasives present include Japanese stiltgrass and phragmites. The landowner has conducted several invasive species removals over the years in this wetland area – mostly targeting multiflora rose removals to ensure native plants reside in this important wetland. In the spring the wetland teams with amphibians and frog choruses are abundant according to the landowner.

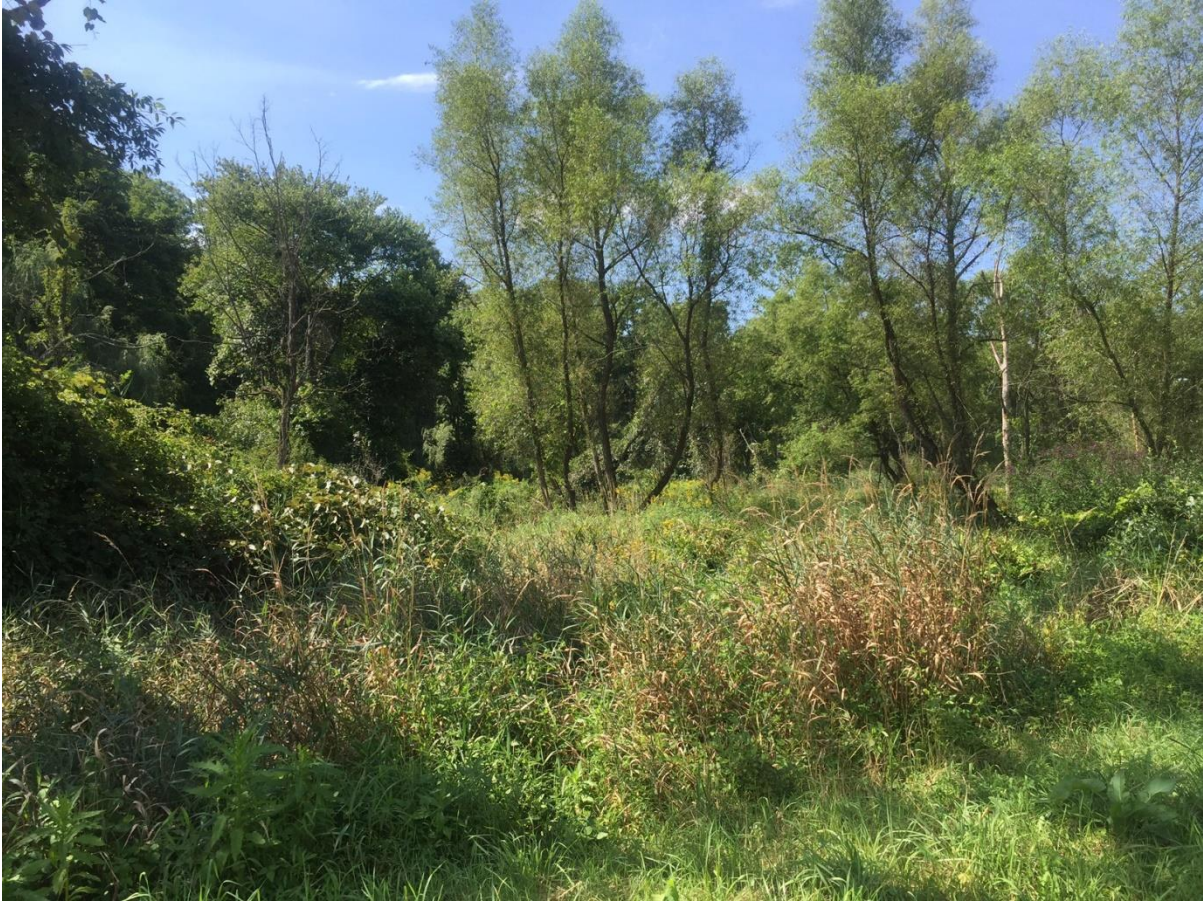
Figure 20. Wetland and stream complex that could be cut by PennEast pipeline around MP 85.3-84.4. The crossing widths (1 ft.) PE provides per wetland type especially related to PFO do not appear comprehensive from observations in the field. Shade from mature trees just outside the wetland would also likely be cut. Photo taken August 12, 2016.

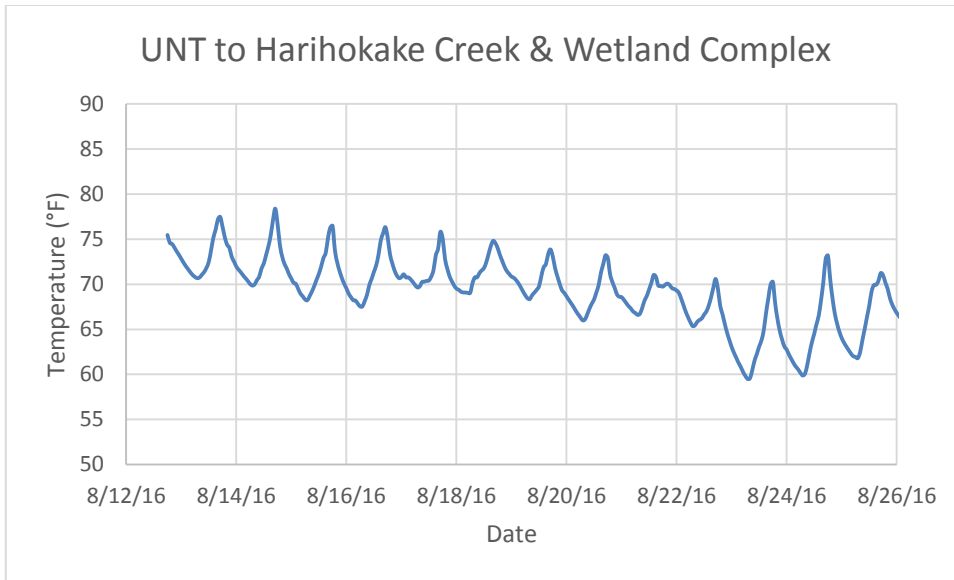
Figure 21: Temperature Data from UNT to Harihokake Creek that flows through wetland complex

The summer stream temperatures collected from this station on the UNT and wetland are indicative of good water quality, ranging from 59.5°F to 79.0°F, with a mean of 69.4°F. The conductivity of the stream on 8/12/16 was 371 uS/cm. From Aug 27 to Sept 7, 2016 the stream was dry and the HOBO probe was taking air temps as a result (air temps. removed from graph above). These dry conditions indicate the very sensitive nature of these headwater streams and wetland complexes PE proposes to cross. The proposed ROW would cut across this wetland and stream complex bringing with it cascading and long term impacts that would impact stream and wetland temperatures and reduce shading and habitat that is currently present in this wetland complex. The proposed ROW would cross the Harihokake and its tributaries at 7 different locations (MP 85.4, 85.6, 85.8, 85.9, 86, 86.3, 86.7), which poses a threat to this watershed individually and cumulatively. Again, FERC has not assessed the cumulative impact of all of these cuts across watersheds, FERC has not required in situ information or stream water quality conditions to be collected by PE, FERC has not required updated alignment sheets and maps – all gross errors and omissions in the DEIS.

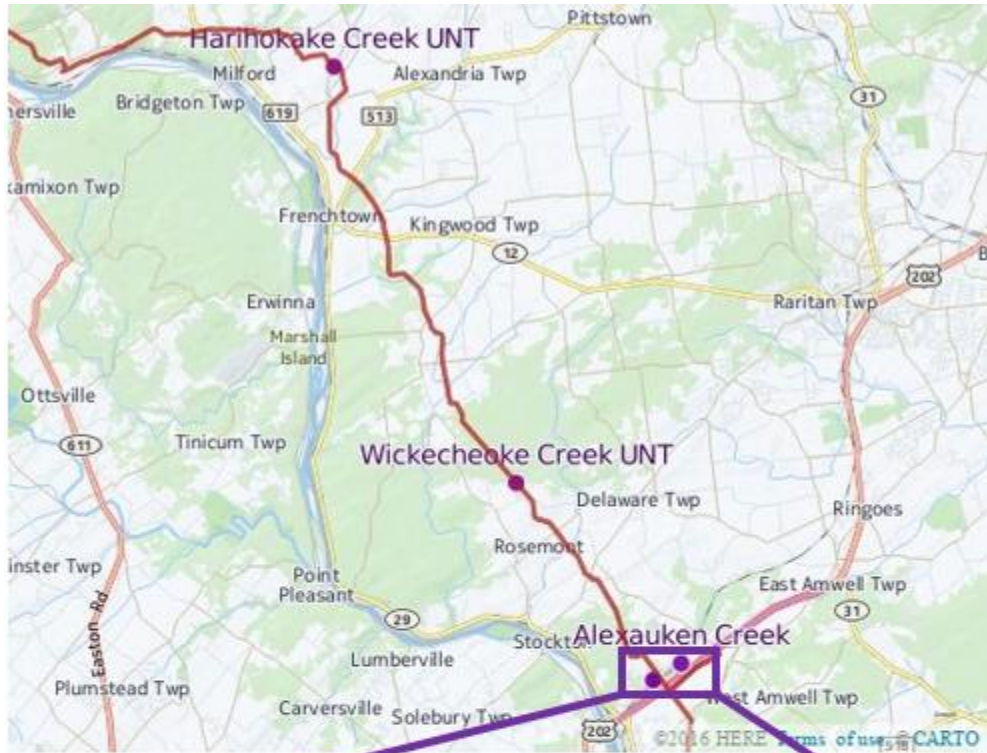
Figure22: HOB0 Probe Locations along C-1 streams in New Jersey

DRN deployed HOBO automatic temperature probes in several C1 watersheds in New Jersey in August, 2016. Locations were selected based on the proximity to the Penn East pipeline route and where we could get access on private lands. The data clearly show long term cascading impacts to streams where existing ROWs cut across these streams. FERC's point that with agency review the CEQ regulations under NEPA will be fulfilled is a false statement. Even with all mitigation measures in place or deemed complete by the agencies on other ROW projects, the data show stream impacts persist. The locations of the HOBO probes can be seen in purple, in Figure 1 below. In addition, a 400-foot buffer zone (200 feet on either side of the proposed ROW) of the proposed pipeline can also be seen on the figure in red.

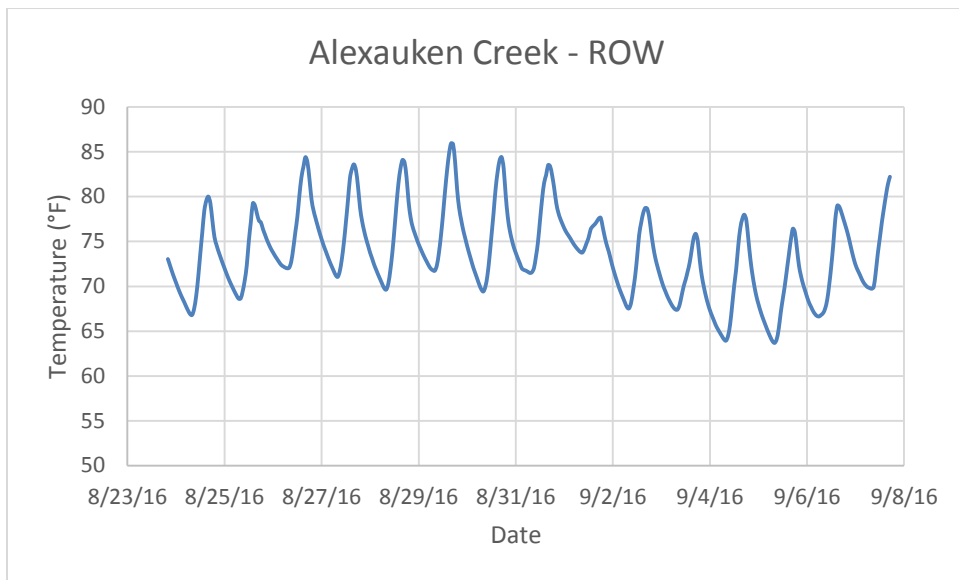
Figure 23: Temperature data for Alexauken Creek, by ROW

The data from the ROW logging station on the Alexauken show daily fluctuation. The temperatures range from 63.7 °F to 85.9 °F, with a mean of 73.7 °F. Whereas, the data collected from the other non-ROW station show much less fluctuations in temperature. For this station, the temperatures ranged from 66.4 °F to 78.5 °F, with a mean of 72.7 °F. Aquatic species generally have a preferred temperature range, and thrive in more stable temperature conditions. A ROW close to a waterbody means that air temperature would affect water temperature more rapidly. These rapidly fluctuating temperatures can wreak havoc on aquatic life. In comparison, a water body away from ROW and surrounded by forested land, would not be affected by air temperature as much, since the forest would act as a buffer to regulate water temperature. These trends can be clearly seen in the data collected for Alexauken Creek. The station by the ROW not only had a higher mean temperature, a much higher maximum temperature than the other station.

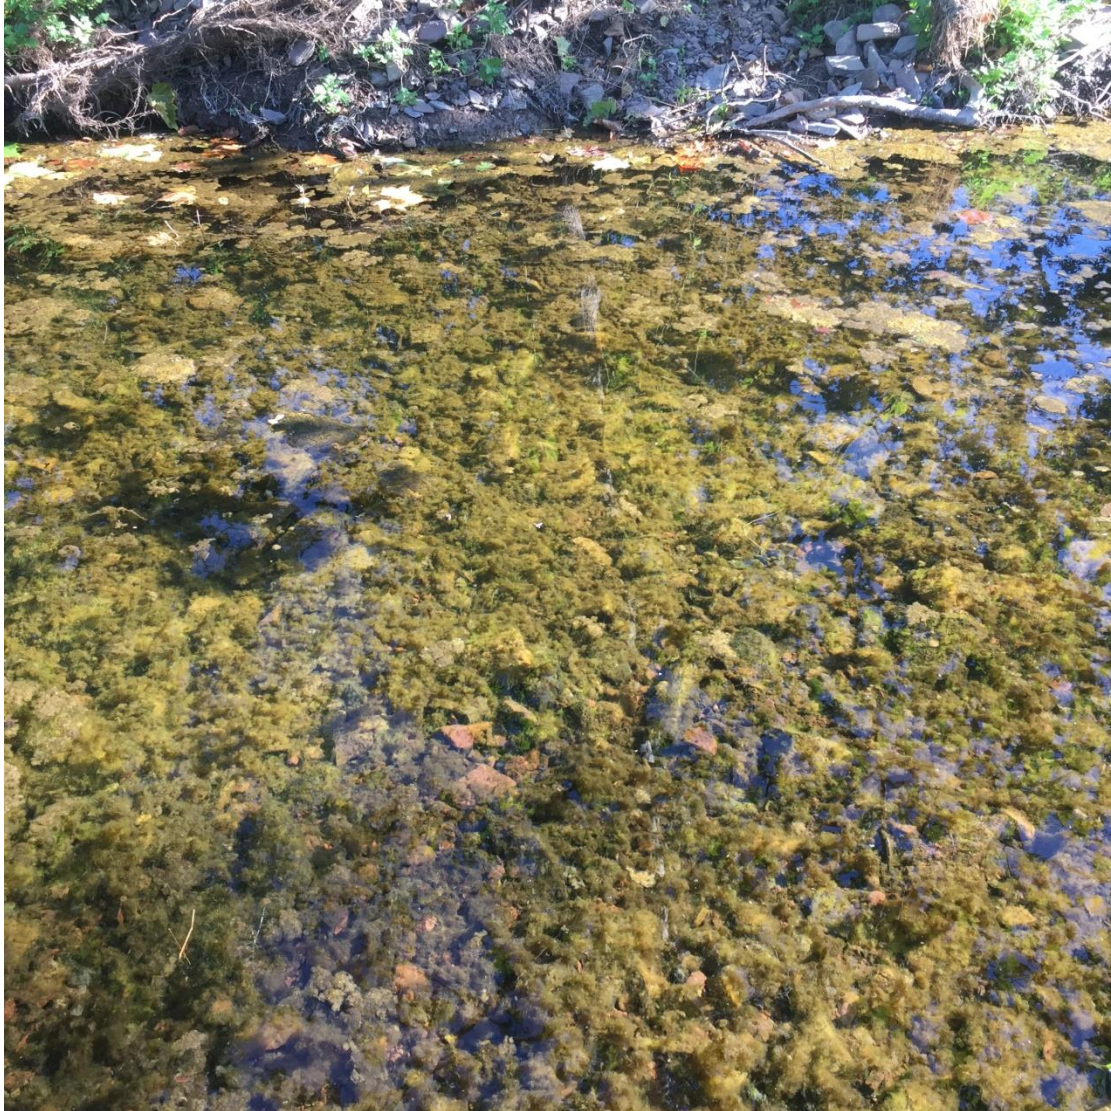
Figure 25: Abundant algae growth in Alexauken Creek, a C1 stream in New Jersey growing in an existing gas ROW

Warmer water holds a lesser amount of Dissolved Oxygen (DO). DO is essential for the sustenance of aquatic life. It should also be noted that algae growth is very abundant in the ROW corridor. Algae blooms are indicative of higher temperatures, and make living conditions tough for other aquatic life. As algae die out and decay, they rob DO in water, available to other aquatic life species (see photo below).

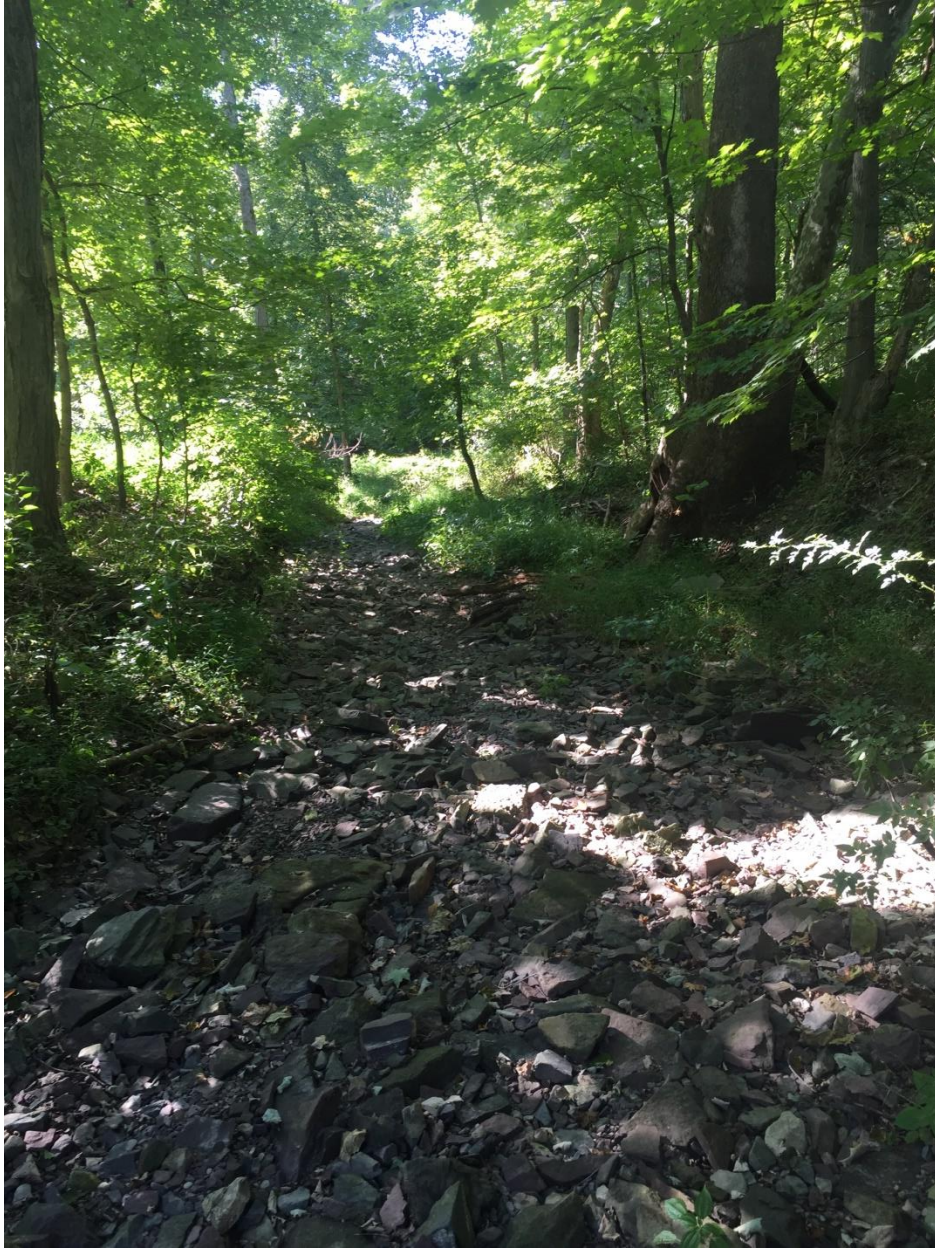
A third temperature logging station was located along an unnamed tributary of Alexauken Creek. This station was located southeast of the downstream Alexauken Creek station. The probe was installed on August 23, 2016. However, on August 28 the unnamed tributary ran dry. During the 5 days the probe was in the water, the temperatures ranged from 63.9°F to 73.0°F, with a mean of 67.0°F. This small tributary is just one of many intermittent streams that are along the proposed PE pipeline ROW. This UNT tributary alone is proposed to be crossed 3 times by the pipeline, which would cause serious harm to an already stressed system and watershed. A picture of the dry streambed observed on Sept 7 below is provided and again these streams that have groundwater seeps within the ROW will be disrupted if another cut is allowed.

Figure 26: UNT to Alexuaken Creek be cut by PE pipeline. Low flows and drought conditions already cause harm to these sensitive streams. A groundwater seep remains in this tributary just upstream where aquatic life and fish are congregating and it is located directly in the path of the proposed ROW which could alter groundwater flow – a key survival need during low flow times and summer months for this tributary.

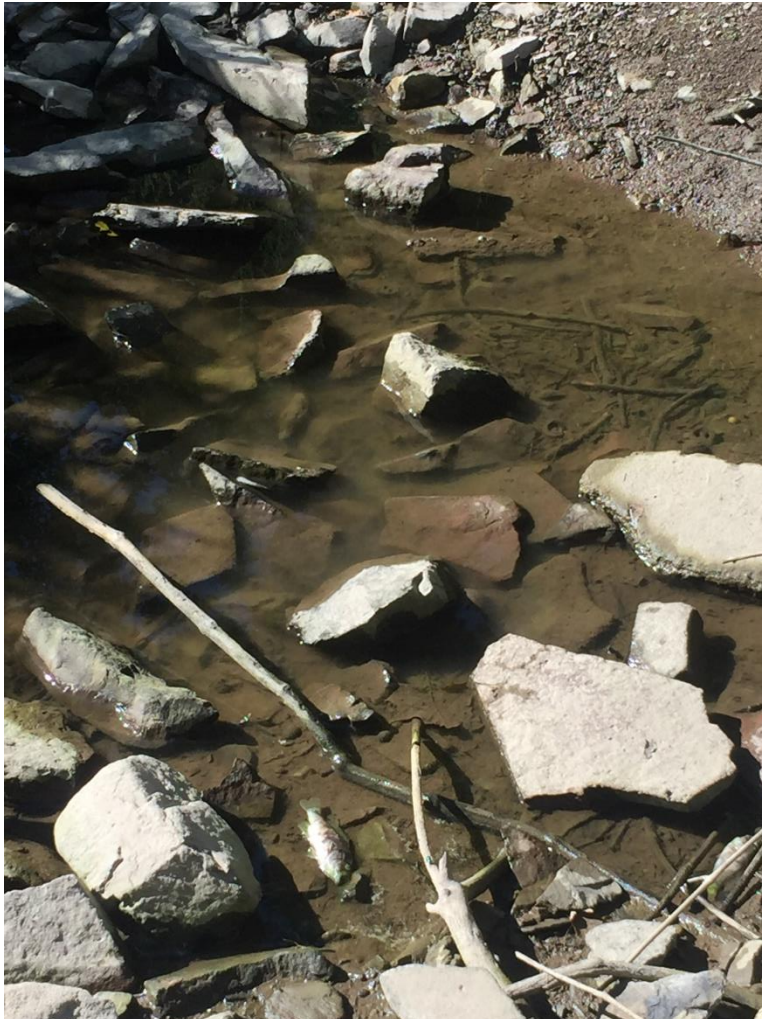
Figure 27: Remaining groundwater seep in the dry UNT to Alexauken Creek. Note dead fish. Over 100 small fish were located in this pool which is directly in the route of the proposed PE pipeline.

According to the National Weather Service, precipitation in the Alexauken Creek Watershed area was 5.6 inches below average. This is the probable cause for the dry unnamed tributary to Alexauken Creek. The lower than average rainfall is a result of extensive development in the area. It goes without saying that a dry stream is not good for aquatic life. An added right of way

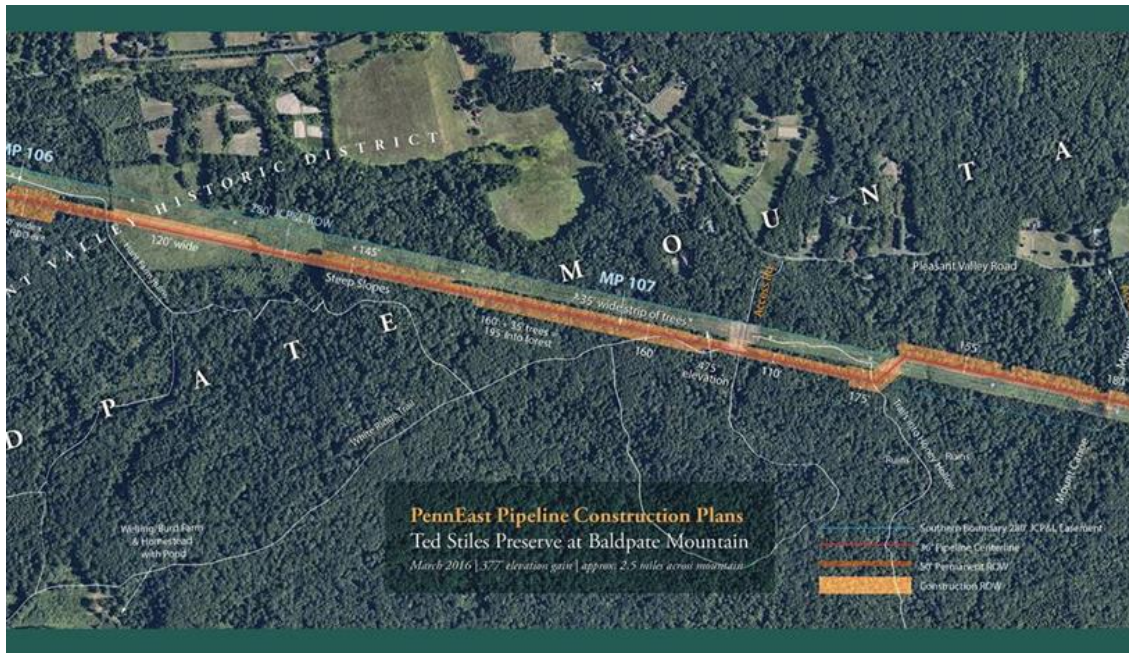
Figure 28: April 2016 Map showing increased fragmentation proposed by PE ROW

colocation is less impactful but this is not what the maps document since in the gas line would run adjacent to the existing ROW cutting through new habitat in the Ted Stiles Preserve on Baldpate mountain instead of being built within the current ROW footprint which means more habitat disturbed, trees cut, and an extension of forest fragmentation further into the woods (in the instance above).

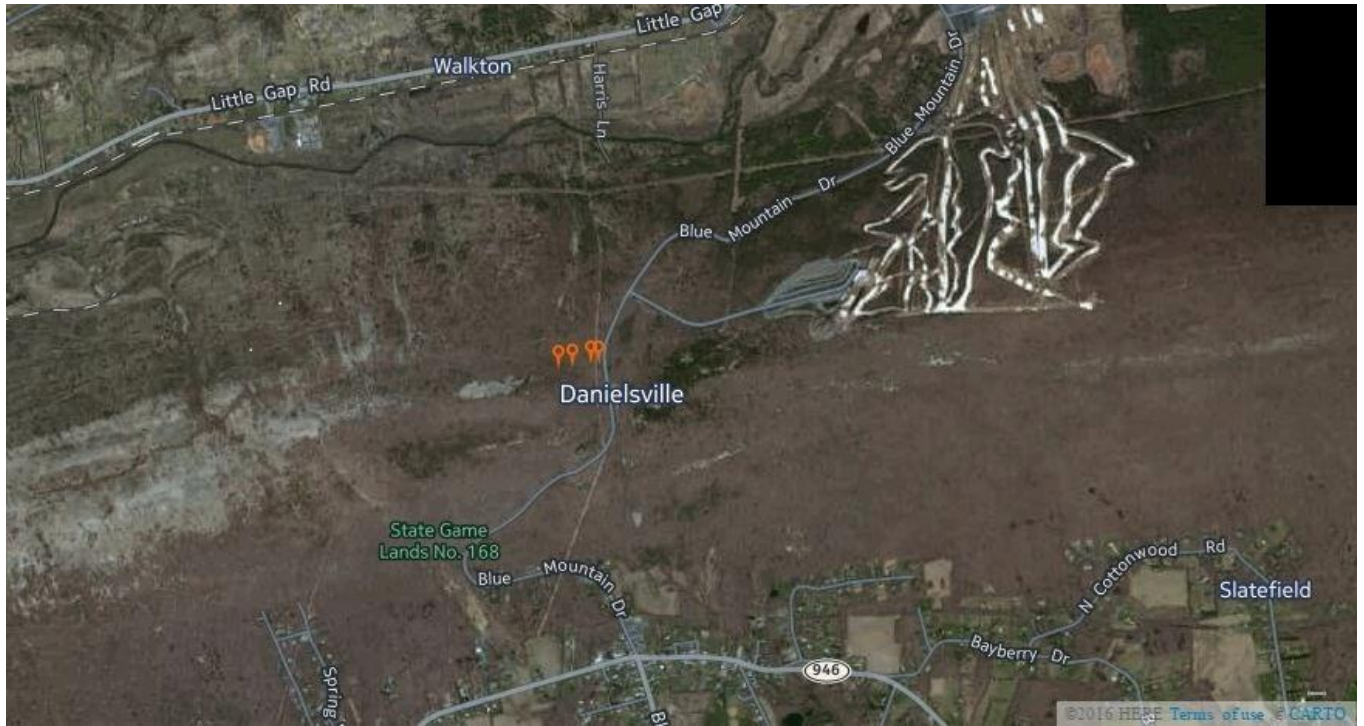
Figure 31. Locations of temperature readings taken on existing Buckeye ROW and from distances away from ROW to illustrate forest fragmentation and thermal impacts. Note Blue Mountain Ski area also to the right frame of the photo.

Sensitive glacial soils, extreme compaction, continued and repeated ATV traffic and pipeline maintenance, lack of diverse growth, bare soils, and thermal heat and fragmentation impacts to the ROW and within the mature forest paralleling the Buckeye ROW were observed.
