**Field-Truthing and Monitoring of the Proposed PennEast Pipeline,
FERC Draft EIS, Docket No. CP15-558**

September, 2016

Prepared by: Delaware Riverkeeper Network

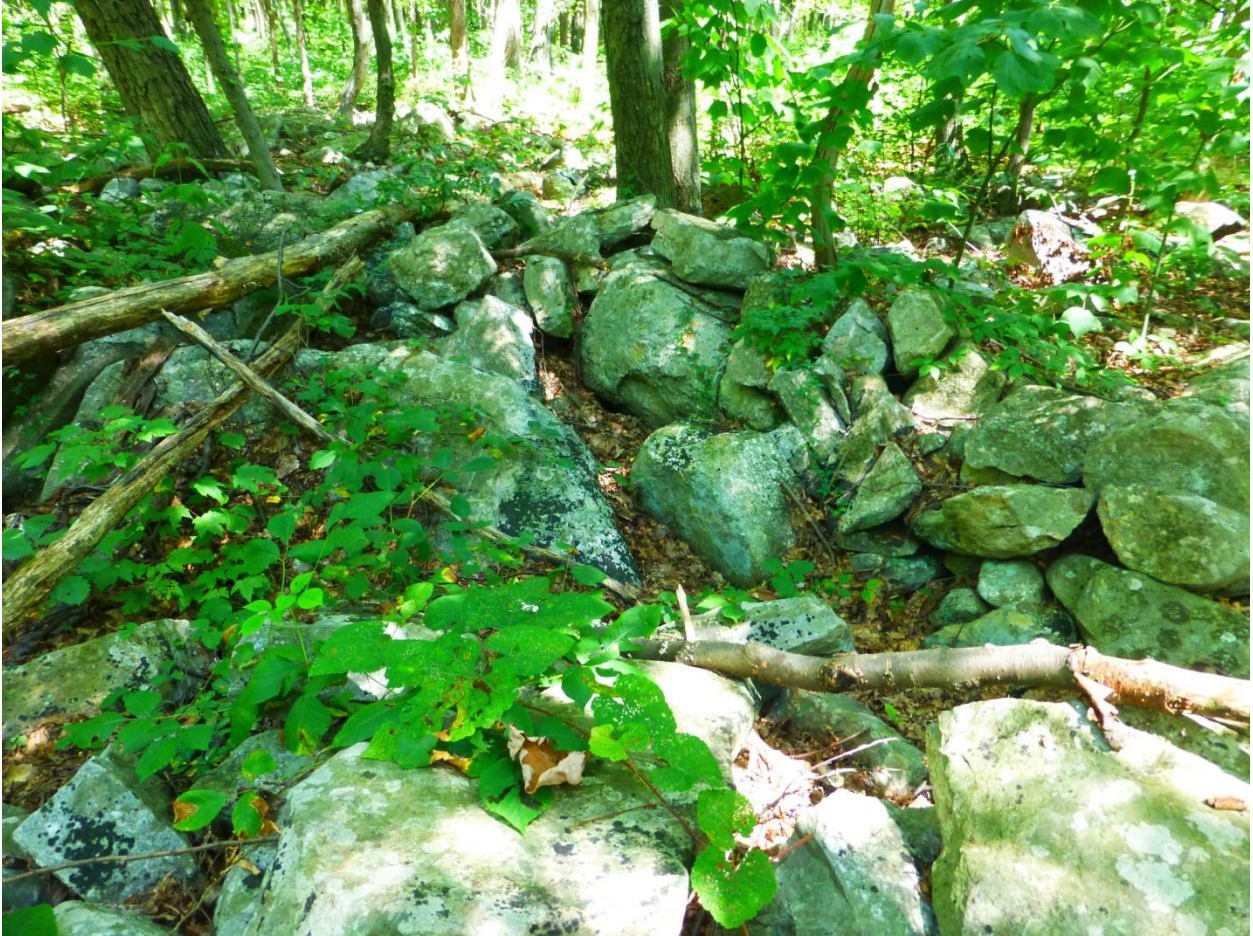
Figure 34: Example of optimum rattlesnake habitat in SGL 168 that was not currently assessed in the herp studies.

The habitats that are listed in the DEIS as being surveyed are not complete and not protective of timber rattlesnakes and copperheads. DRN documented optimum timber rattlesnake habitat during assessments conducted in SGL 168 from at least MP 52.9 to 51.0 along Blue Mountain near Danielsville, PA. The DEIS states that 51.1 to 51.6 was surveyed for timber rattlesnake but this only includes one section of this habitat and does not include all of the optimal habitat areas in that area of SGLs; therefore the DEIS is not complete nor protective of these important species. Below some images of the habitat observed during field reconnaissance.

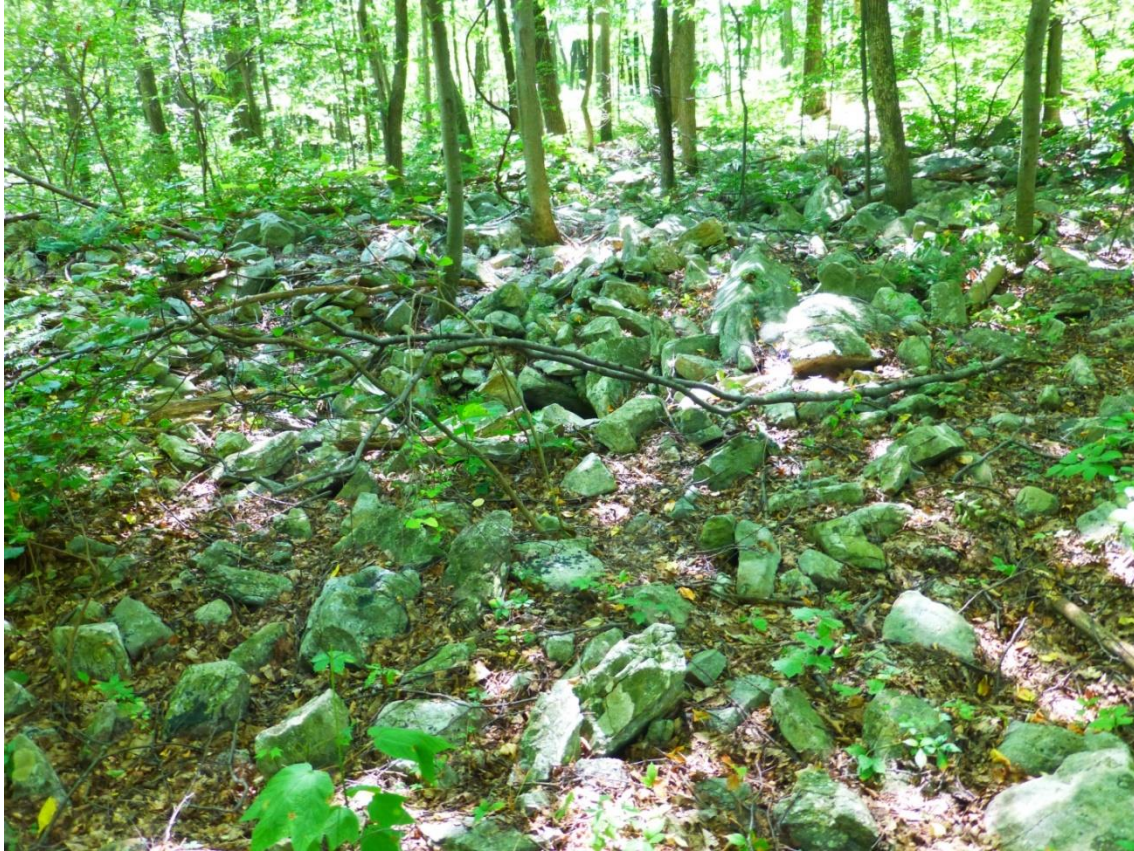
Figure 36. Typical geologic conditions and optimum rattlesnake habitat in SGL 168.

Rocky outcroppings, boulder habitat, and rodent populations and hiding places were all observed between MP 52.5 and MP 52.9. This SGL dominated area is natural and includes intact native plant habitat, boulder conditions, and mature forest on steep slopes and along the base of the mountain ideal for rattlesnakes and likely copperheads also. This area is not included in the MP Phase 1 surveys listed above and this is a large omission, especially in light of the DEIS stating that PE would adhere to the recommendations of the state agencies, including completing all necessary surveys for state species. Landowners along Cottonwood Road whose properties about the SGL 168 have heard and observed timber rattlesnakes over the past few years. Milk snakes and black racers have also been observed as well as black bears. Local residents also said that snakes are found on the top of the ridge along the AT very regularly. With these observations, it would be prudent to expand the Phase 1 studies to include ALL areas, especially in these intact habitats and public lands and to see a Phase 2 survey conducted in this area through this entire stretch. From the DEIS, this area largely in SGL 168, is not fully included. It also seems unusual that the DEIS lists only one den site for timber rattlesnakes considering the extensive length of the pipeline route in Pennsylvania counties containing known timber rattlesnake habitat.
