**Re: Headquarters Road over Tincum Creek Replacement Project
Permit No. E0901120-026, Pennsylvania Department of Transportation**

²⁹ Rippled Waters Engineering "Technical Expert Report regarding Environmental Impacts related to the Headquarters Road Bridge Replacement Tincum Township, Bucks County, Pennsylvania," report issued July 16, 2020 (hereinafter "Rippled Waters Engineering 2020")

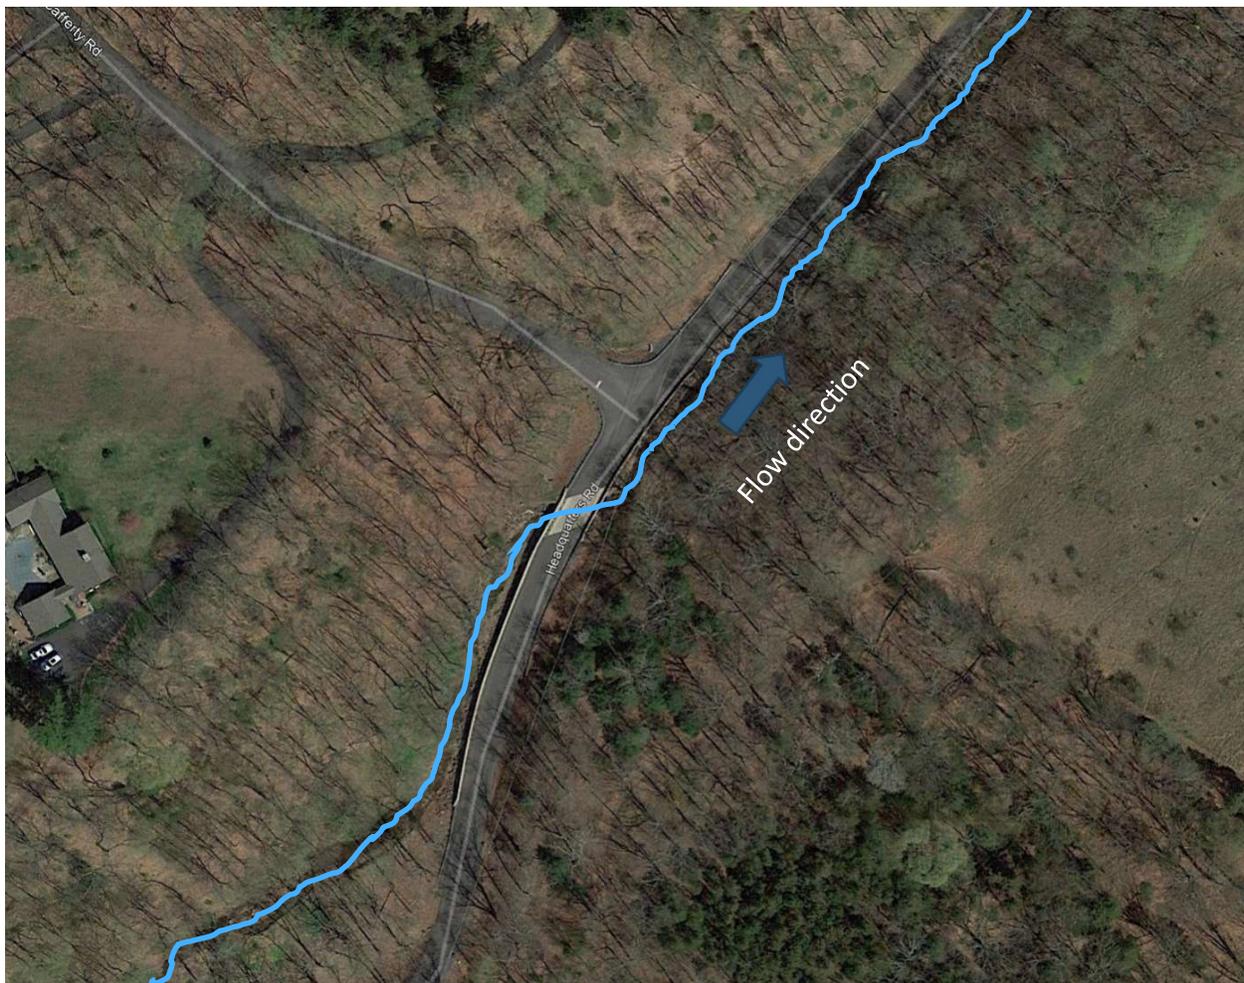
Figure 1. Aerial view of Cafferty Bridge.

Cafferty and Headquarters Road Bridge. The Little Tincum Creek travels through the bridge opening and makes a 90-degree bend to the left immediately downstream as shown in Figure 1 below.

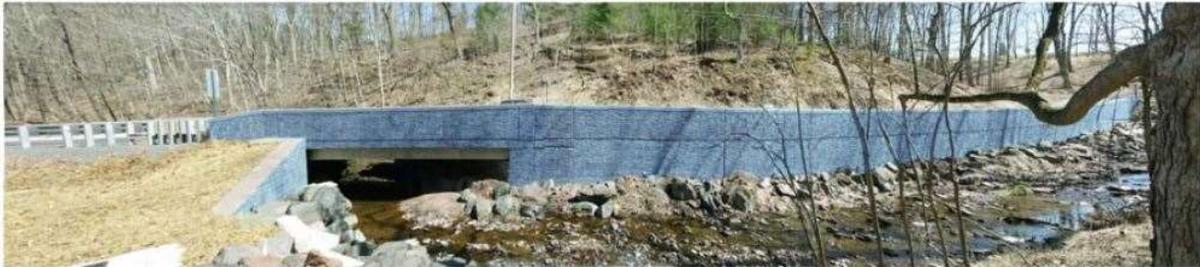
Figure 2. Cafferty Road As-built Photograph circa 2017.

The preliminary concept shared for the project indicated that the span would be the only portion of the bridge replaced and no modification was proposed to the stream channel. As evidenced in the as-built photo shown as Figure 2 below, the bridge was replaced with a nearly 200' long retaining wall on the left bank. The edge of the wall was buried with some rocks and fill.

Since the bridge was installed, it is my understanding that numerous efforts have been made to stabilize the new streambank with riprap as erosion has increased along the river left bank. Given the typical soils and geology in the watershed, the surficial soils are prone to erosion and attempts to stabilize a straightened reach of the stream will be ongoing. The riprap placed on the streambank since

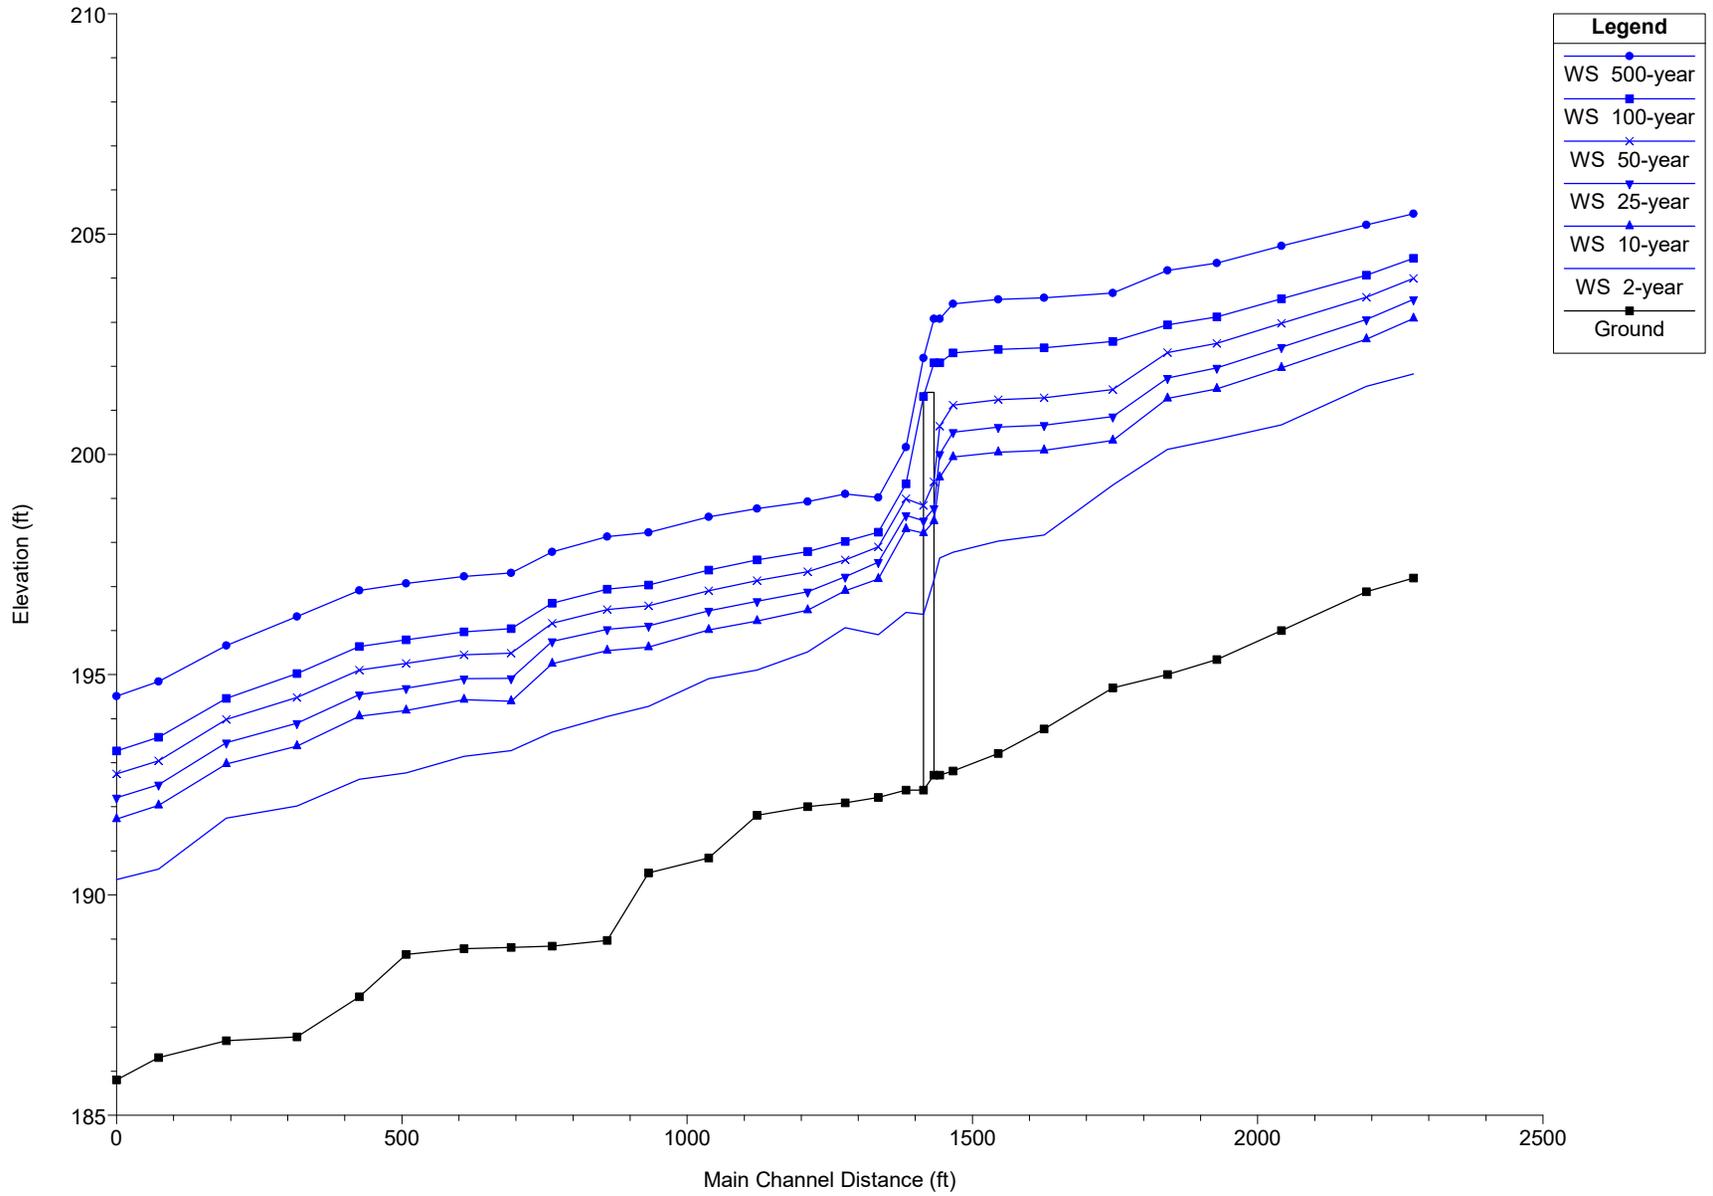
Headquarters Bridge Plan: Existing_DRN 7/16/2020

HEC-RAS Plan: Ex-DRN River: TincumCreek Reach: Headquarters

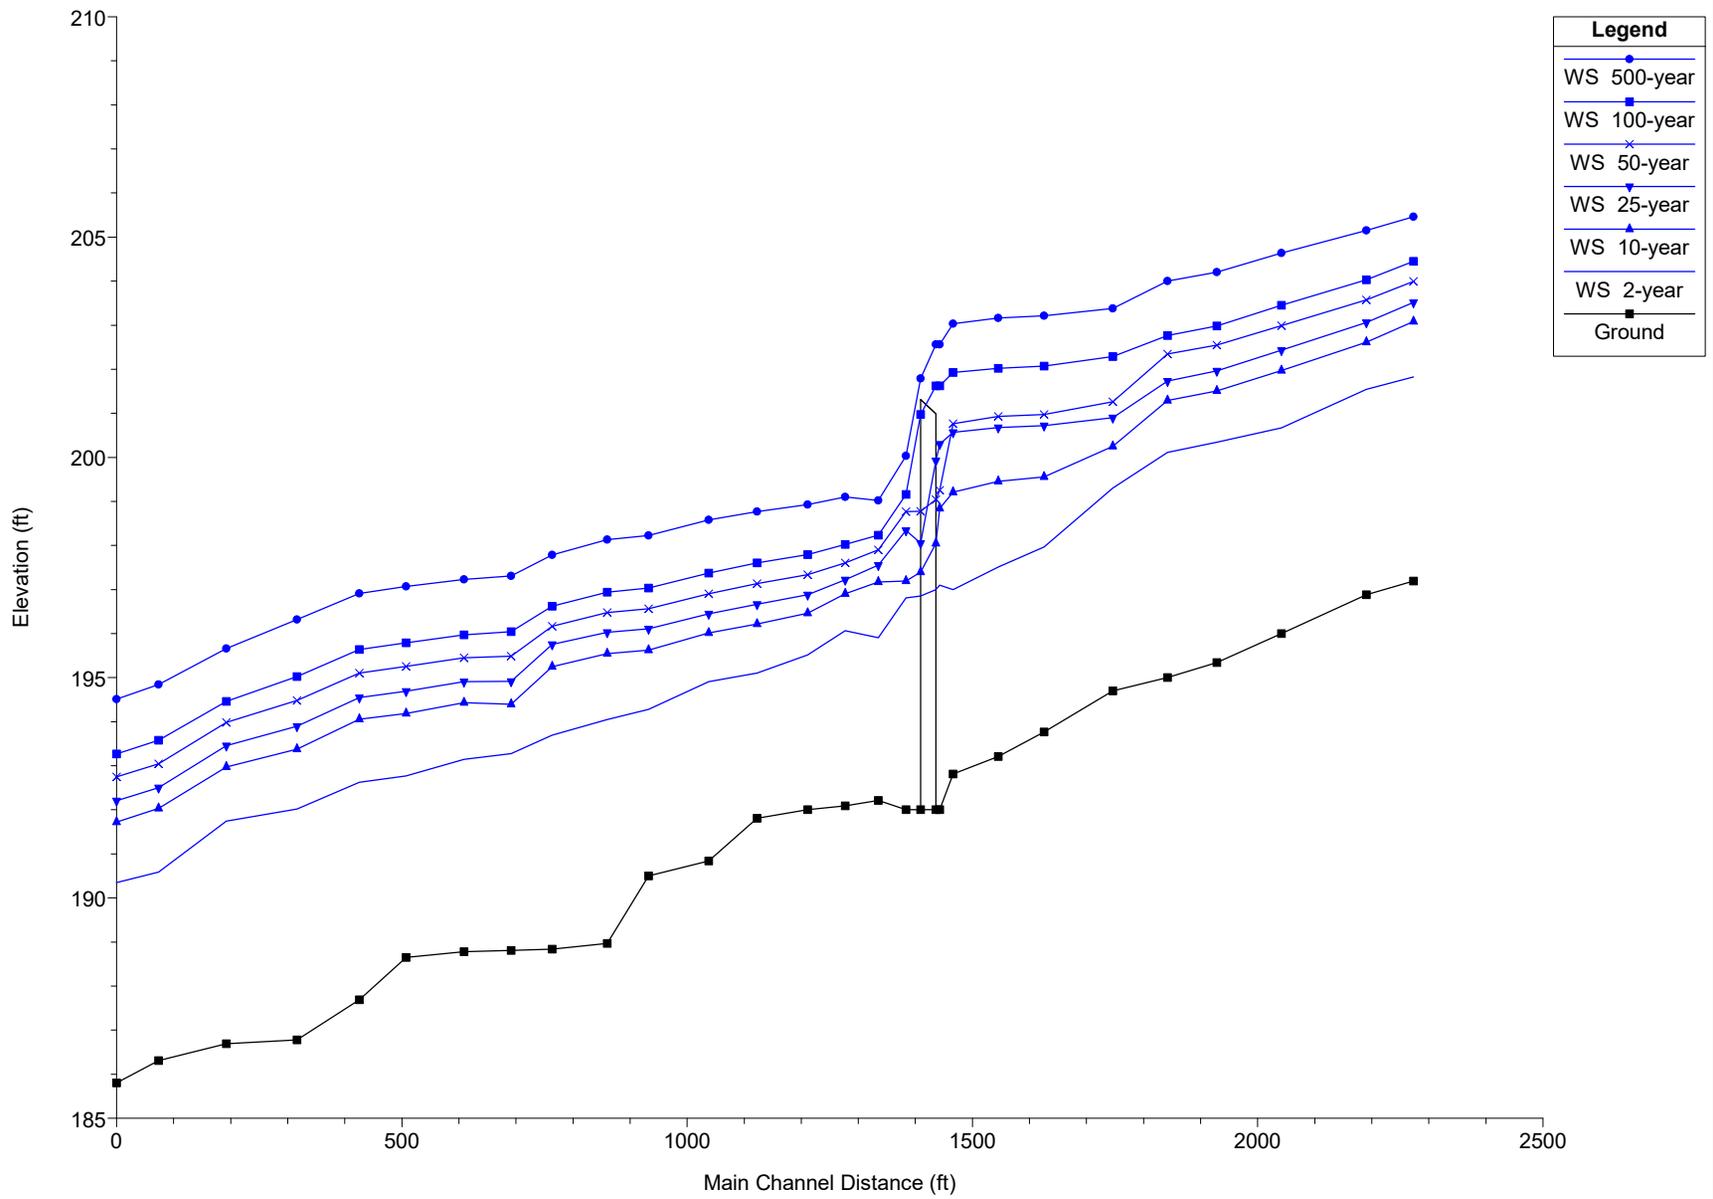
Headquarters Bridge Plan: Prop_Channel_regrade 7/16/2020

HEC-RAS Plan: Prop_final River: TincumCreek Reach: Headquarters

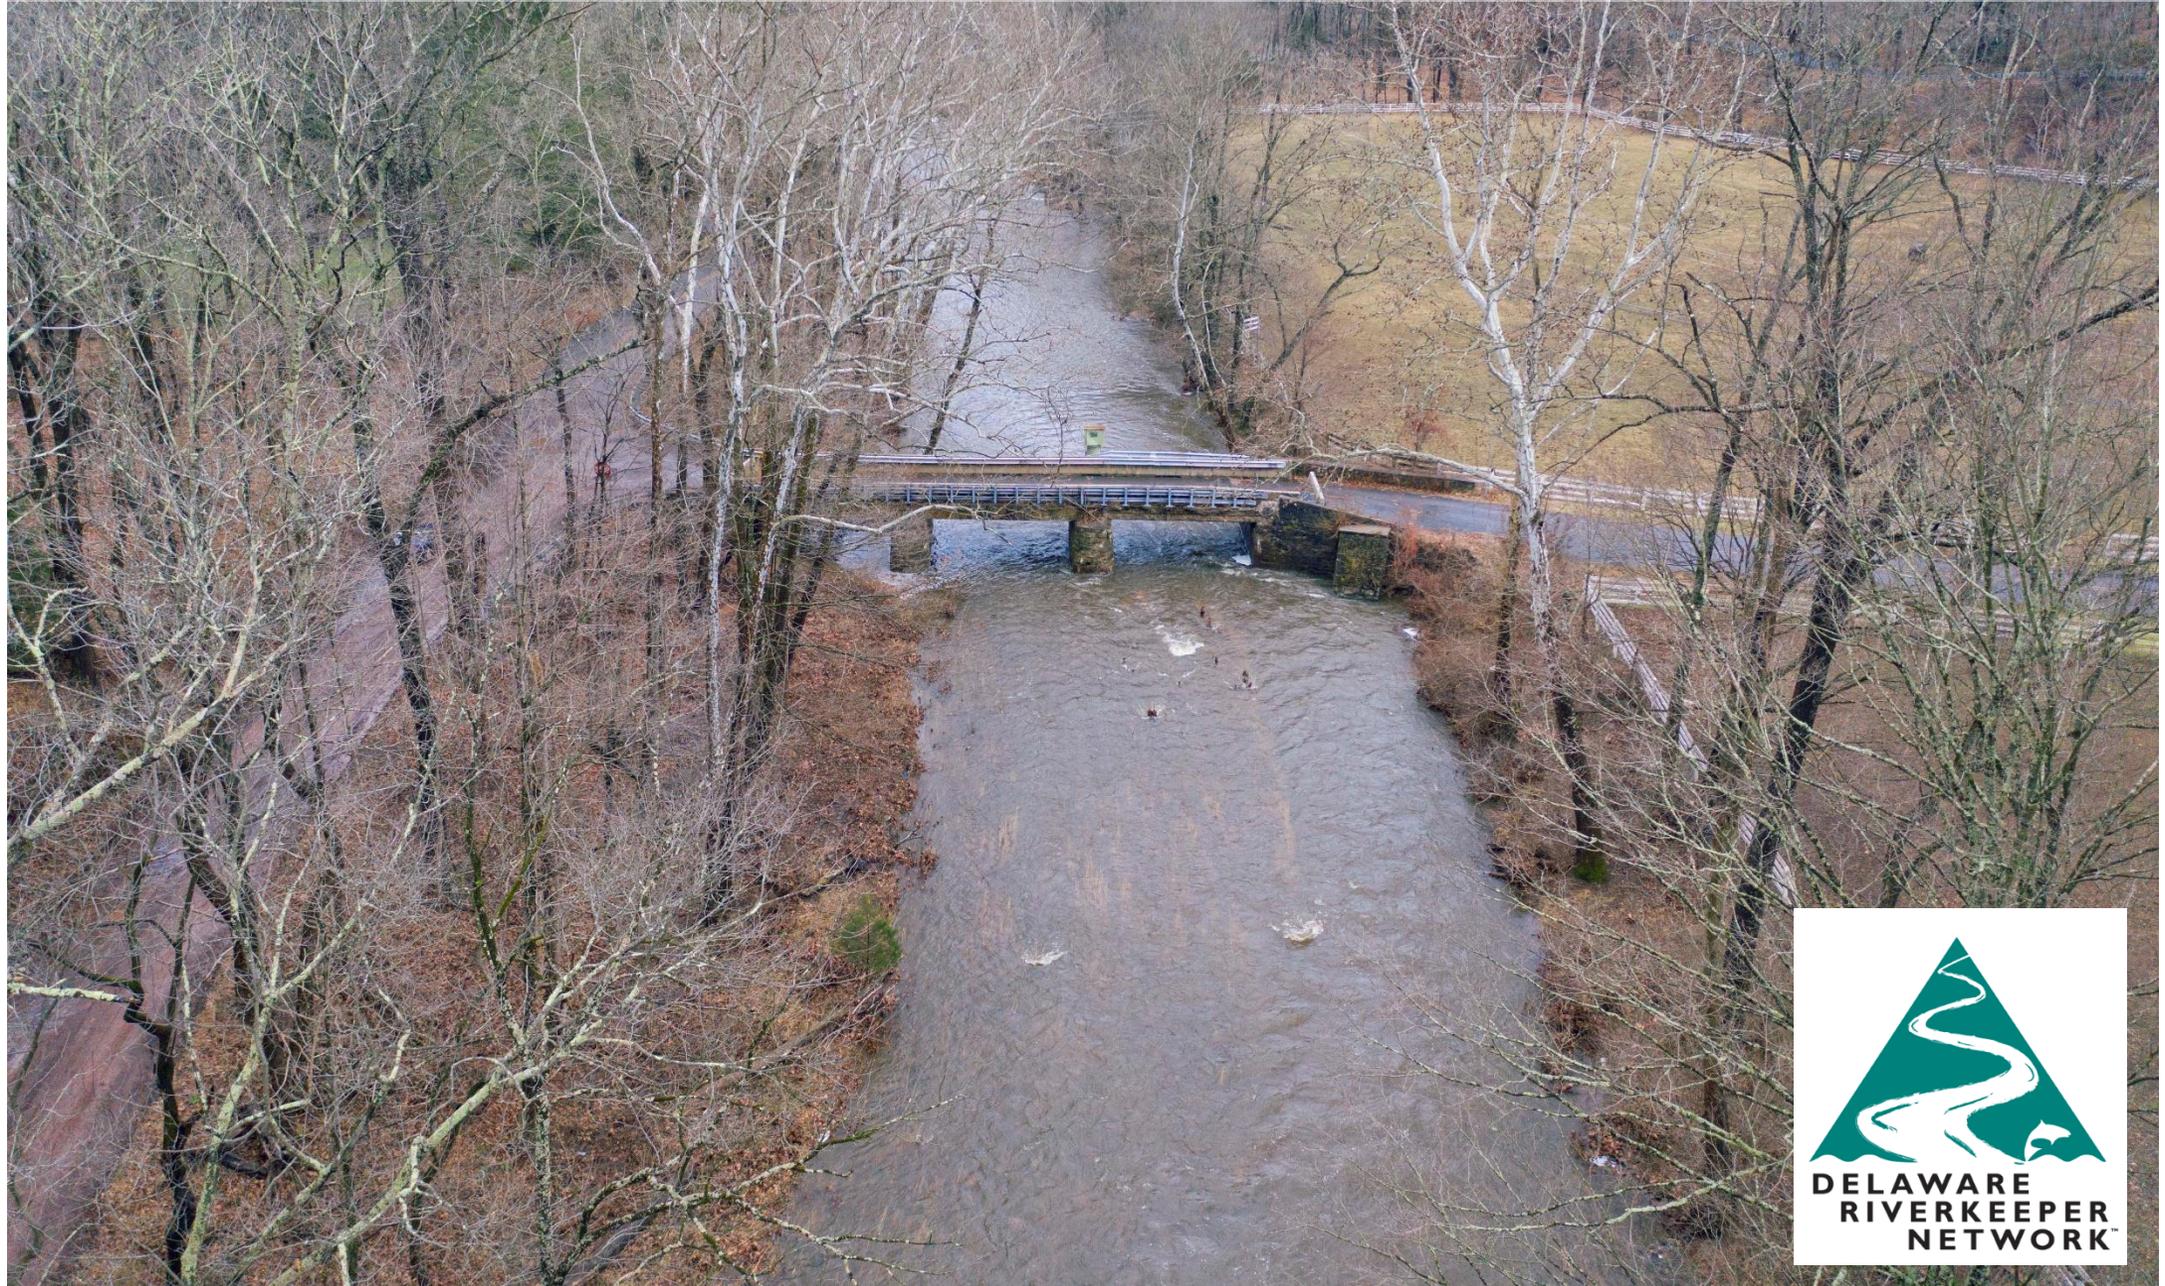
Current Conditions Looking Downstream (from aerial drone)

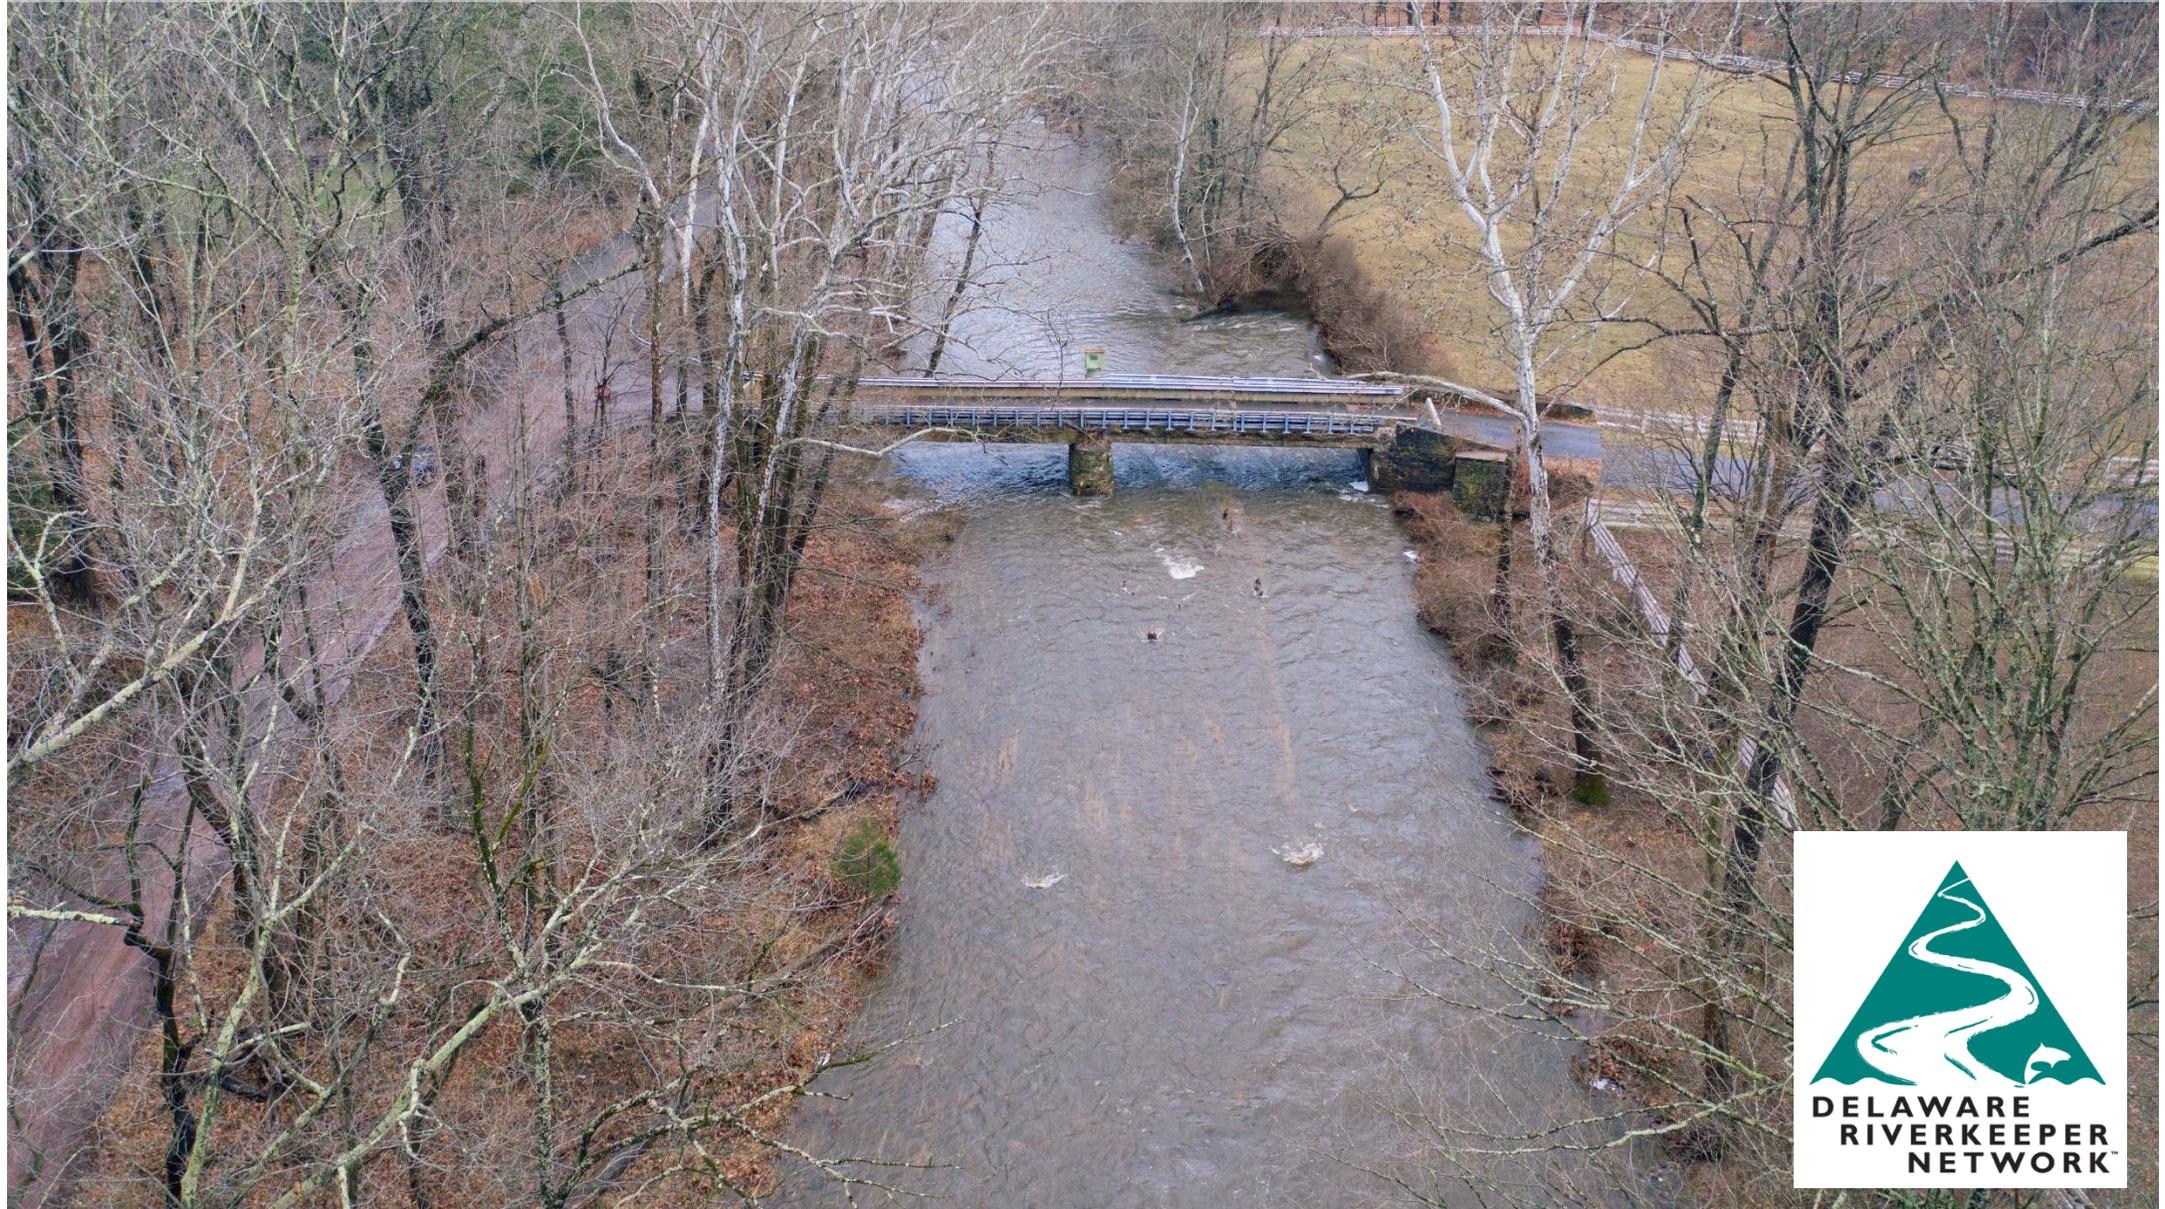
Simple Forecast / Rendering with bridge abutments shifted 15 ft westward
(Delaware Riverkeeper Network project file)

From our calculations using partial data provided on these plans and estimation using the scales of the drawings, it appears that the bridge abutments are moved between 15.5 and 17.5 feet for the western bridge abutment, and between 10.0 and 12.0 feet for the eastern bridge abutment.^{46,47,48} Similarly, the application materials quantify the existing bridge opening with different numbers and dimensions for different submissions. These inconsistencies and incomplete submissions call into question the validity of all analyses that are based on the proposed bridge conditions, including the Scour Calculations, the Hydrologic &

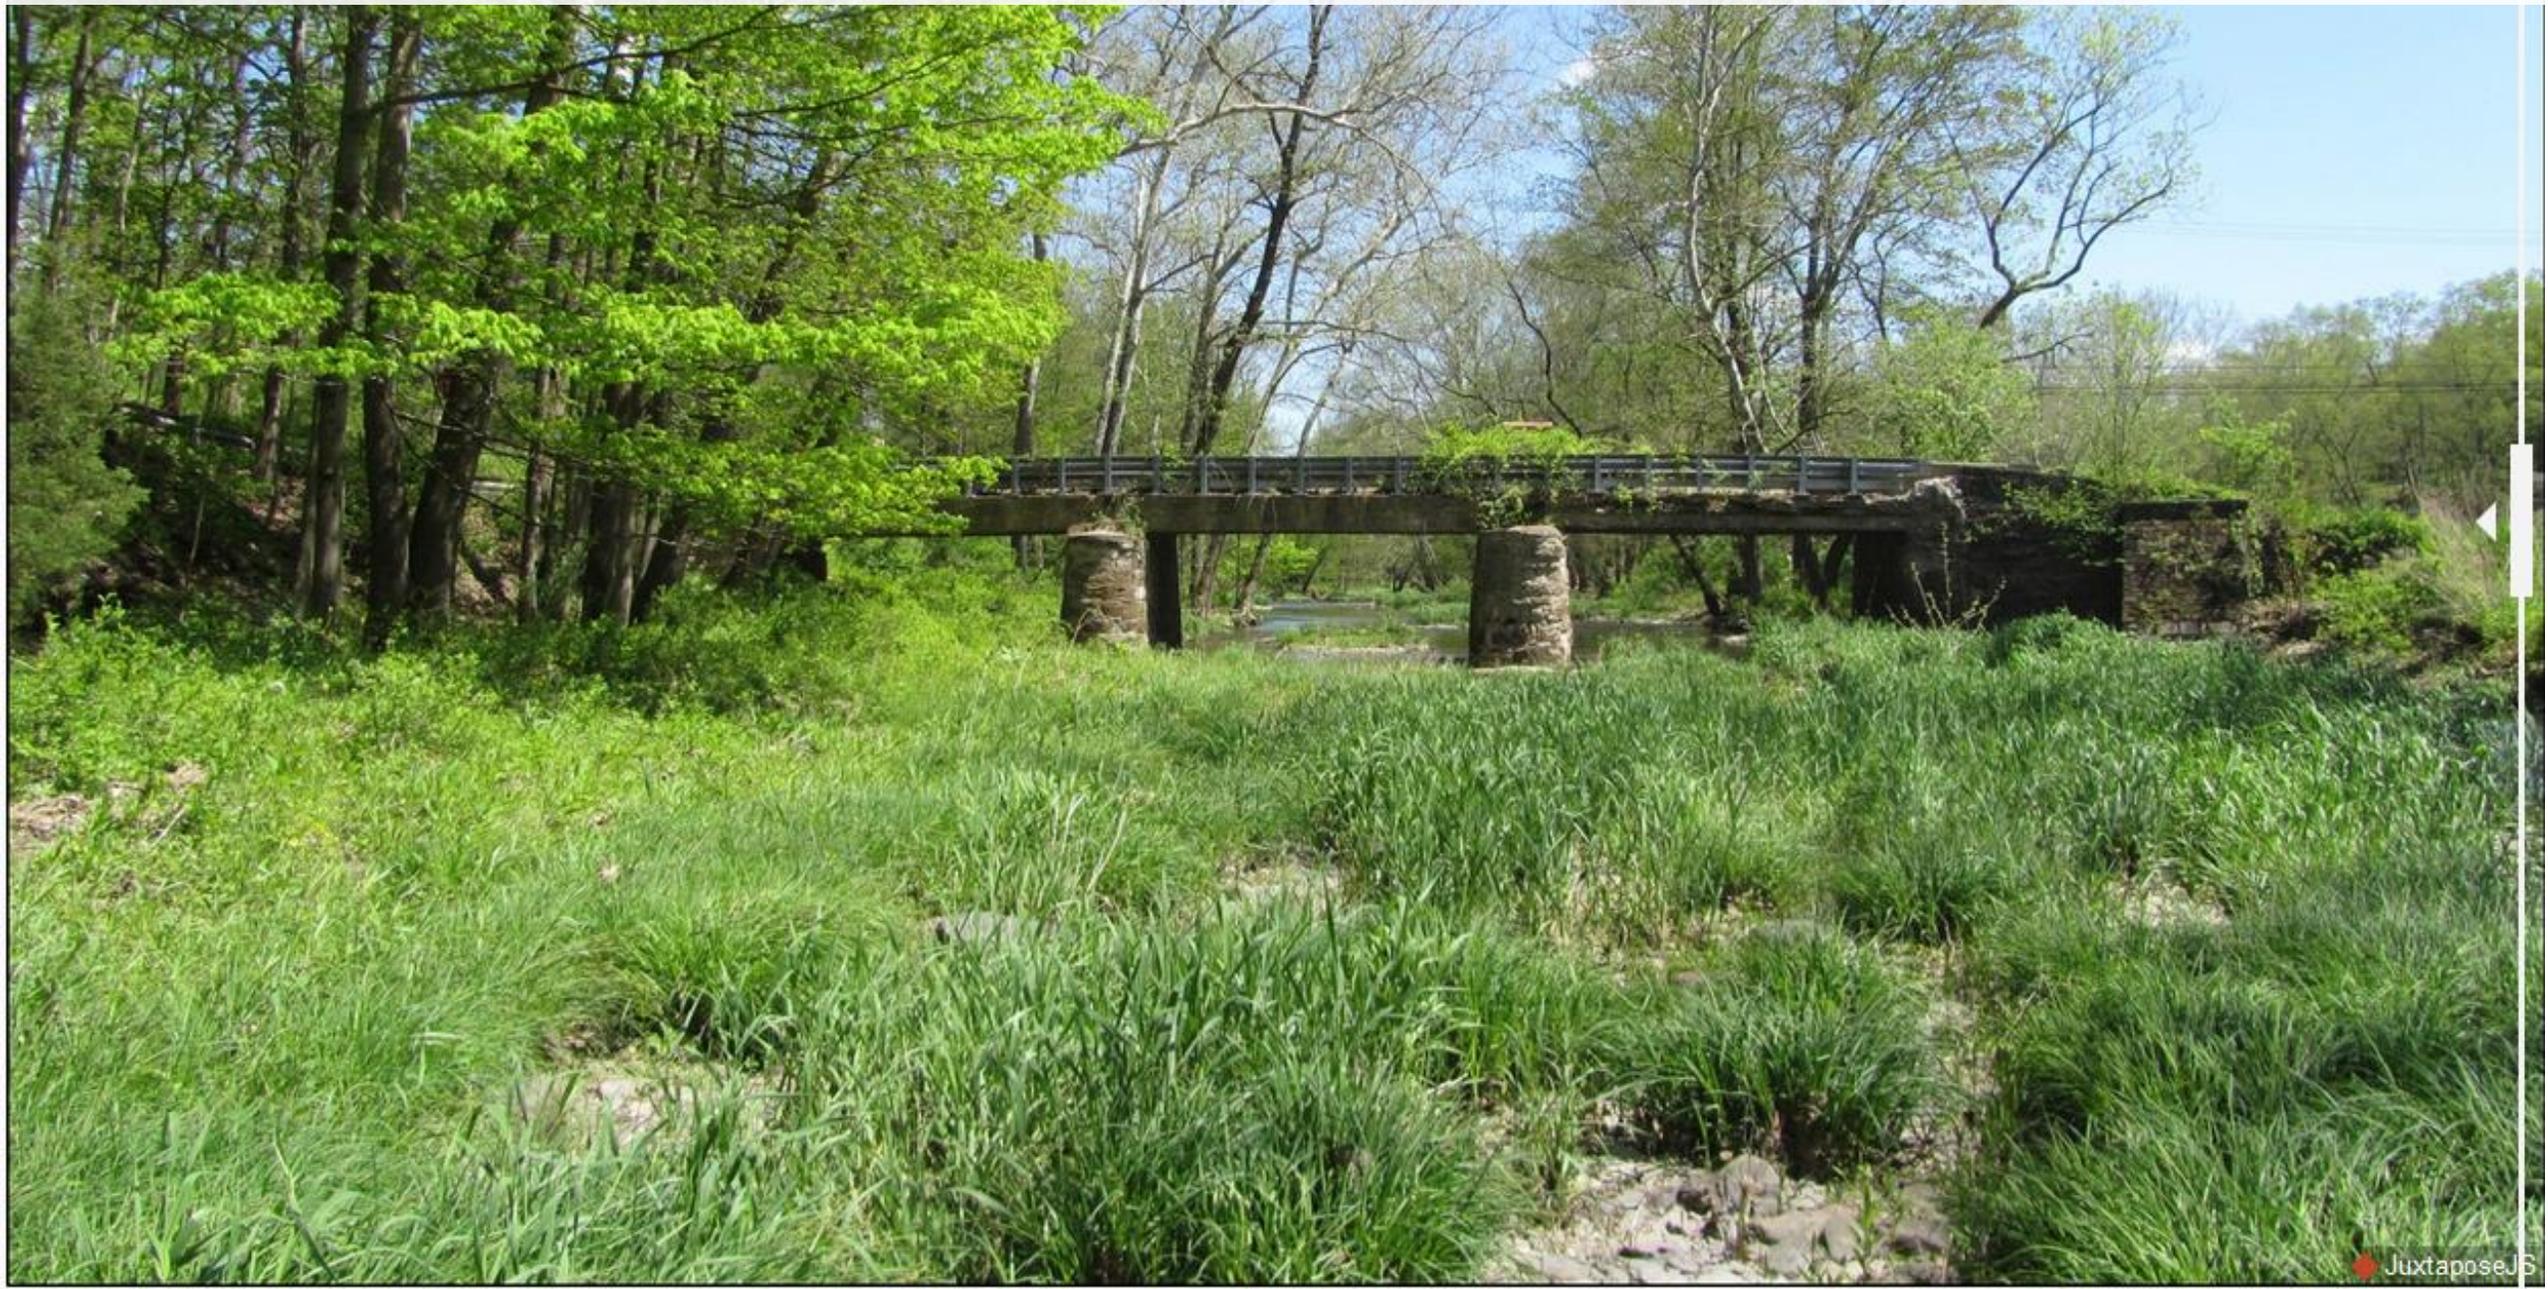
New Bridge Rendering Looking Downstream (from PennDOT)

** note the exposure and impact to the downstream riparian corridor on RiverRight

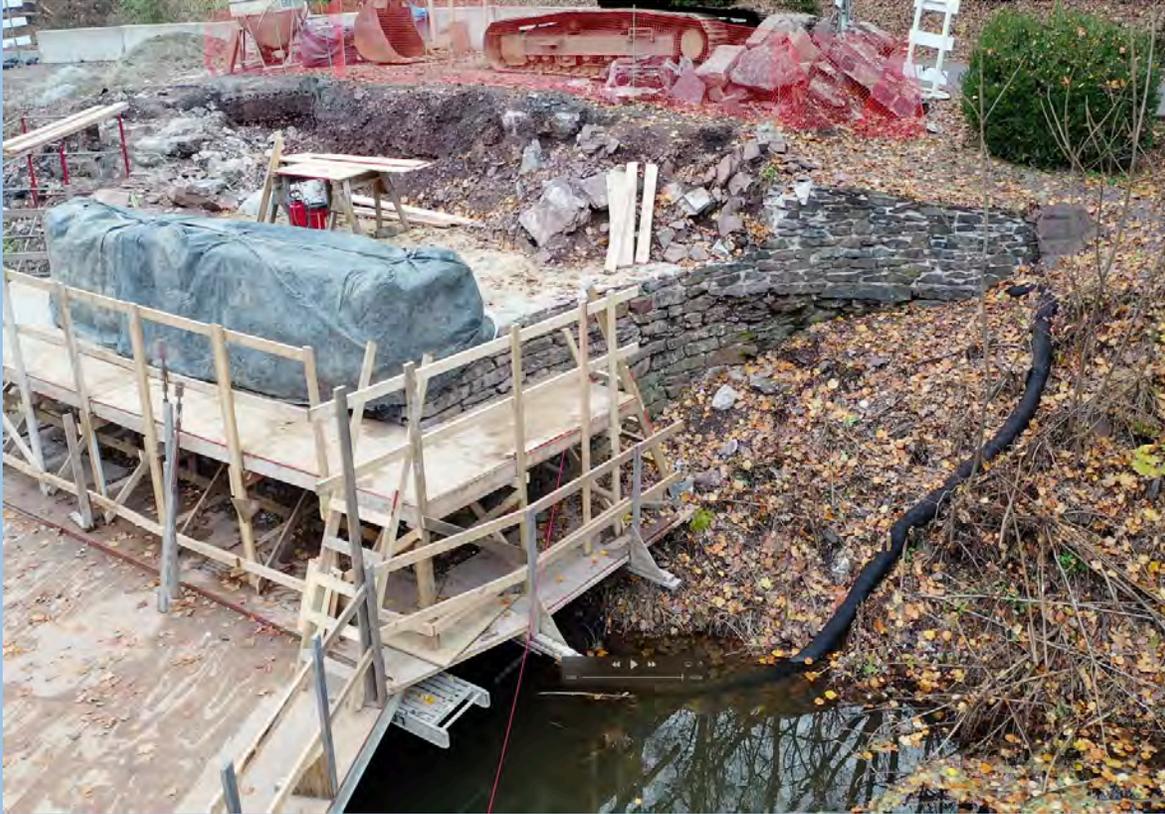
Golden Pheasant Masonry Abutments are similar to Headquarters Road Bridge. PennDOT's repair entailed significant stonework.

During Rehabilitation/Repair, Golden Pheasant abutment interiors exposed

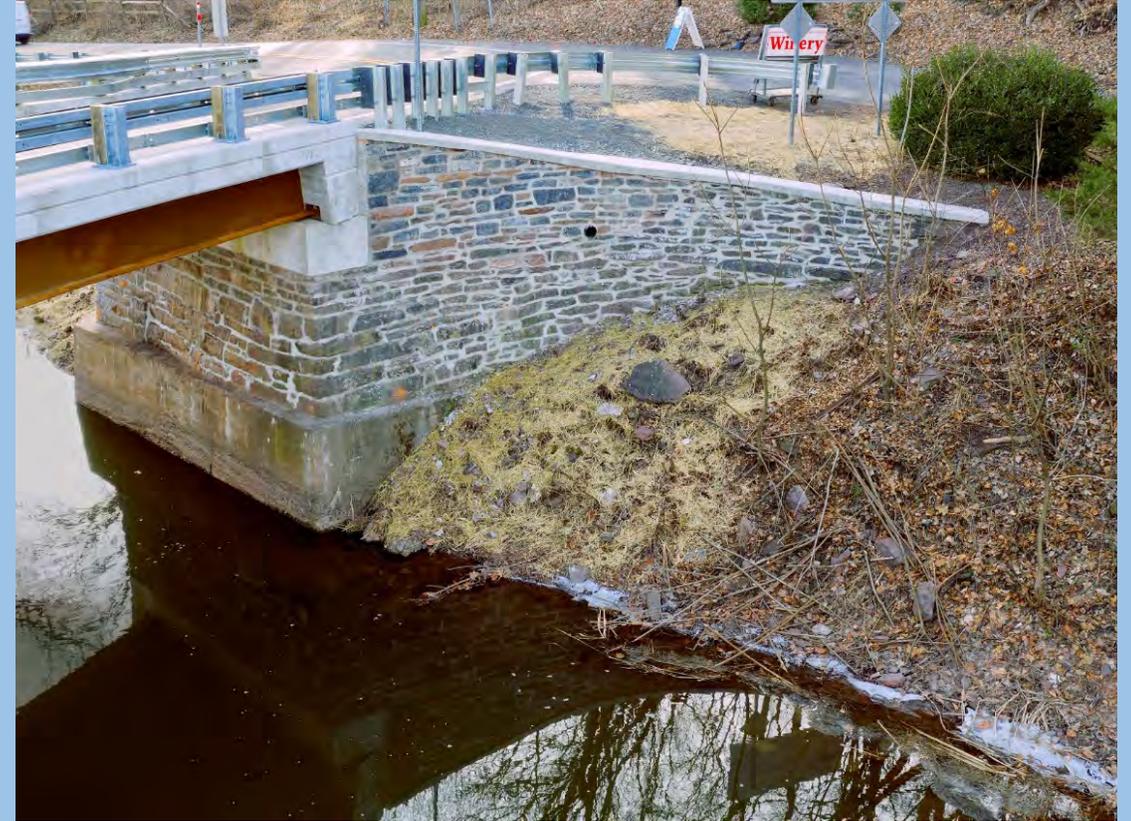
After wingwall rebuilt

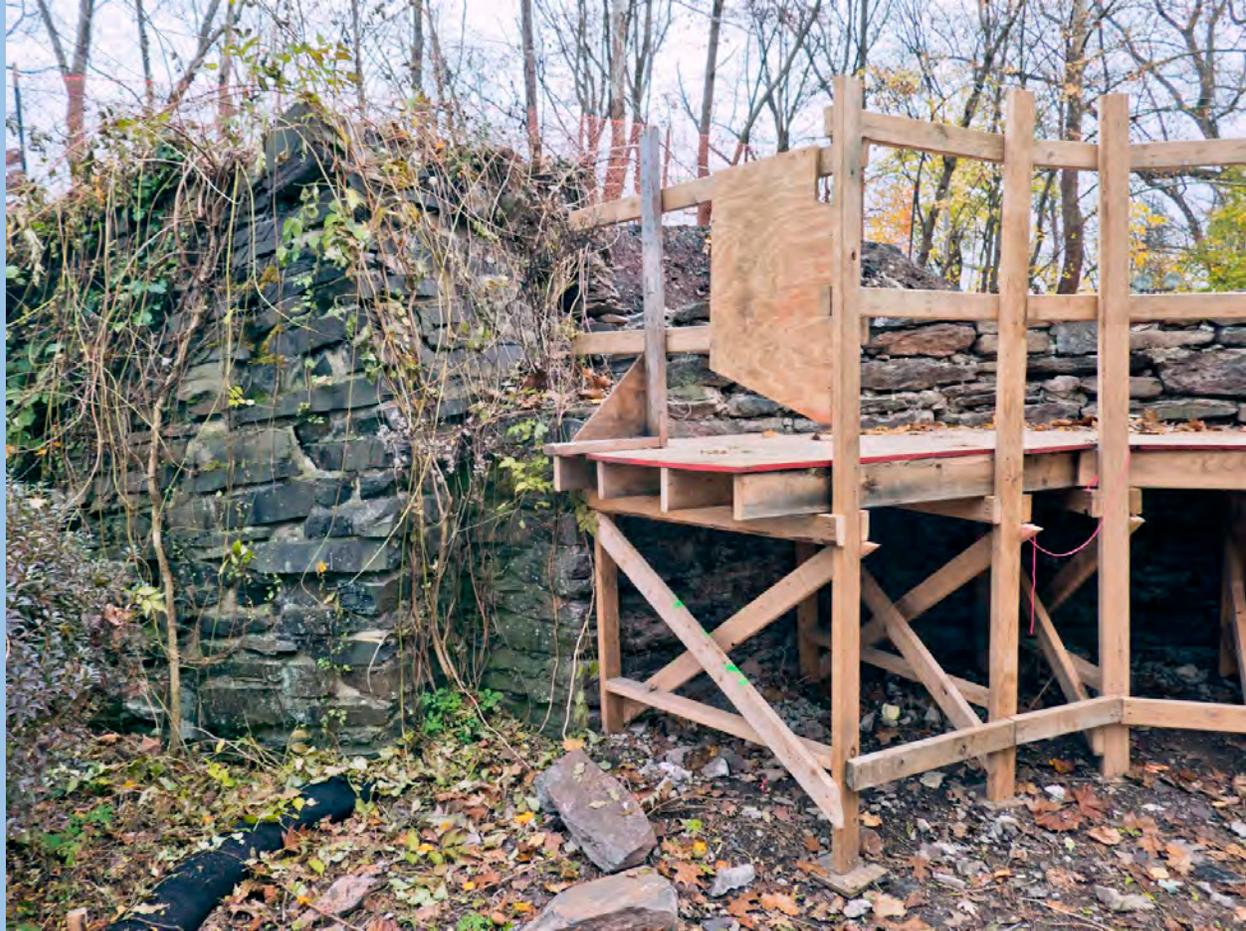
Golden Pheasant Bridge NW abutment and wing wall before:

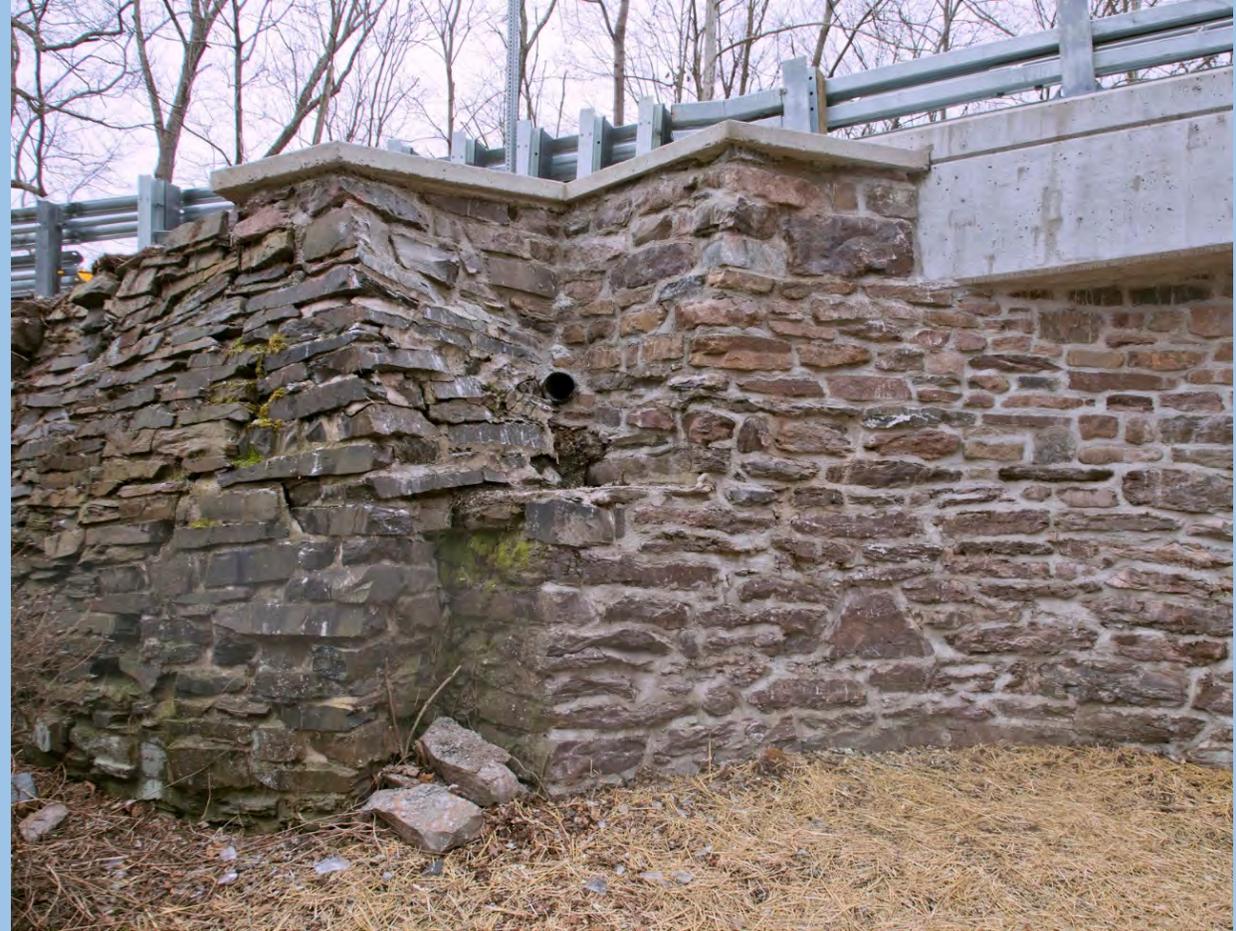
And after:

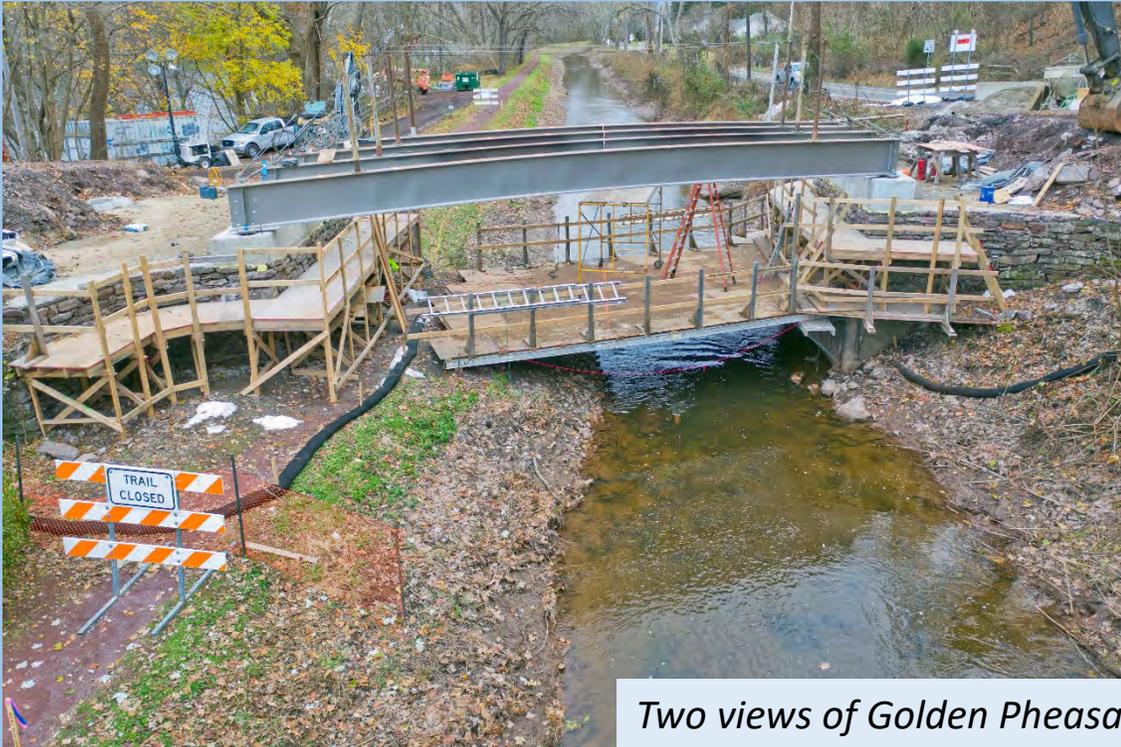
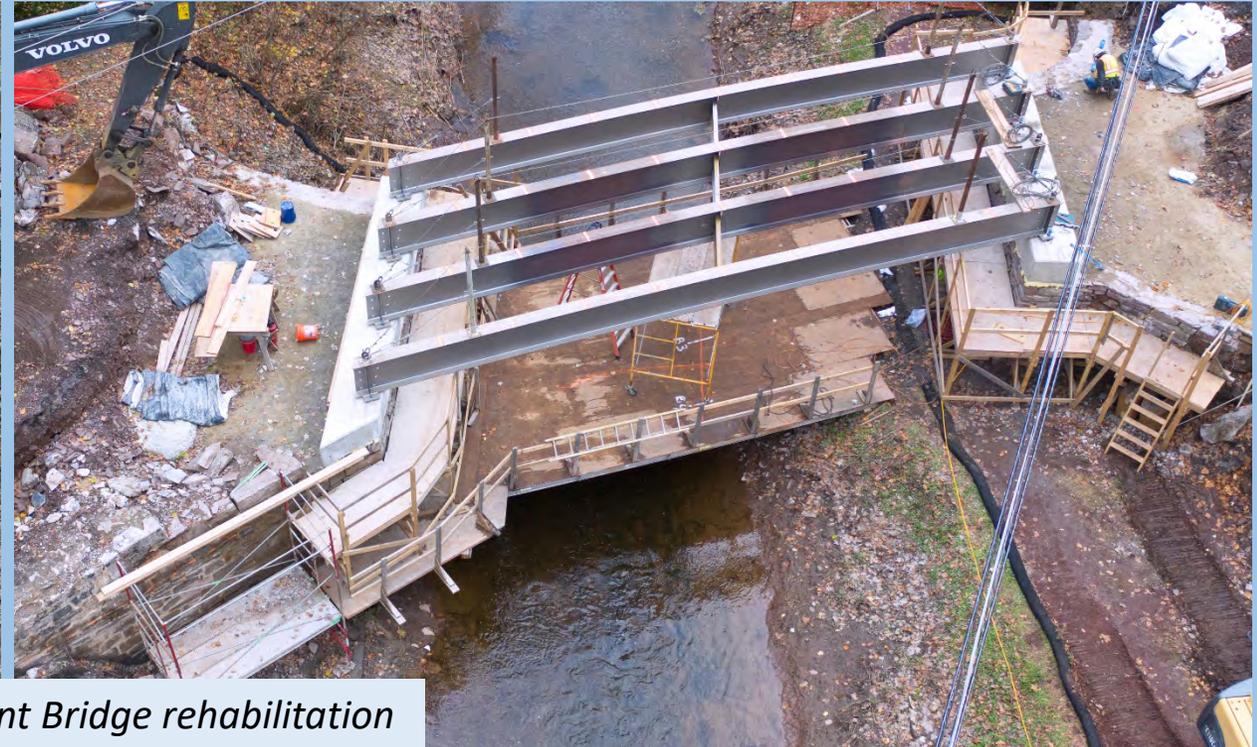
PennDOT's repair work on the Golden Pheasant bridge included replacing the deck. The PennDOT design is essentially the same concept as the design recommended by historic experts for Headquarters Road Bridge:* using poured concrete caps on original stone masonry to support new steel stringers and distribute the deck loads into the stonework below.

Two views of Golden Pheasant Bridge rehabilitation

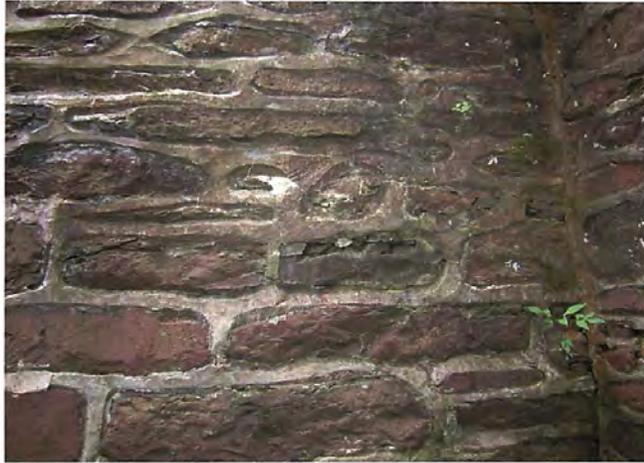
Cracked and crushed stone in NW wingwall.

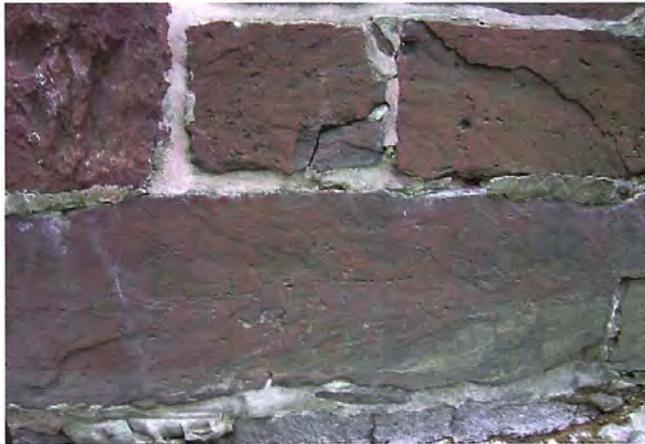
Cracked and crushed stone at Ottsville abutment.

Above: Problem areas of stonework identified by PennDOT in their 2006 report on the Headquarters Road Bridge.

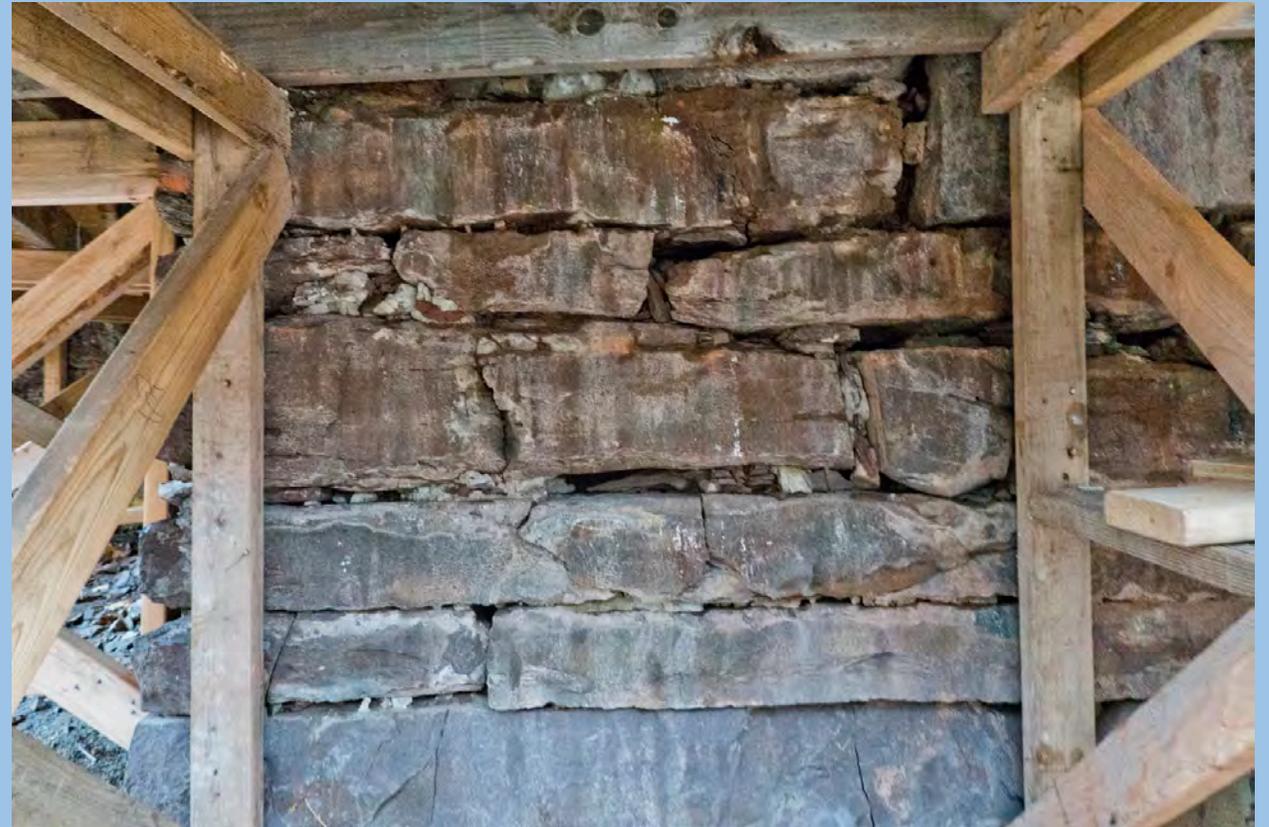
The stones in the abutments at Golden Pheasant Bridge have the same types of damage as found in the stones at the Headquarters Road Bridge abutments and piers.

As the photo above shows, cracked stones in the Golden Pheasant bridge are similar to Headquarters Road Bridge cracks. At the Golden Pheasant Bridge, these cracked stones were determined adequate and left in place to support the bridge deck.
