**Re: Headquarters Road over Tincum Creek Replacement Project
Permit No. E0901120-026, Pennsylvania Department of Transportation**

²⁹ Rippled Waters Engineering "Technical Expert Report regarding Environmental Impacts related to the Headquarters Road Bridge Replacement Tincum Township, Bucks County, Pennsylvania," report issued July 16, 2020 (hereinafter "Rippled Waters Engineering 2020")

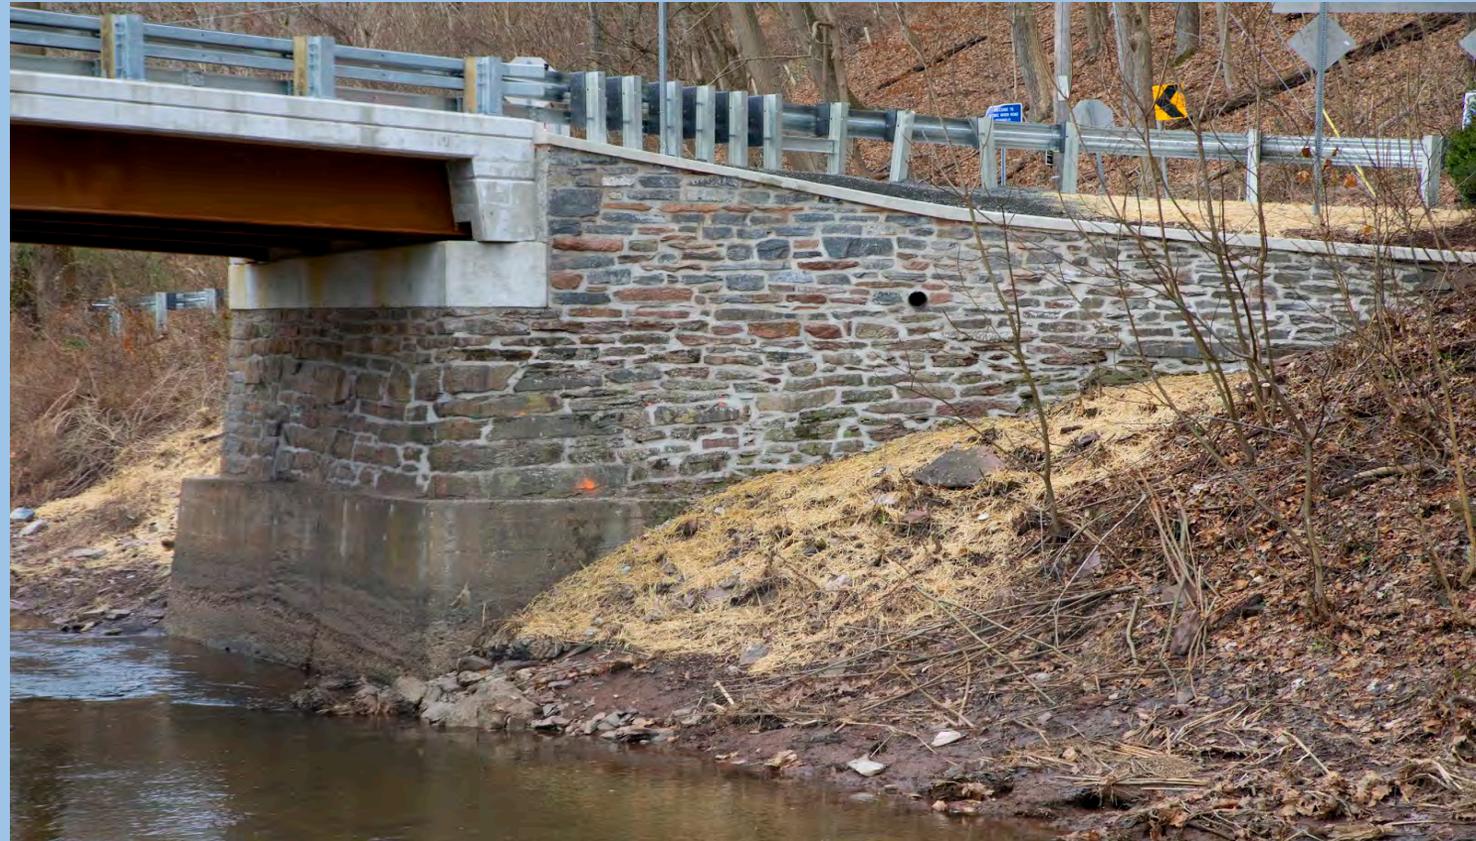
Scour concerns at Headquarters Road Bridge could be addressed by concrete encasement of the masonry below the water line down to the bedrock on which the piers and abutments sit. This photo shows a similar concrete apron, although extending above the waterline, in an old repair to the west abutment at the Golden Pheasant bridge.

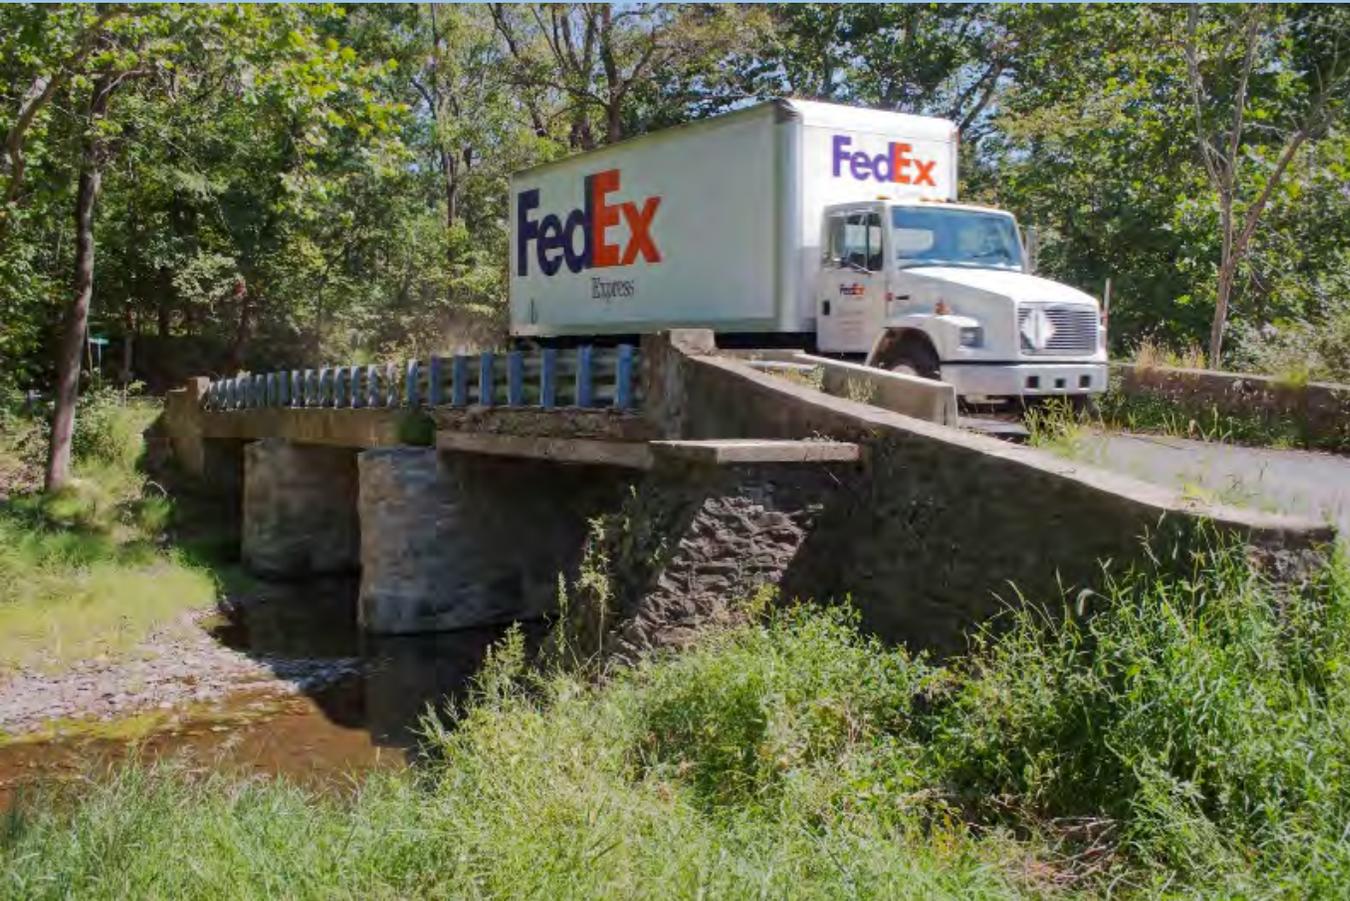
Headquarters Road Bridge before it was closed – note the Jersey Barriers in place reducing the width.

In fact, emergency vehicles and the town's largest fire truck were able to use the bridge without problem before it was closed, even after PennDOT narrowed the travel lane to ten feet with the Jersey Barriers.

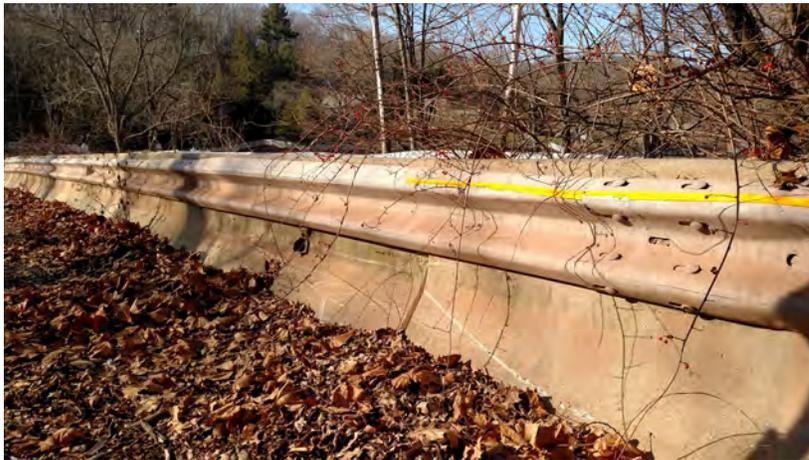
Figure 2
Jersey barrier on Headquarters Road Bridge, showing impact scrapes, possibly resulting from the 24 October 2003 crash

- 24 October 2003 – A vehicle driving westbound on Headquarters Road attempted a left turn onto the bridge and slid on an icy road surface on the bridge, resulting in contact with the bridge wall (see figures 1 and 2).
- 1 April 2006 – An unregistered, uninsured vehicle left the scene of the crash while the driver and passengers were out for a “joyride.” Details of the crash are minimal but do indicate that contact was made with the Jersey barrier on the bridge.
- 7 May 2006 – A motorcyclist reported losing control of his eastbound motorcycle on loose gravel as he entered the bridge (see figures 3 and 4).

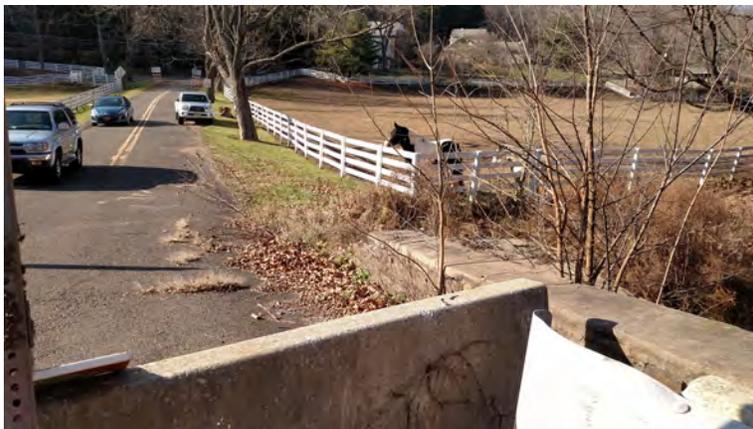
Figure 6
The fence to the west of the bridge, the apparent site of
impact in the 6 July 2007 crash

A fourth crash, on 6 July 2007, appears to have been near the bridge. A vehicle driving westbound was reported as having made contact with a fence or wall near the bridge. Based on the limited description and the police sketch (figure 5), the

vehicle probably made contact with the fence on the western end of the bridge (figure 6).

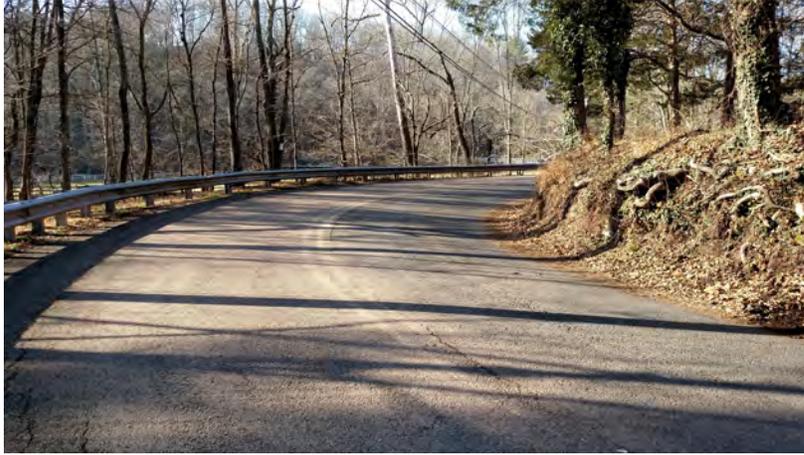
Figure 7
Westbound view of the curve on Headquarters Road located 250 feet east of the intersection with Sheephole Road, the site of 5 crashes within the reporting period

Of the crashes at the curve, 3 occurred when the road surface was wet and all 5 involved a westbound vehicle crossing the centerline (see figures 7 and 8). These crashes are all well beyond the influence of Headquarters Road Bridge, but do indicate a “hotspot” where PennDOT should consider upgrading such safety measures as signing and striping.

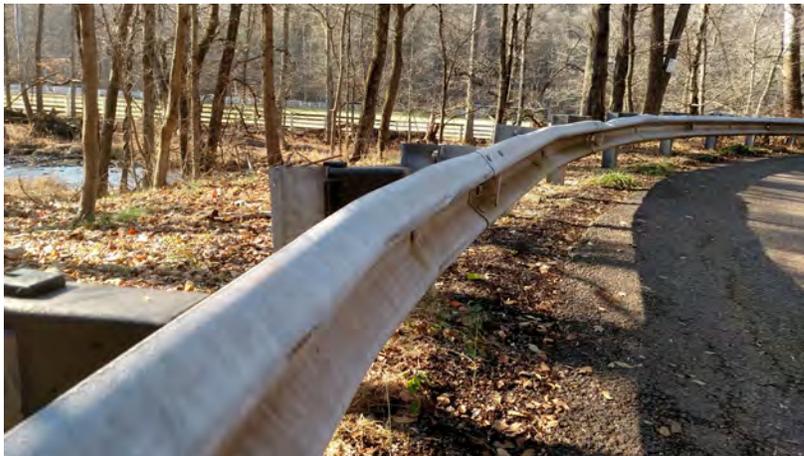
Figure 8
Guardrail along the Headquarters Road curve, showing signs of multiple impacts

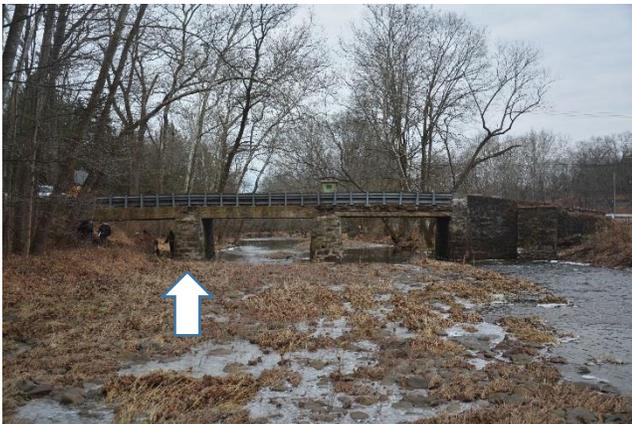
Figure 1 – North Elevation of the Bridge. The Arrow indicates the East Pier

Cores were taken with a rotary core barrel by Pennoni Associates under contract with PennDOT consultant, Urban Engineers. An electric rotary drill with a 2.75 inch diameter core barrel was used to horizontally core the East and West Piers and East Abutment. Core material was extracted and saved in a wooden box. A small amount of water was pumped into the barrel for cooling and lubrication. The core barrel extensions were 15 inches long. After drilling the length of one barrel, it was withdrawn and another 15 inch section added to extend the core length. The depth of the cores varied slightly up to about 40 inches. The core barrel machine was fastened to a stone at each location using an expansion type anchor placed into a hole drilled into the stone with a rotary hammer bit.

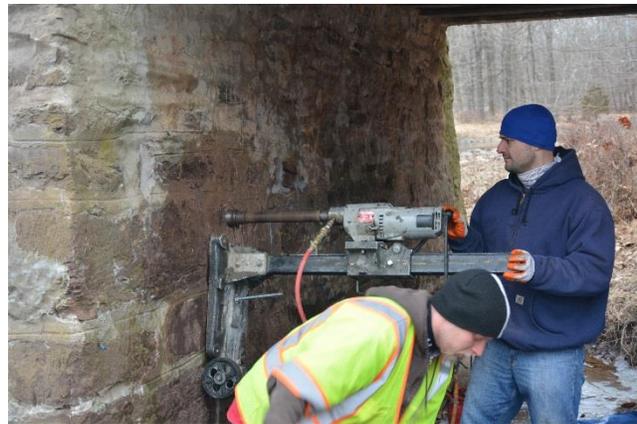
Figure 2 – Core drill setup on the east face of the East Pier with the drill machine fastened to the stone

After measurements of the core hole were completed, the core holes were patched with high strength mortar flush to the surface of the stone.

Due to snowy weather and high water, a total of 3 days of coring were needed in order to core each of the piers and abutments. A core was not extracted from the face of the West Abutment due to high water, but a core was taken from the adjacent north side wing wall and this core is assumed to be representative of the conditions at the abutment face.

The cores holes were observed using a flashlight and photographs were taken. Measurements of the widths of the face stone were taken. The widths of the stones beyond could not be accurately measured due to the small diameter of the hole and the angle of the tape. The material inside the core barrel was photographed each time after it was extracted.

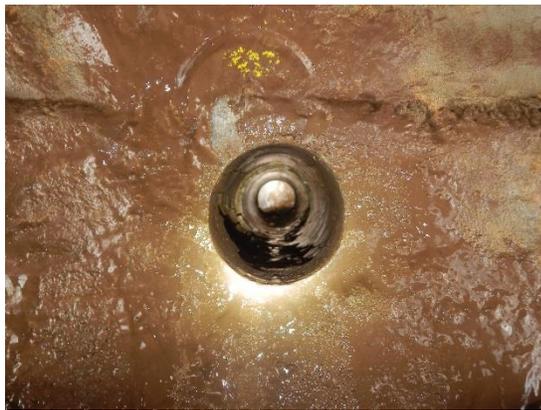
Figure 3 - Core hole on the East Pier

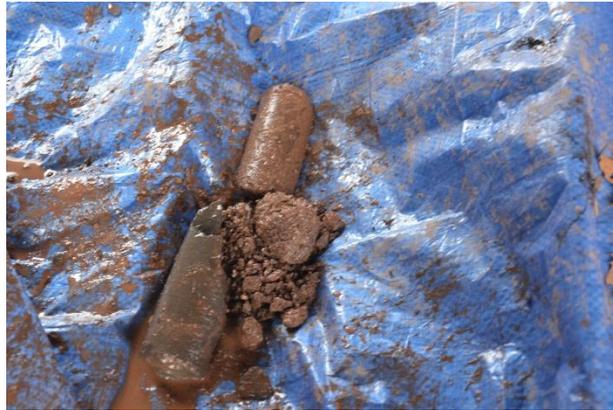
Figure 4 – Extracted core material from the East Pier

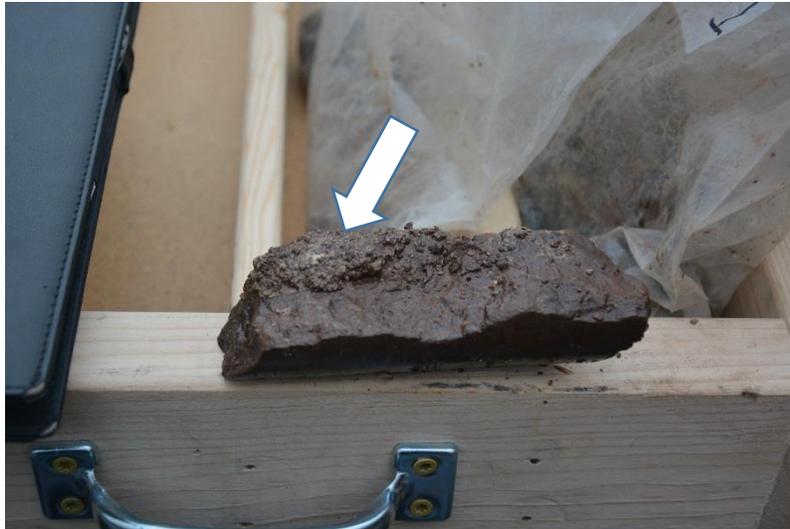
Mortar was observed attached to some of the pieces of stone that were extracted from the lower cores. These lower cores also contained a sandy material that could be deteriorated mortar.

Figure 5 - Piece of stone extracted from pier with arrow indicating mortar bonded to the stone

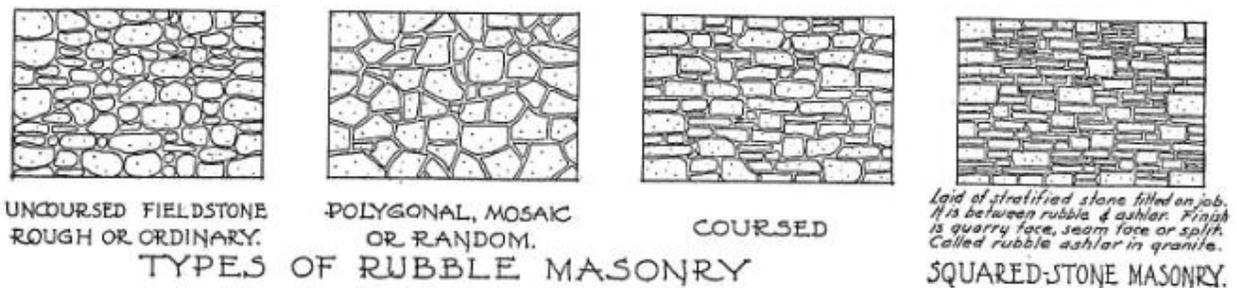
The stone piers are constructed with a Coursed Rubble type of masonry with larger squared stones near the bottom of the piers and smaller stones near the top. Coursed masonry and Squared-stone masonry typically have more compressive strength than Uncoursed or Random. See figure below for a graphic representation of the types of stone masonry.

Figure 6 - Graphical representation of the types of rubble stone masonry (AGS, 1932)

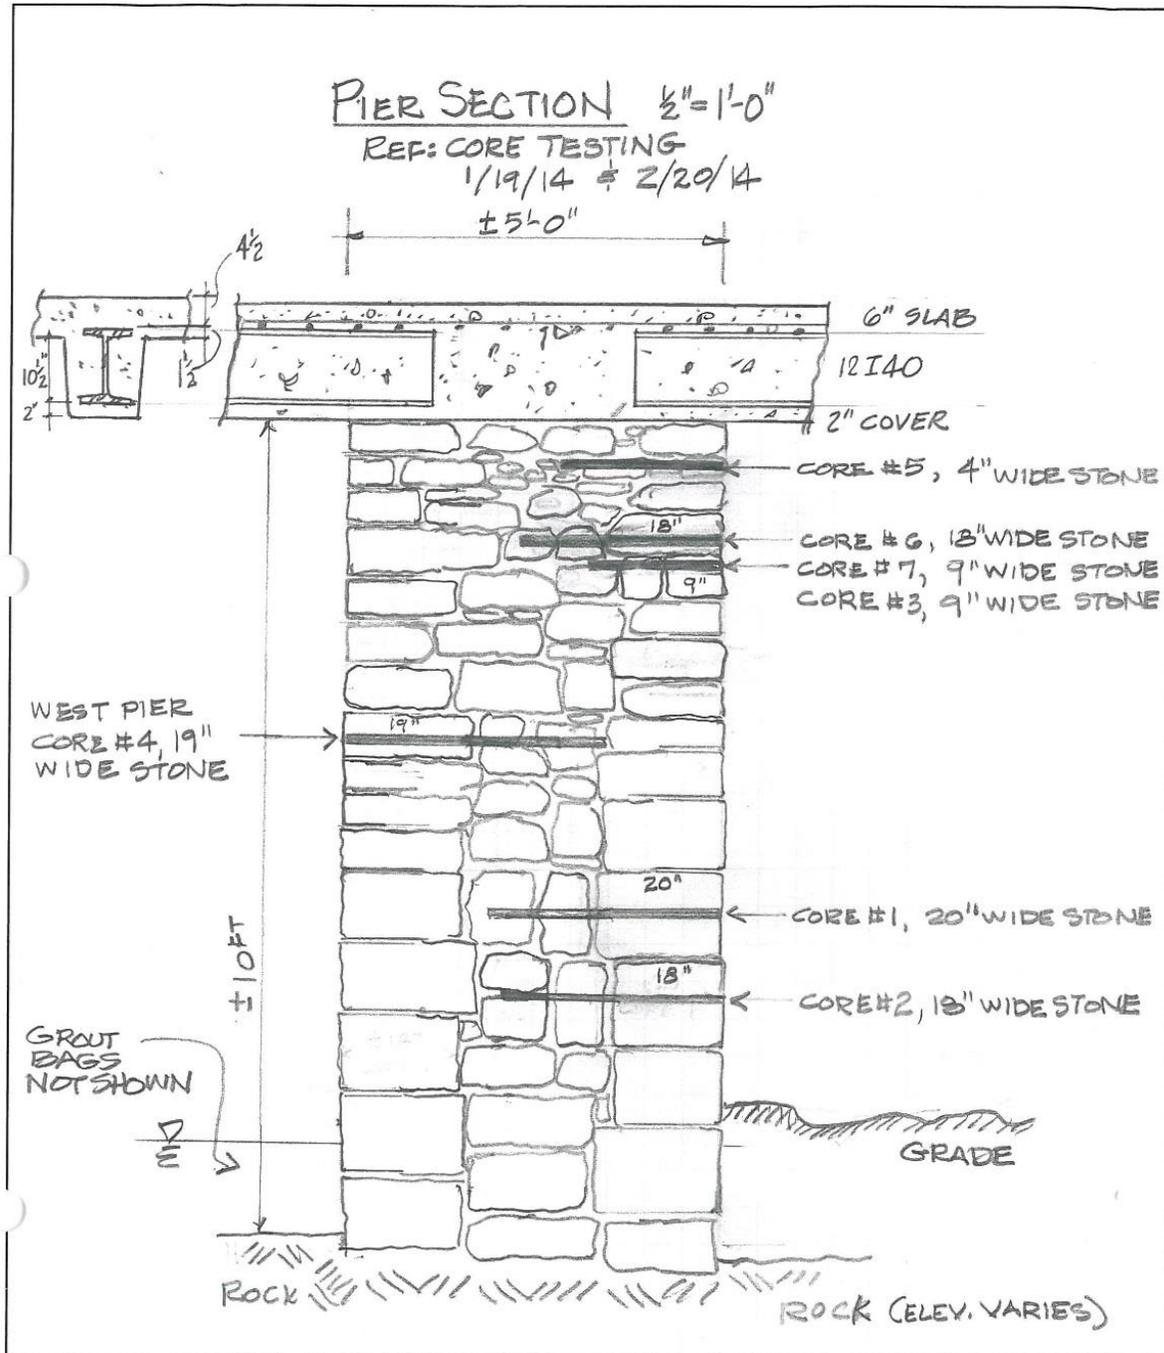
Figure 7 - Cross Section through the pier as interpreted from core results
