TGP 300 and TGP NEUP
Thermal Impacts to Exceptional Value Waterbodies
in Pennsylvania Cut by Gas Pipeline Projects

September 22, 2016

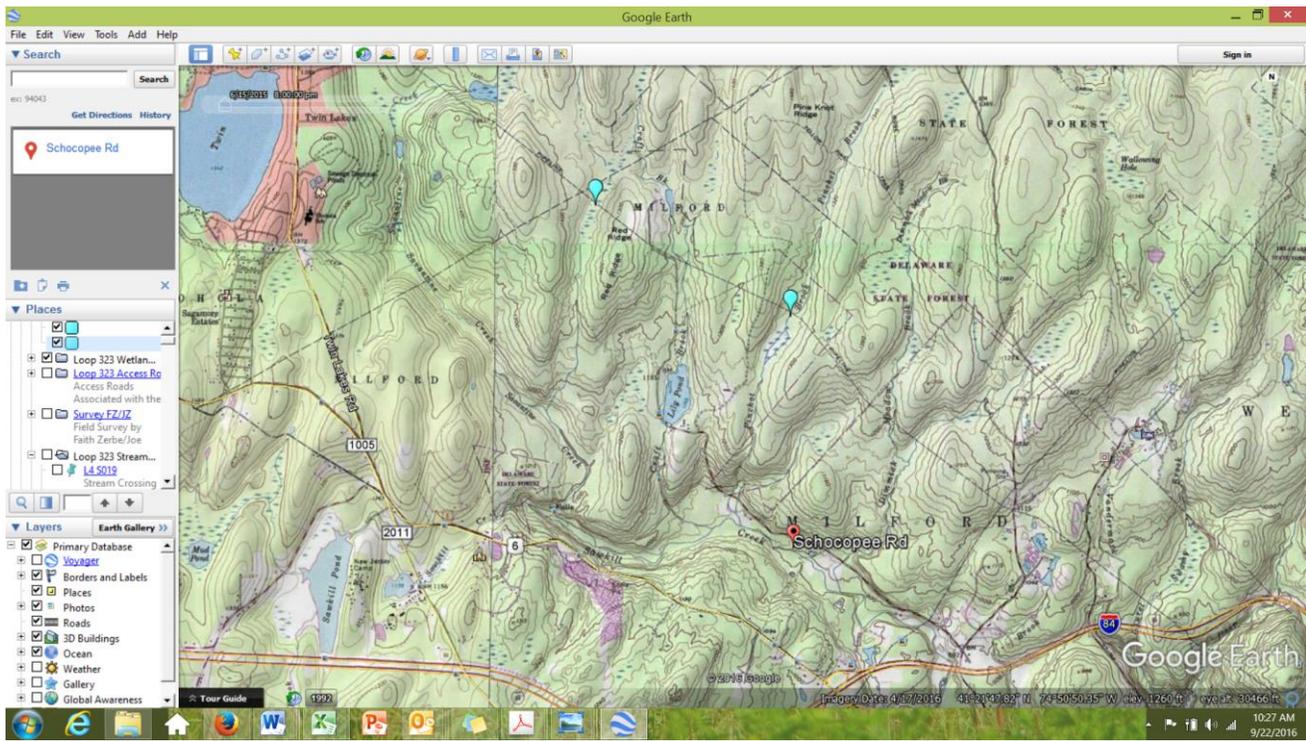
Figure 1. Overview Topo map of the TGP ROW pipeline cuts and study areas. Blue pins denote two tributaries and wetlands of the Sawkill Watershed that were a focus of this temperature study.

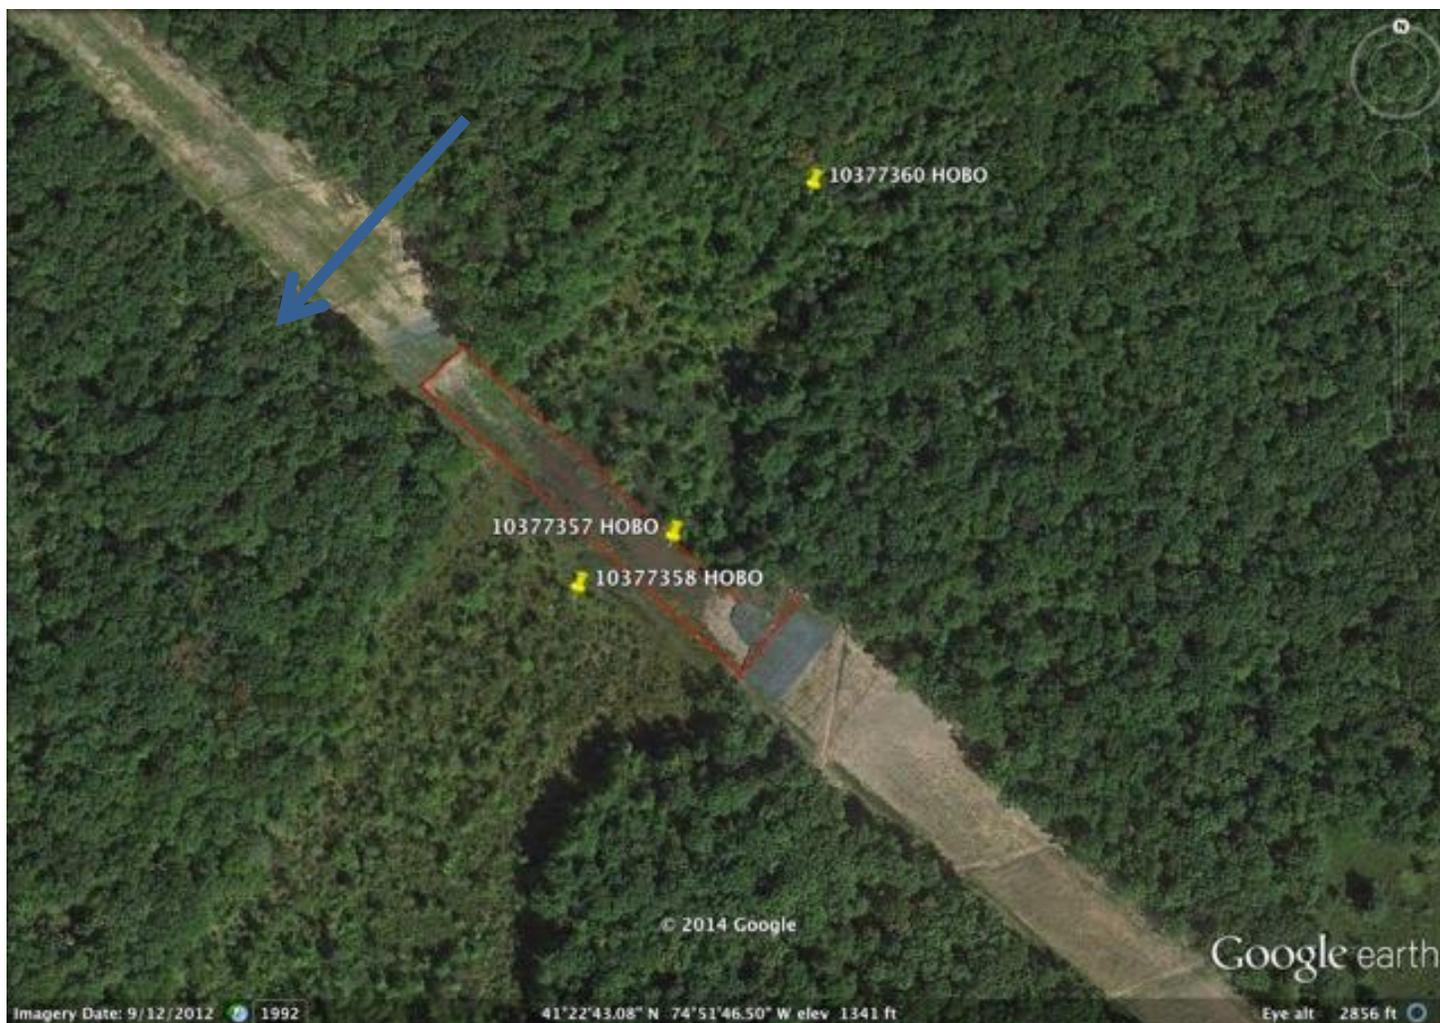
Savantine Creek Complex – W038 and location of HOBO loggers – blue arrow denotes stream flow direction. 10377357 HOBO was placed within the ROW cut; ROW – 10377358 is downstream pipeline ROW cut and 10377360 is upstream the pipeline ROW cut (blue arrow denotes stream flow) (points were documented from Google Earth not in the field)

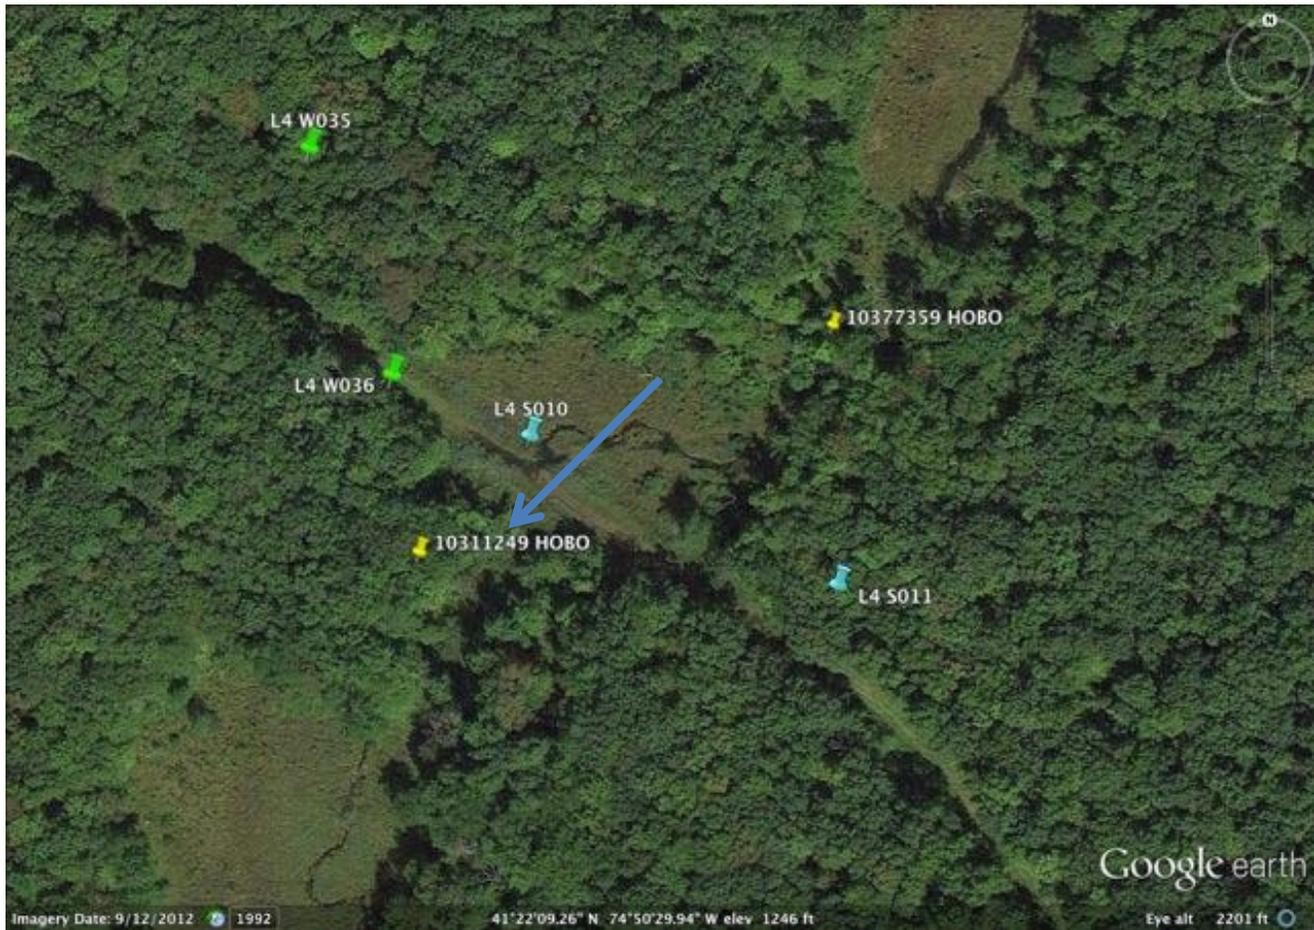
Pinchot Brook – location of 2 HOBO loggers upstream (10377359) and downstream (10311249) of pipeline cut.

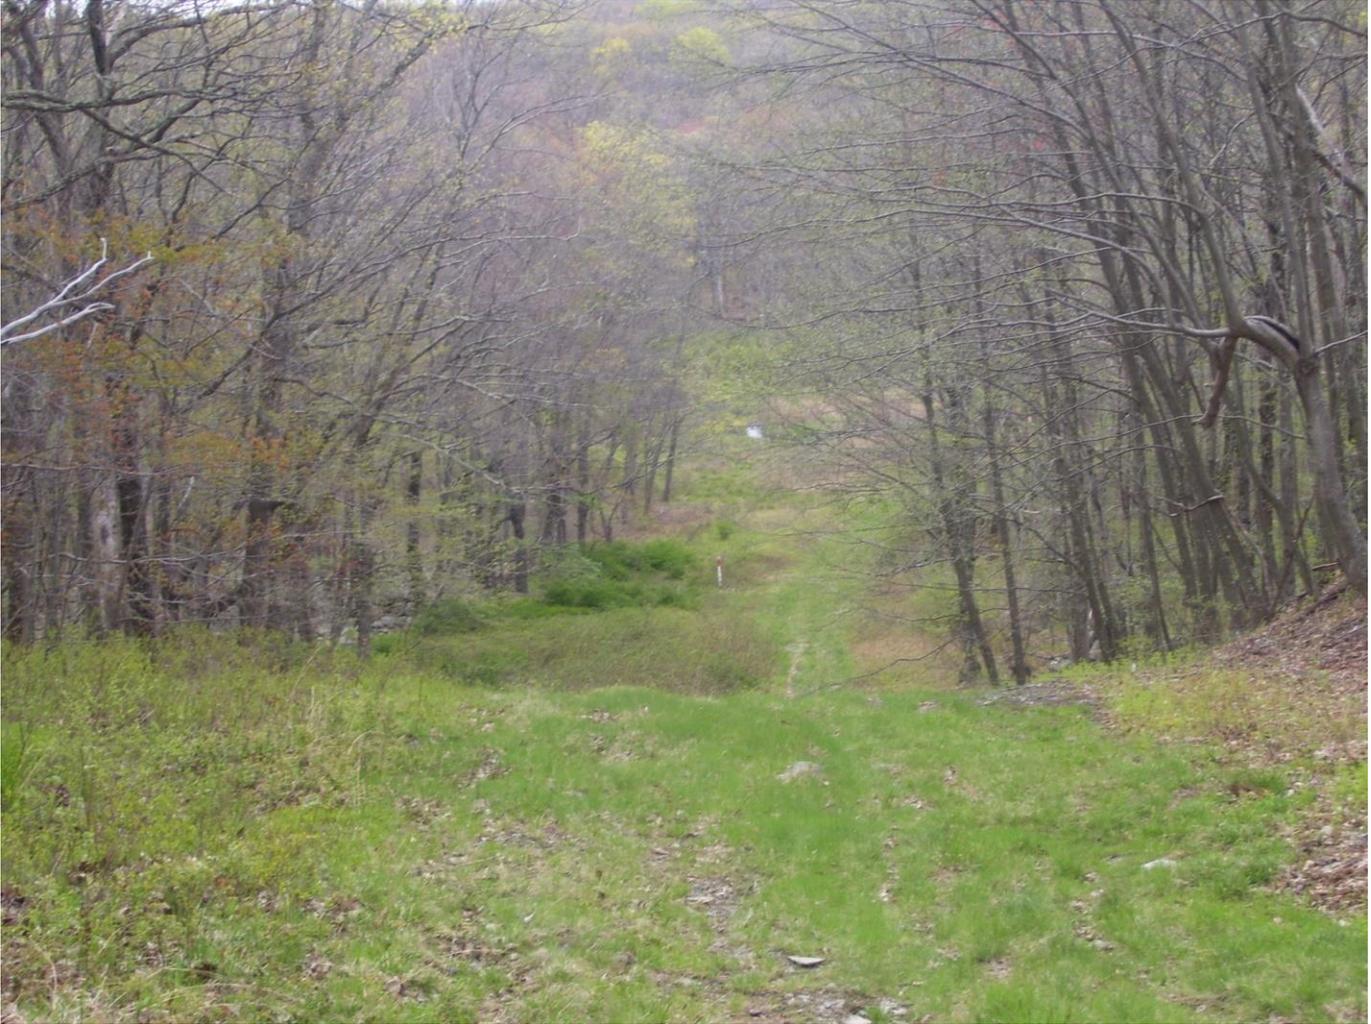
Pinchot Brook conditions before TGP NEUP expansion. Existing TGP ROW. Photo taken July 22, 2012

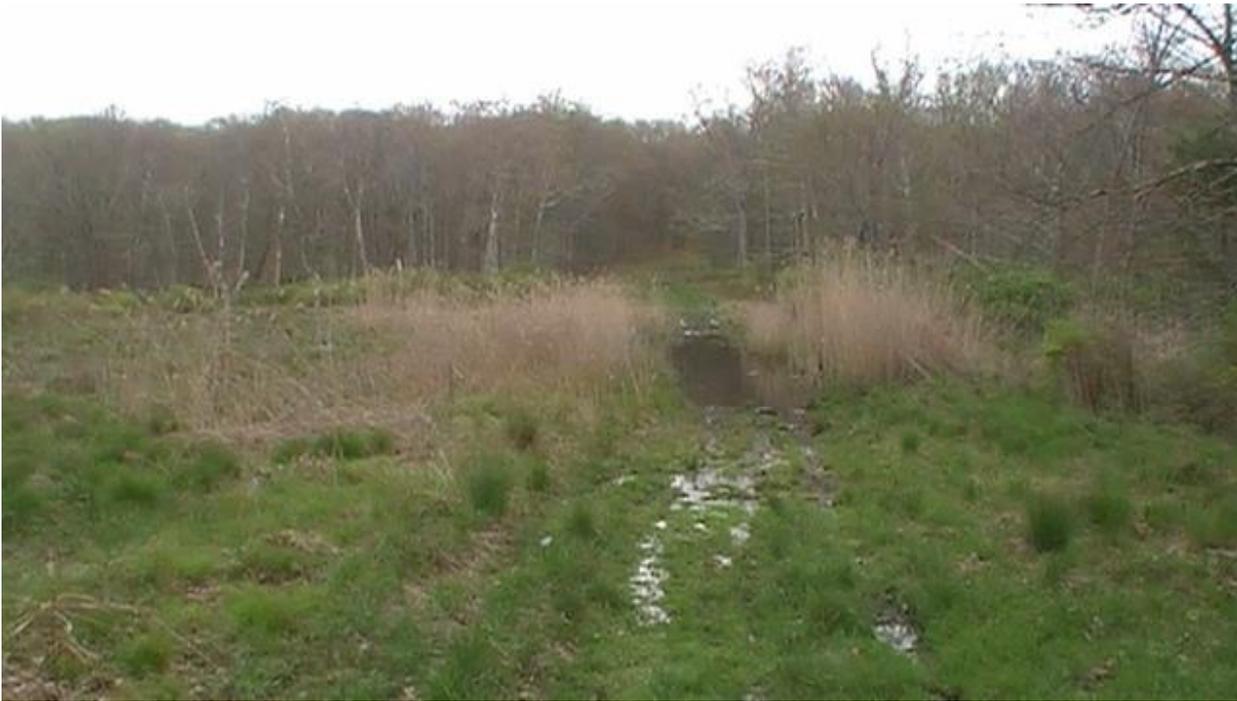
Looking down to Pinchot Brook. conditions before TGP NEUP expansion. Existing TGP ROW. Photo taken before leaf out - April 25, 2012, Standing on West side of Pinchot Brook from top of hill facing down to Pinchot Brook and wetland and East.

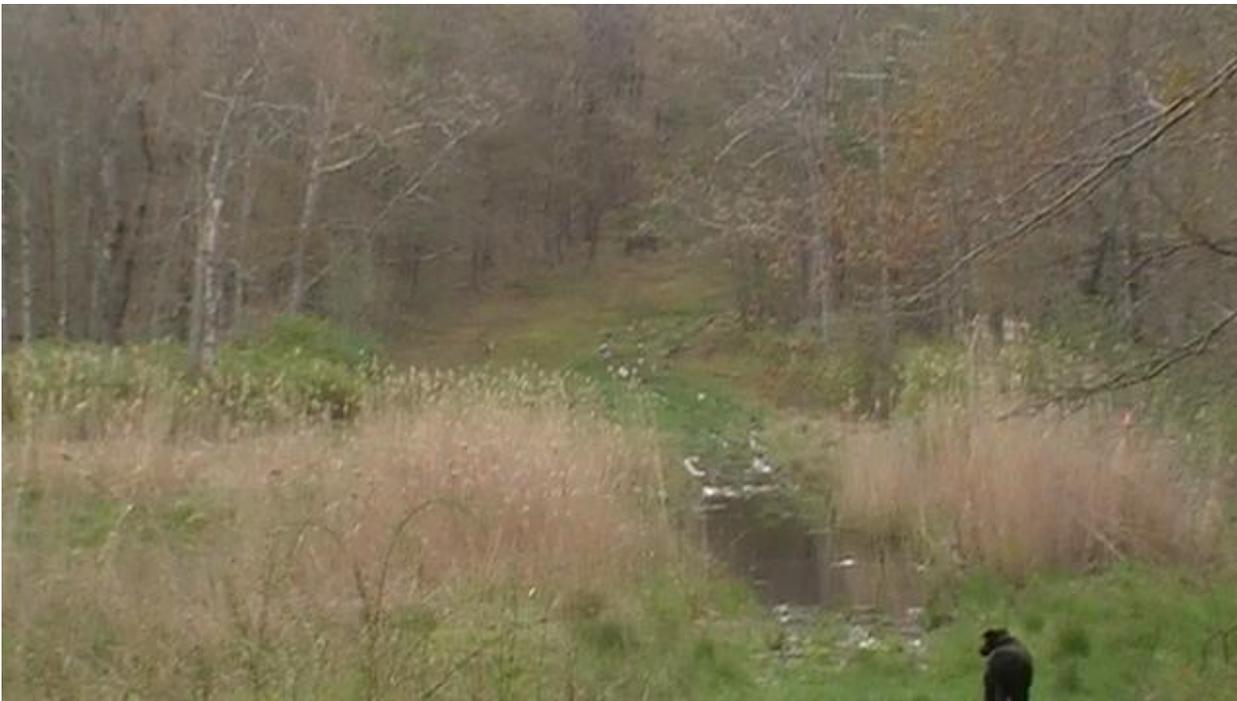
Pinchot Brook TGP 1950's Pipeline Cut. Note Phragmites and active ATV impacts. Photo April 25, 2012

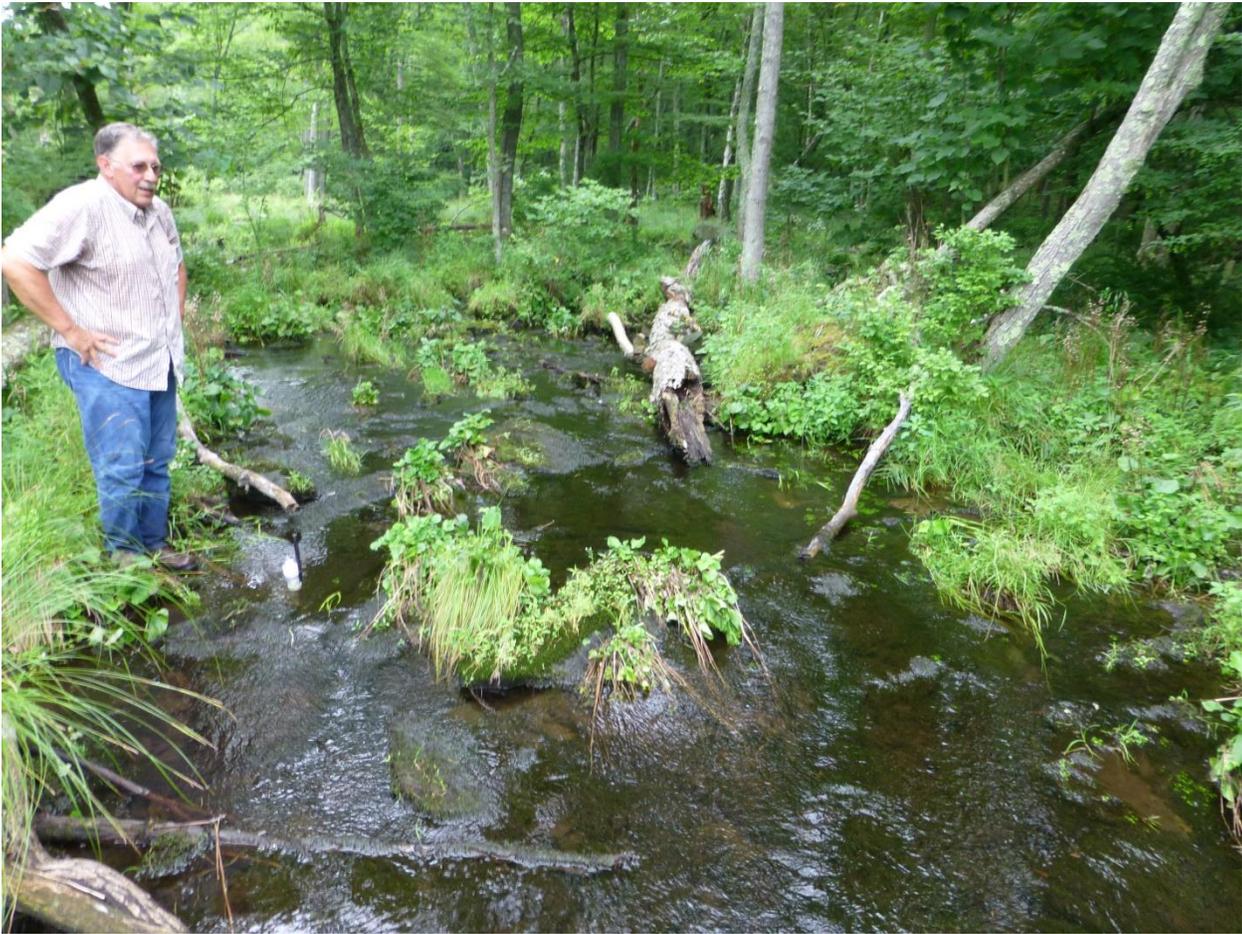
April 25, 2012 – closer view of Pinchot Wetland and stream – note ATV damage on opposite side of wetland and phragmites. Standing on West Side Pinchot Brook, facing East.

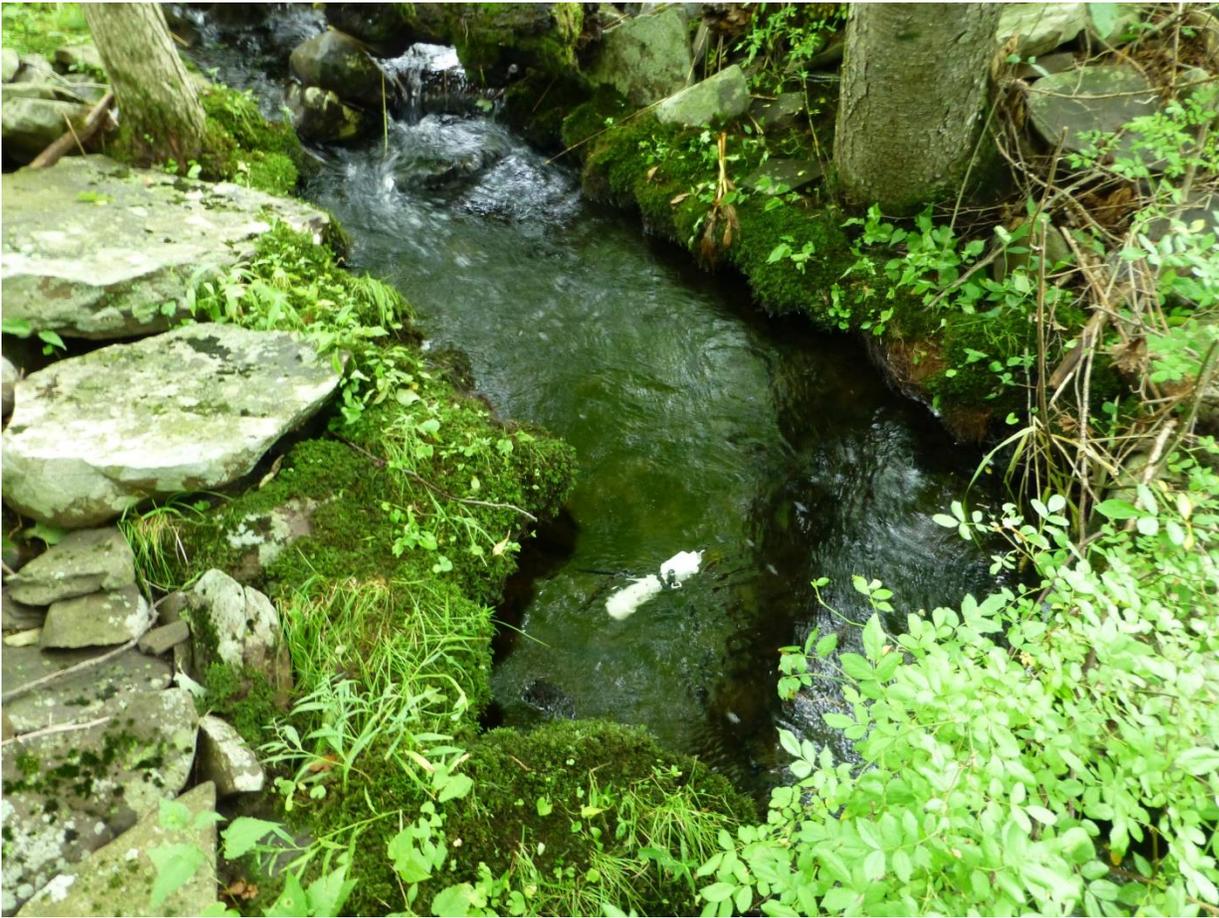
Hobo Temp Station, Downstream of Pinchot Creek TGP NEUP Pipeline Cut in Forested Area. Photo taken 7/14/13

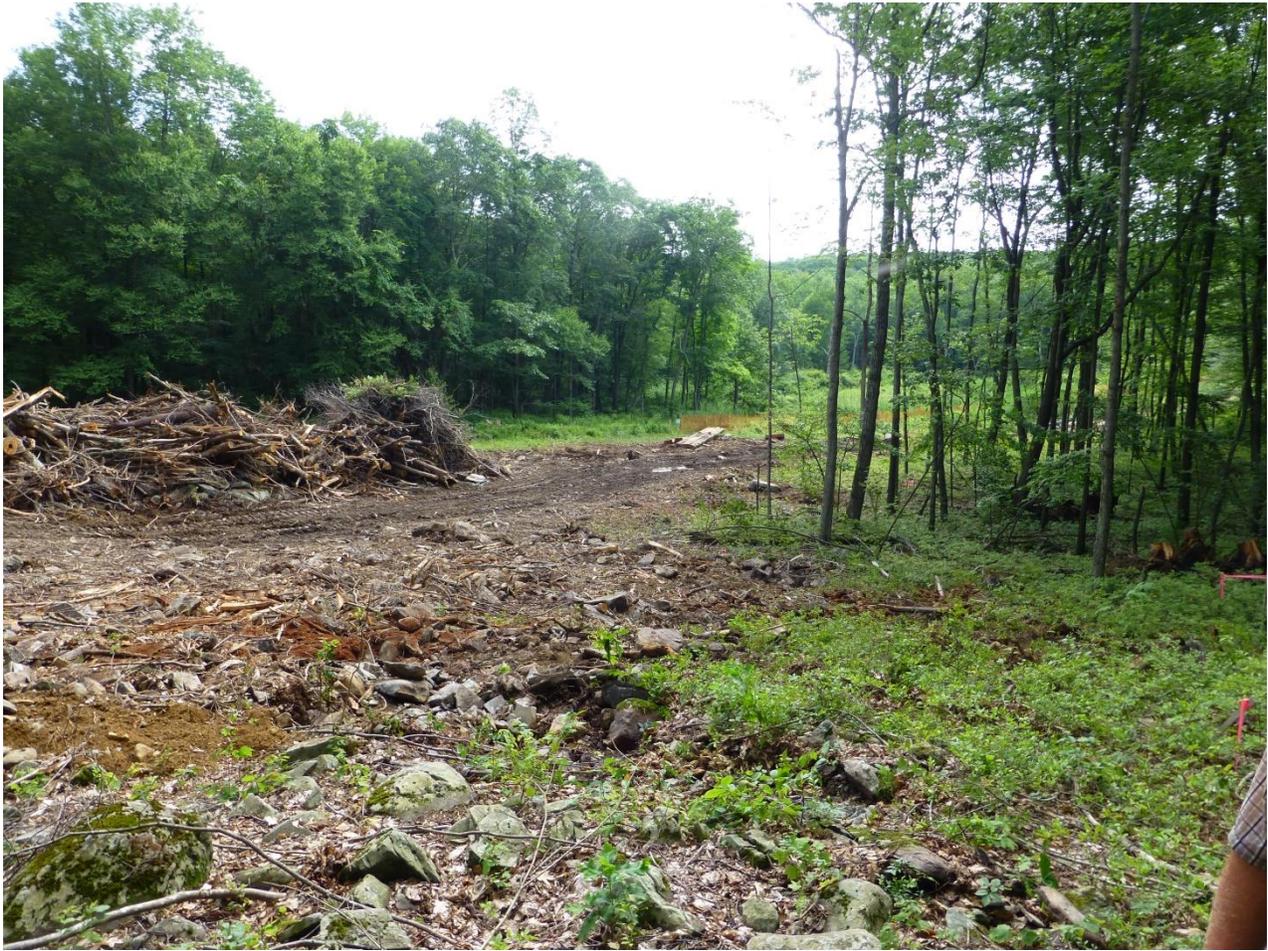
Close up of Hobo Temp Placement – Downstream Pinchot Pipeline cut. Photo taken 7/14/13

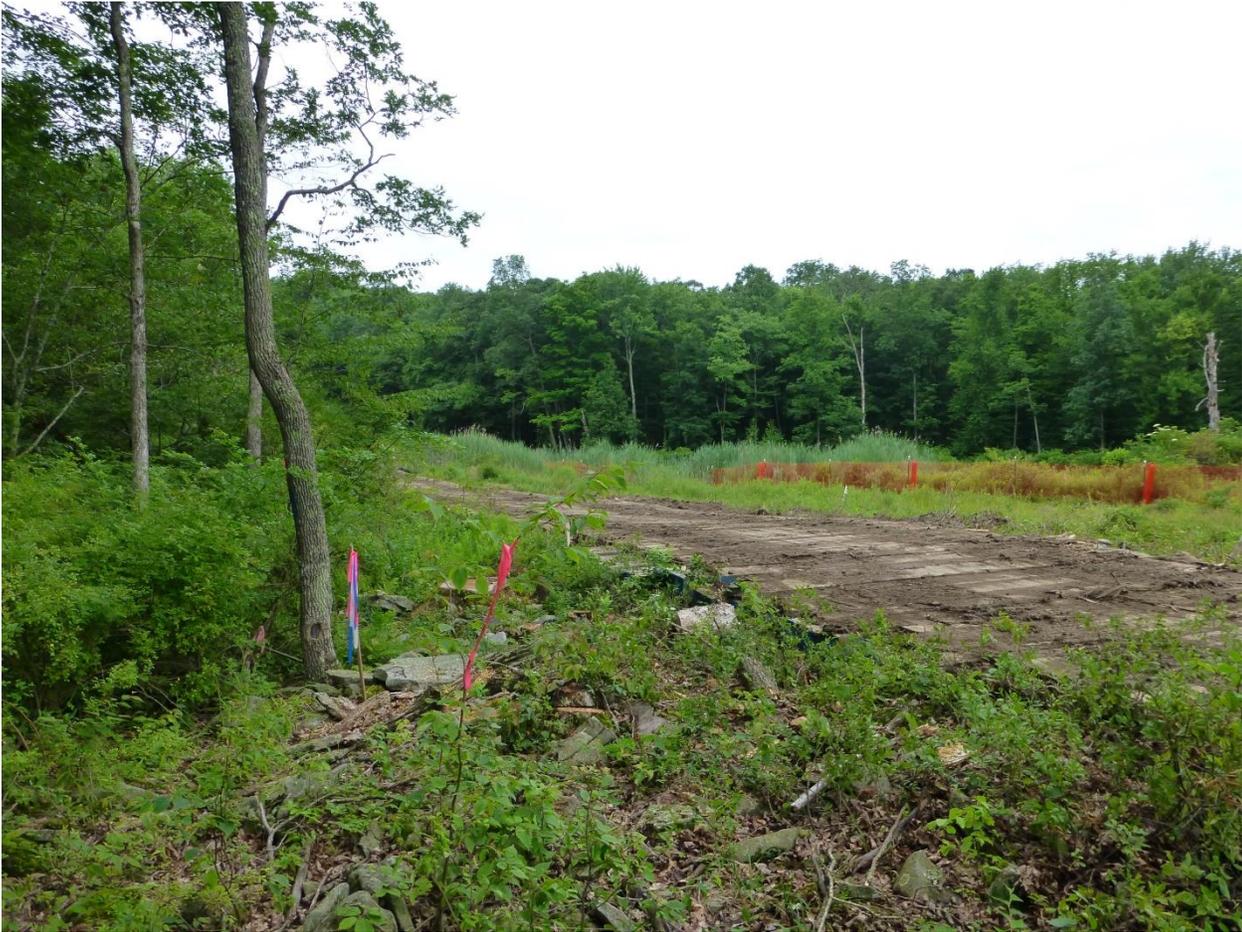
TGP NEUP Active Pipeline Cut Across Pinchot Brook, Photo taken 7/14/13. Standing in TWS on East side of Pinchot Brook crossing.

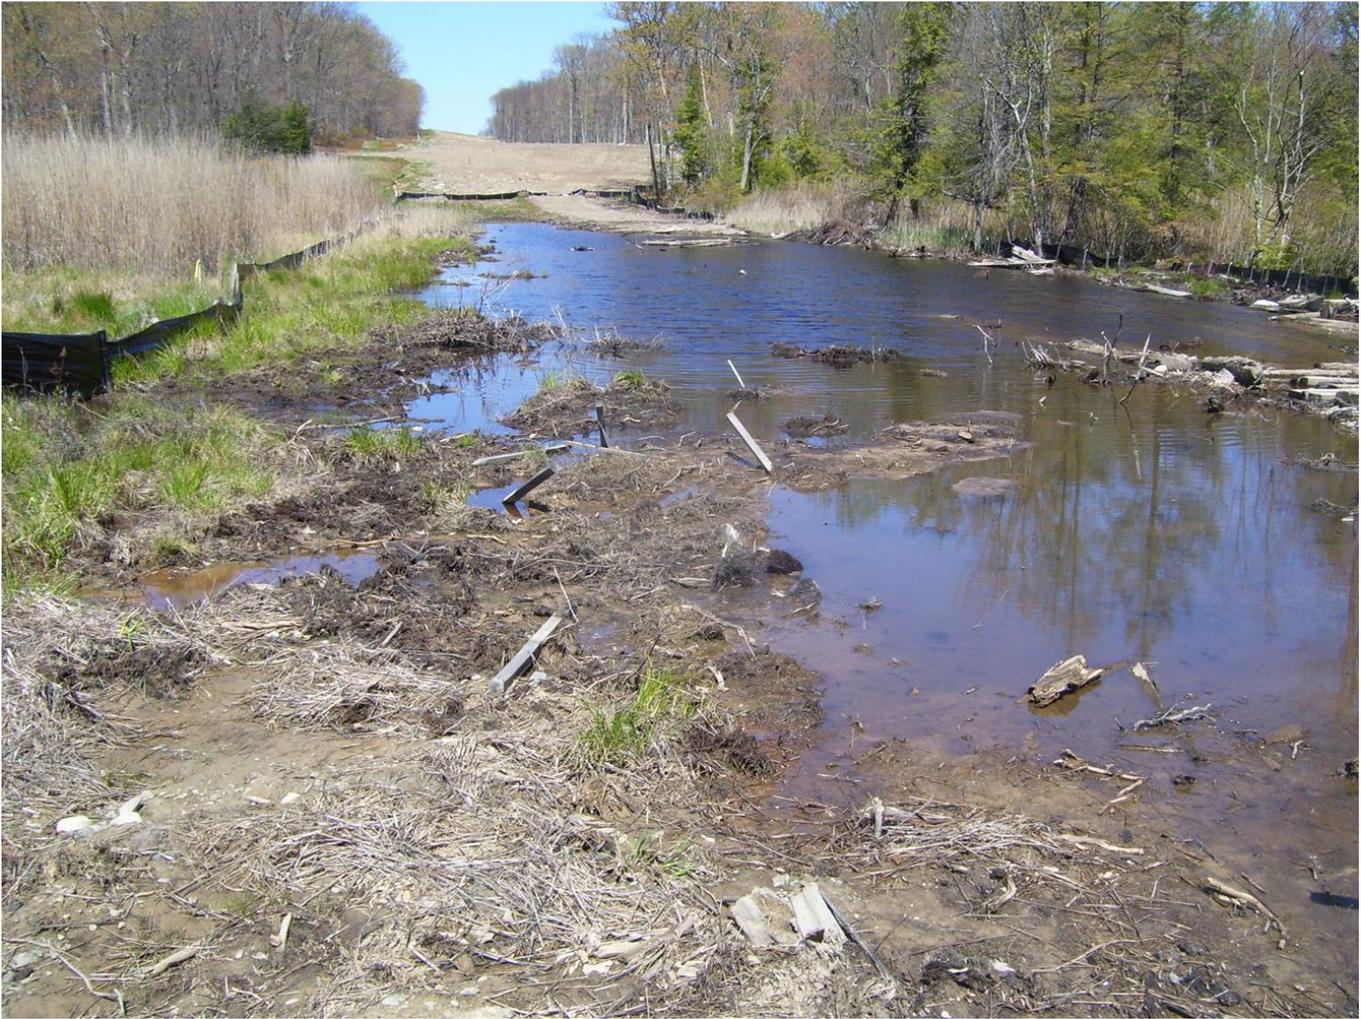
2012 Google earth imagery after the pipeline cut. W038 – note open water

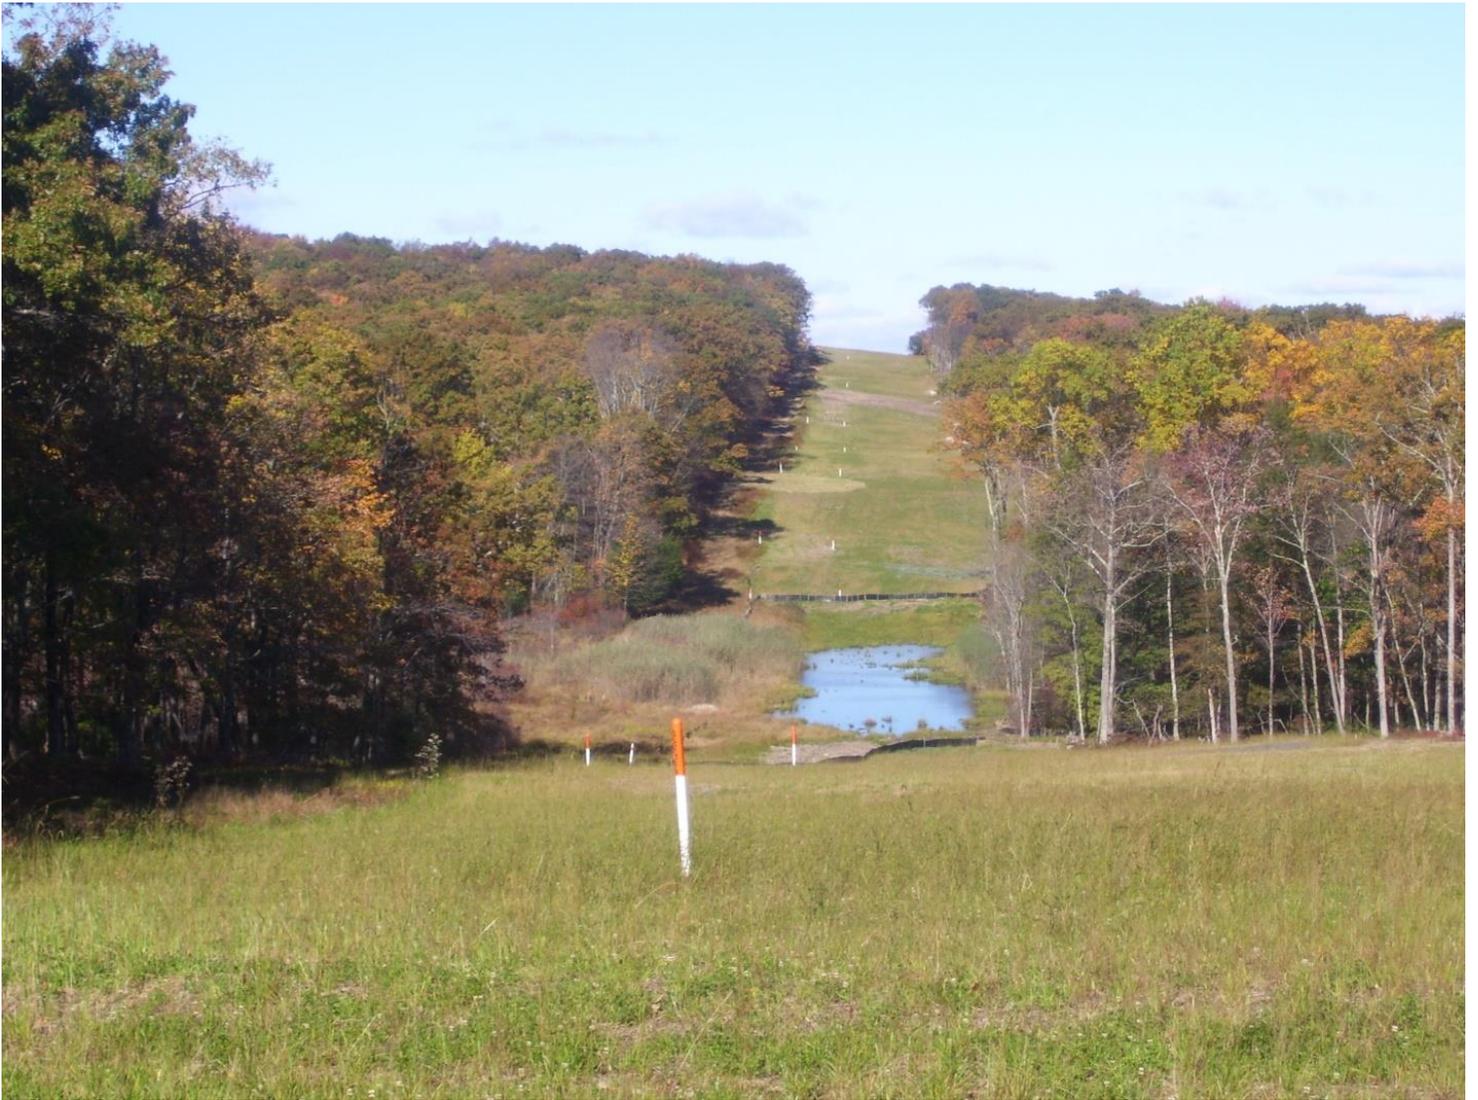
Savantine wetland complex W038 – Photo taken April 29, 2012. Note open water wetland converted from forested wetland. Note *Phragmites* in old ROW.

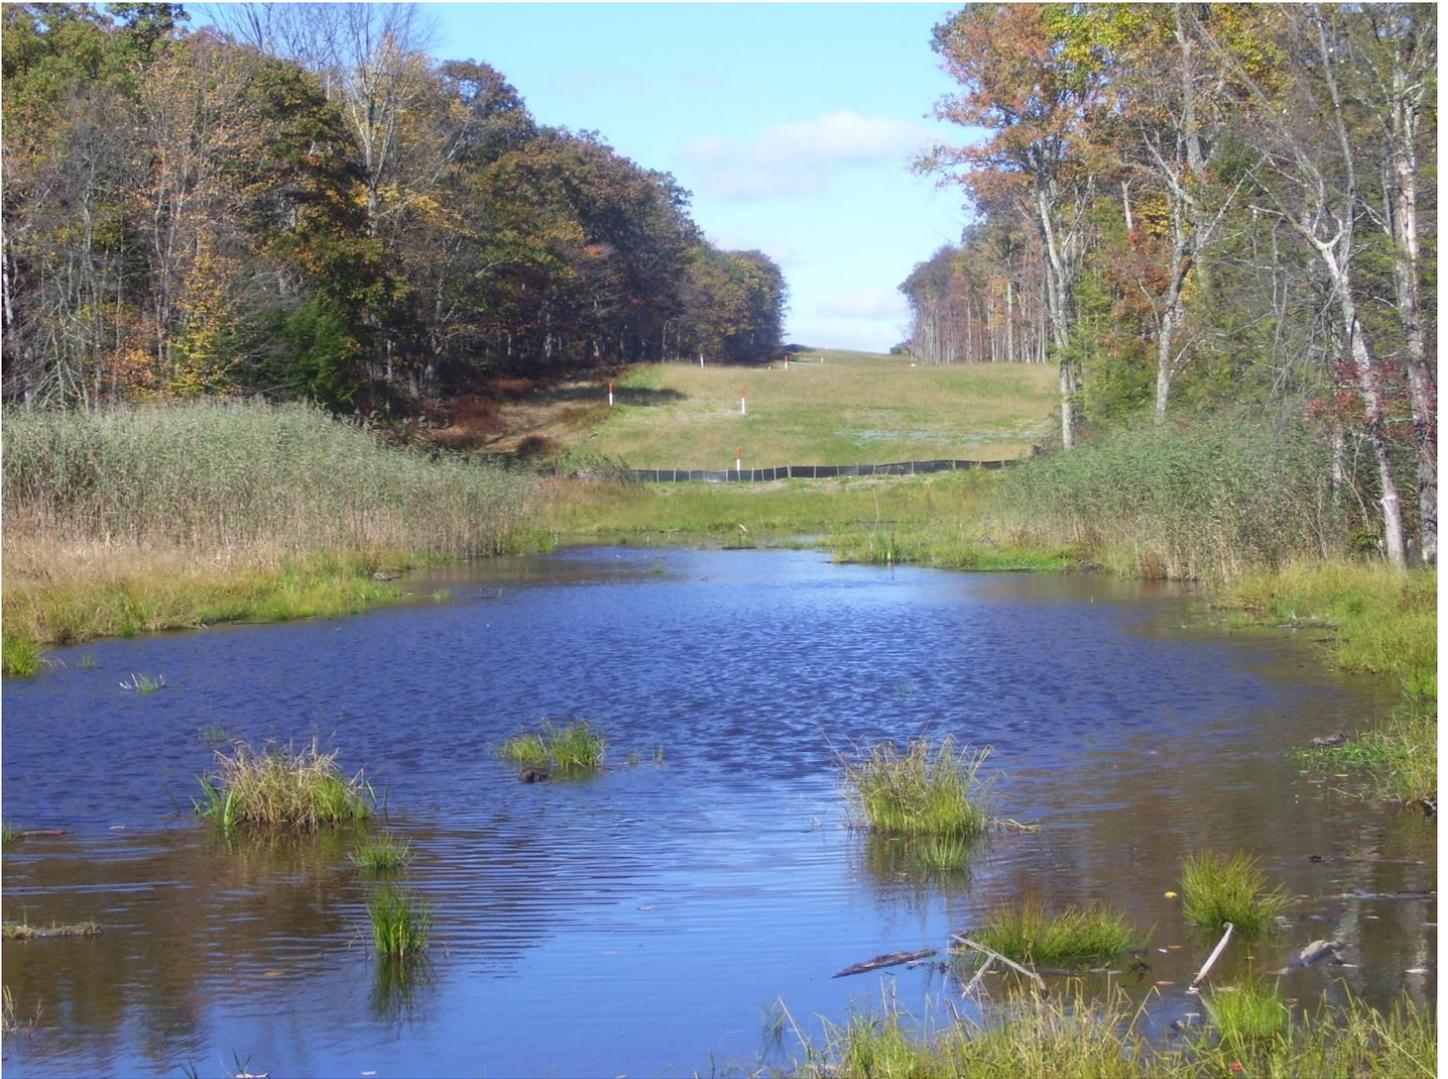
W038 was converted from a forested EV wetland to an open waterbody EV wetland. Photo taken 10/11/12. TGP 300 was completed and transporting natural gas by November 2011.

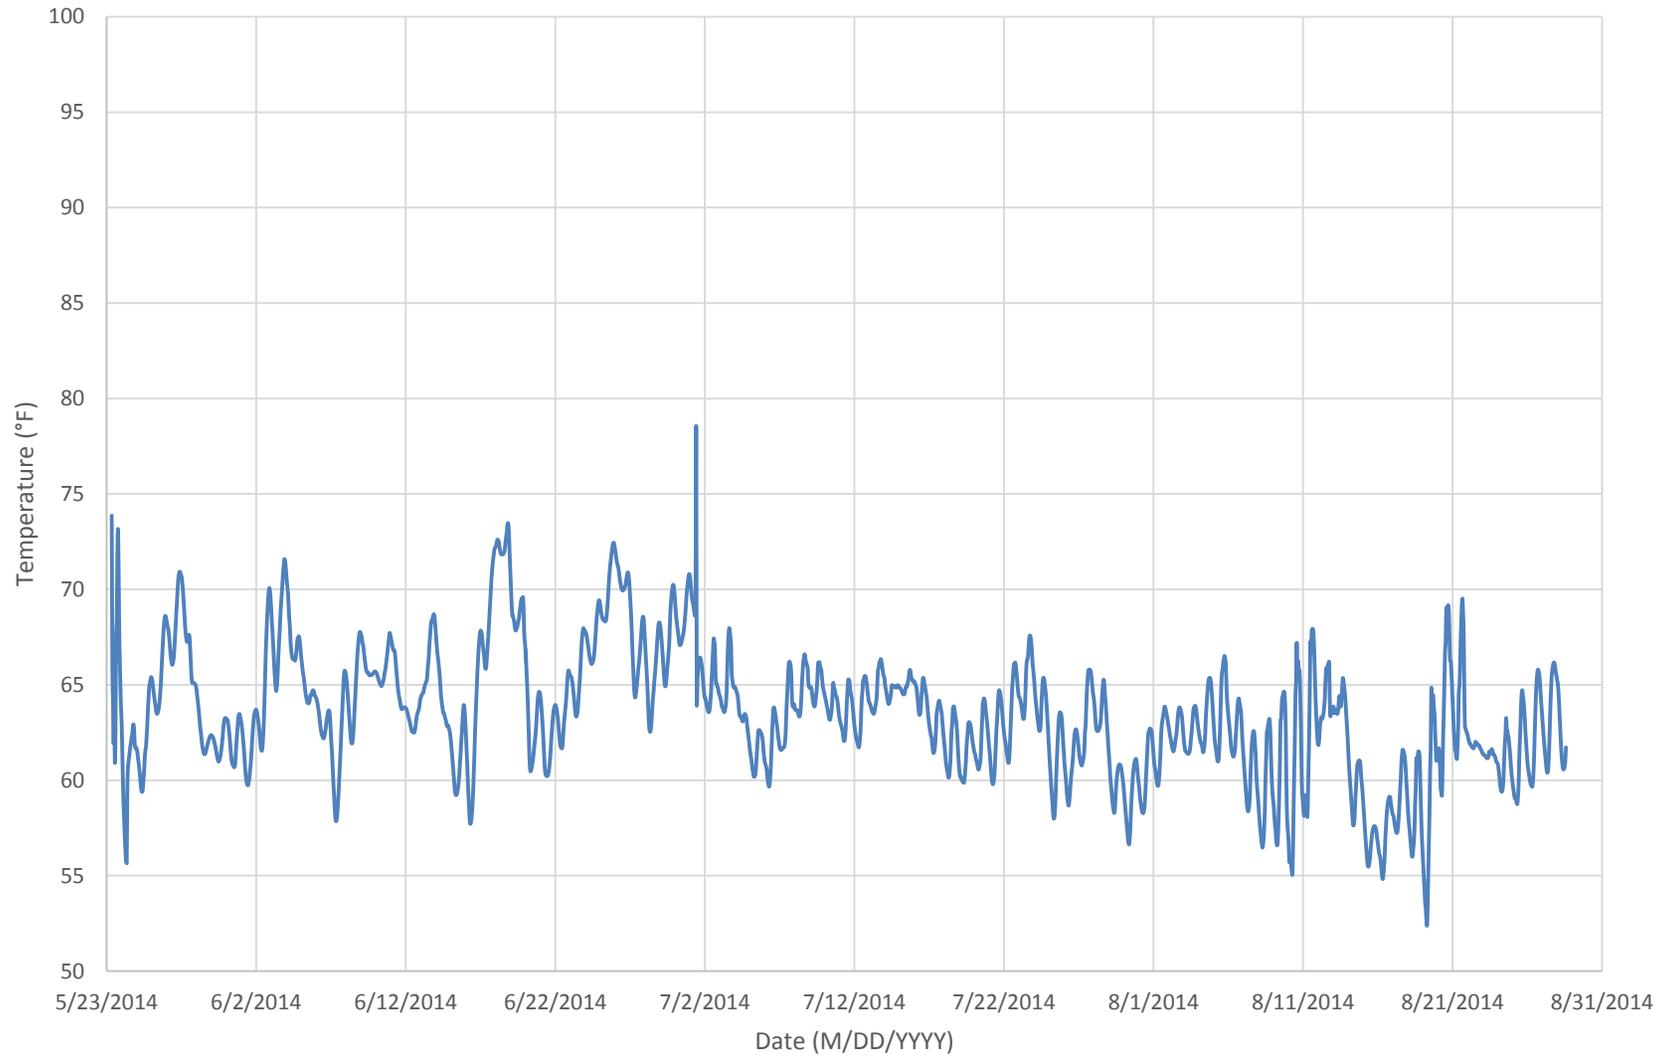
Savantine Brook/Wetland Complex – 500 ft. Upstream Pipeline ROW Cut - 10377360

| Savantine Brook/Wetland | # of readings | Avg. (°F) | Max (°F) | Min (°F) | Std. Dev. | Span of samples | Serial # |
|---|---|---|---|---|---|---|---|
| W038 Savantine Brook Wetland Complex (500' US pipeline cut)* | 2335.00 | 63.53 | 78.56 | 52.38 | 3.34 | 5/23/14 – 8/28/14 | 10377360 |

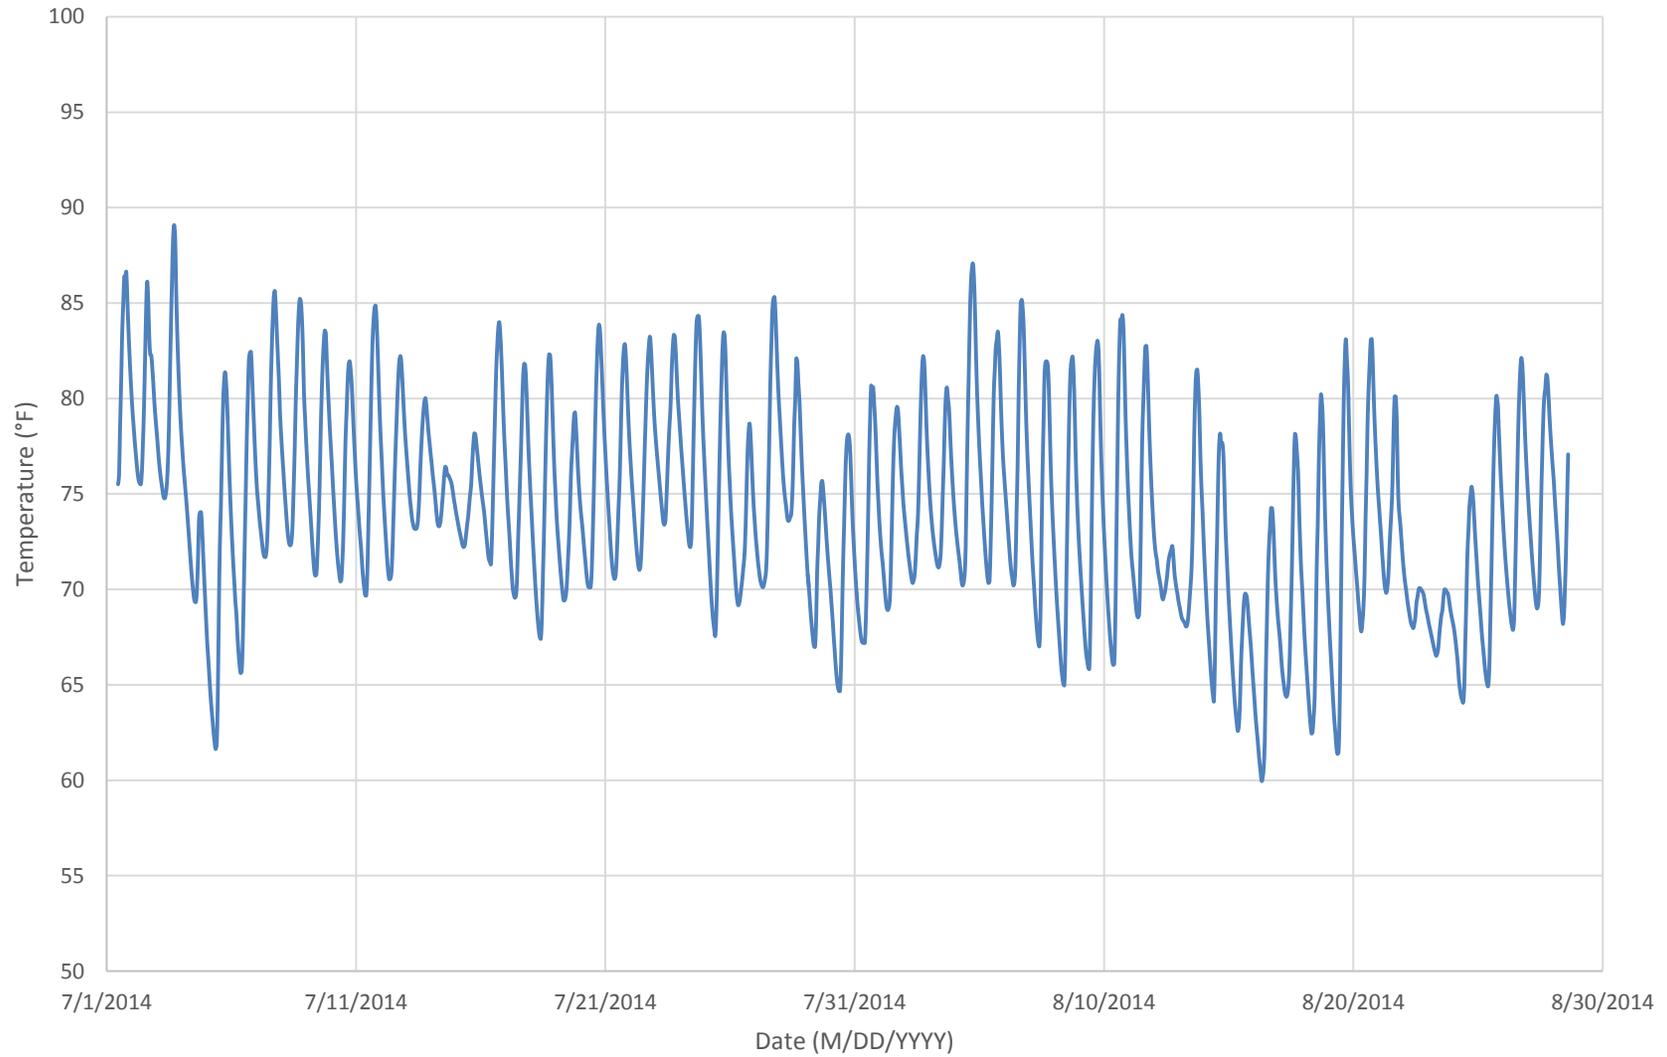
Sanvantine Brook/Wetland Complex, Within Pipeline ROW Cut - 10377357

| Savantine Brook/Wetland | # of readings | Avg. (°F) | Max (°F) | Min (°F) | Std. Dev. | Span of samples | Serial # |
|---|---|---|---|---|---|---|---|
| W038 Savantine Brook Wetland Complex (Within Pipeline ROW Cut)* | 1397.00 | 74.14 | 89.09 | 59.96 | 5.38 | 7/1/14 – 8/28/14 | 10377357 |

Temperatures within the pipeline ROW cut of the 300 pipeline upgrade project for Savantine Creek and wetland complex had the highest average temperatures from all the probes indicating direct thermal impacts due to the pipeline cut to this Exceptional Value waterway. Savantine Creek within the pipeline cut had instream average temperatures of 74.14° F and a maximum of 89.09°F with a standard deviation of 5.38 (1,397 temperature readings collected). Downstream of the pipeline cut temperatures were elevated for Savantine Creek with the average stream temperature at 67.26° F (N=2,336) compared to the station located Upstream of the pipeline cut with an average temperature of 63.53° F (N=2,335). These impacts to Savantine Creek were documented in the summer of 2014, three years after the 300 upgrade project was completed – the 300 Upgrade Project was constructed in 2011 and running gas by November 2011. These temperatures indicate sustained thermal impacts to the stream more than 2.5 years after the 300 upgrade was running gas through its pipeline.

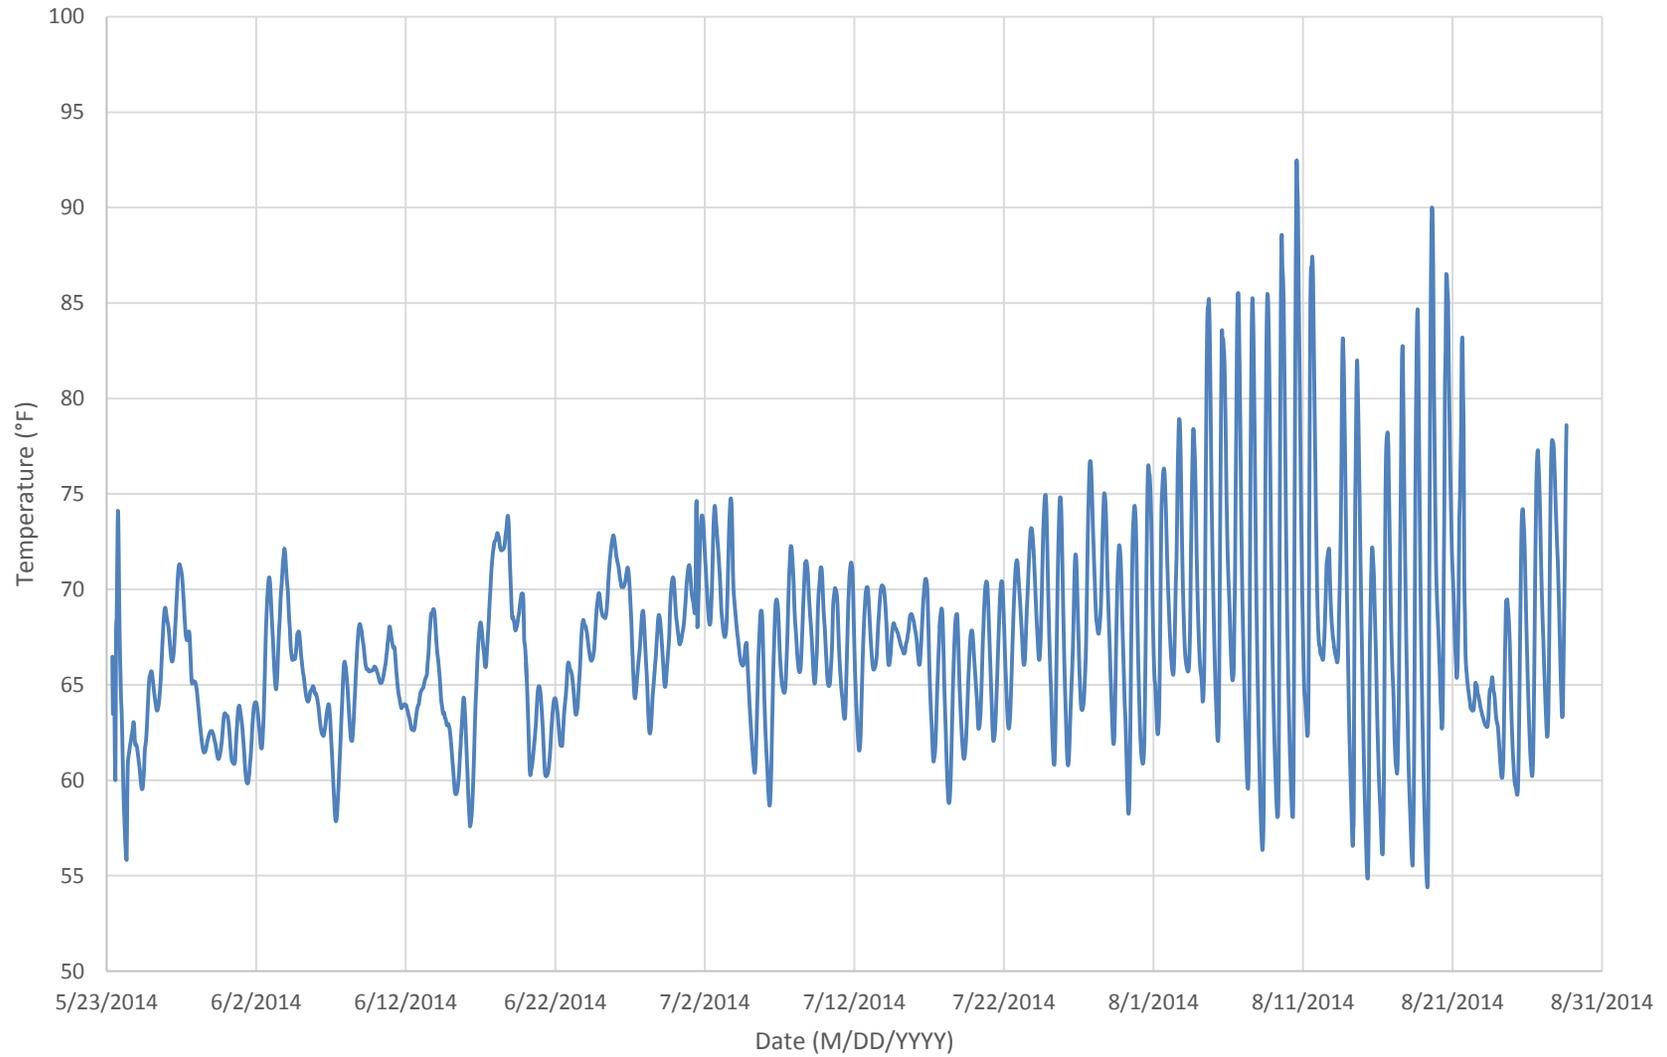
Savantine Brook/Wetland , Downstream Pipeline ROW Cut - 10377358

| Savantine Brook/Wetland | # of readings | Avg. (°F) | Max (°F) | Min (°F) | Std. Dev. | Span of samples | Serial # |
|---|---|---|---|---|---|---|---|
| W038S1 Savantine Brook Wetland Complex (DS pipeline ROW cut)* | 2336.00 | 67.26 | 92.48 | 54.39 | 5.40 | 5/23 – 8/28/14 | 10377358 |
