April 5, 2013

Re: Tennessee Gas Pipeline Company, L.L.C., Docket No. CP11-161-000 Northeast Upgrade Project - Loop 323 Field Inspections – Inadequate protections to Sensitive Waterbodies and Wetlands Listed as “Non-Impacted” by TGP

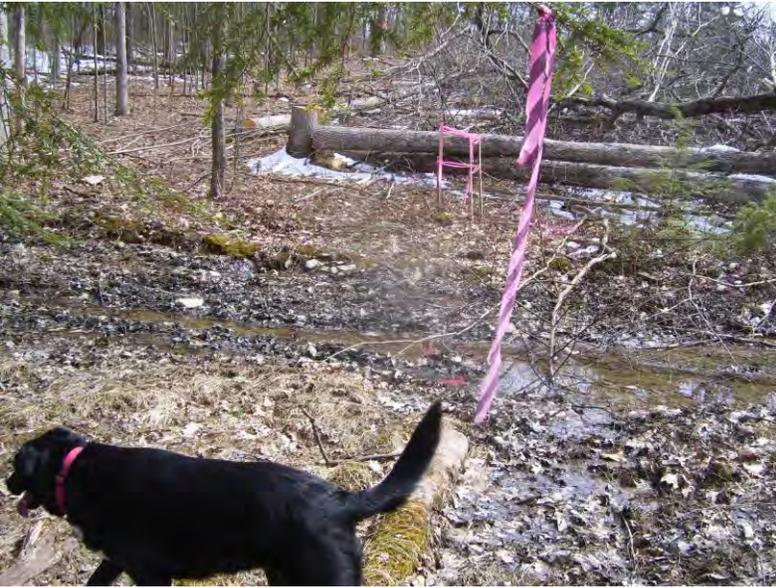
DRN Photo 100_4903 W045

Delineation Flagging

- 6) Observations at Laurel Swamp Brook S020 (EV) and three wetlands W043/W044/W045 indicate that W044/W045 have a hydrologic connection with Laurel Swamp and are not "isolated". Resource signage for these wetlands indicates they continue into TGP's ROW and are and will be impacted.

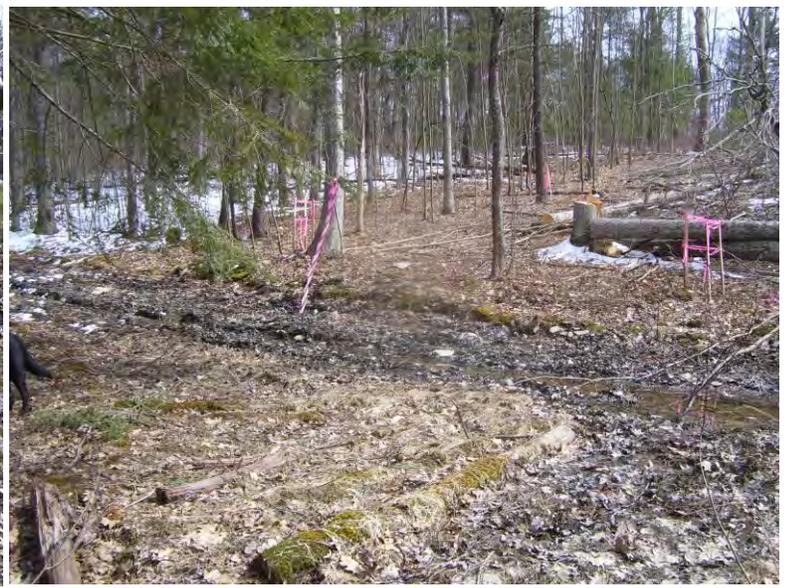
DRN Photo 100_4905 W045 Flowing

into ROW

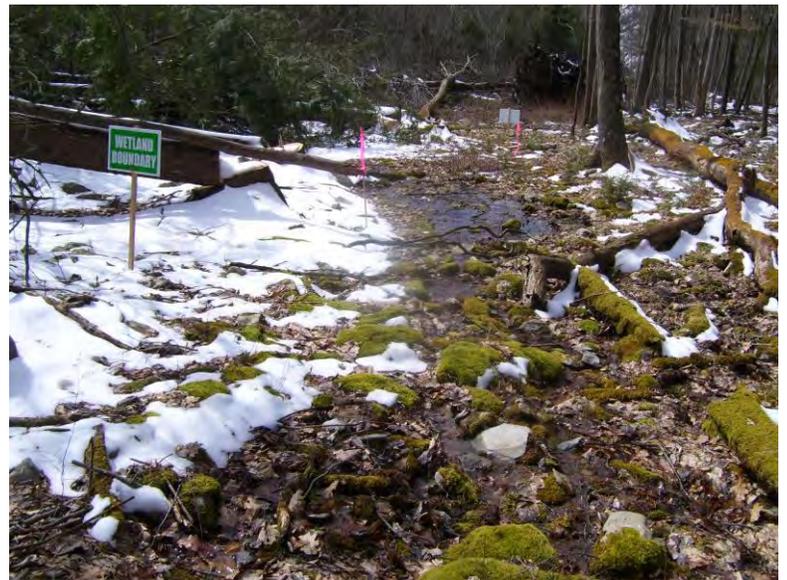
DRN Photo 100_4800 surface above the wetland boundary

DRN followed the construction ROW east towards Crawford Branch (S046). W093 is listed as “not crossed by pipeline in workspace only”. DRN believes an unidentified stream exiting south of TGP’s ROW is connected to W093 under the pile of felled trees. Field observations indicates surface water downhill from W093 resource signage crossing woods road in TGP’s ROW and exits as an unidentified stream. There are no field delineations for W093 and no identification for the stream exiting the ROW, however DRN believes they are connected and crossing TGP’s ROW. (Report 043-4) (Report 043-4a)

- 4) W093 is listed as "not impacted" but field observations document this sensitive resource crossing the pipeline ROW.
- 5) Pink and black flagging used for wetland delineations was observed under felled trees near Crawford Branch but is not listed in the Pa. Bulletin as a wetland crossing at this location.

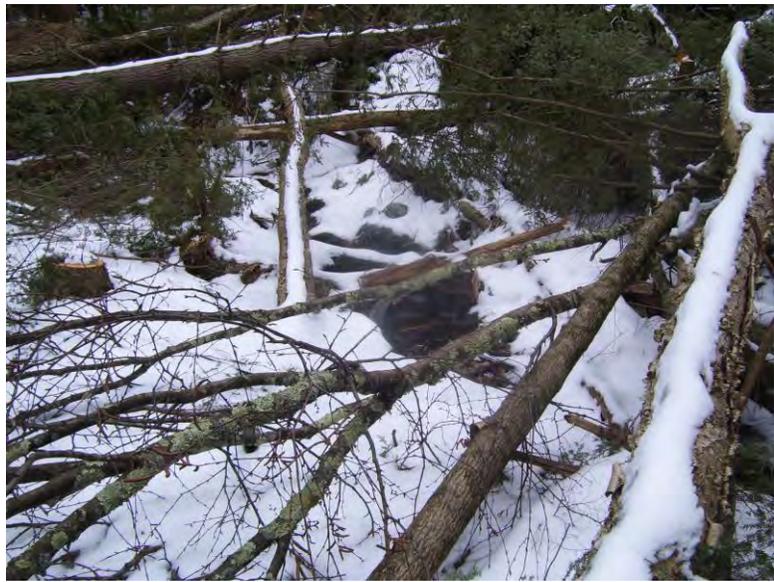
DRN Photo 100_4737 S045A buried under east

Felled trees S045A has no resource signage

On March 22, 2013, DRN accessed Deep Brook (S045) and UNT of Deep Brook (S045A) both Exceptional Value (EV) streams at location where TGP crosses S045/S045A. S045A is a small stream parallel to S045 at the crossing and is associated with W090. W090 is listed as a 21’ wide crossing spanning both sides of S045 which is listed as a 20’ wide crossing. Alignment sheets (20120808-5072 (27476900)) do not show W090 extending to the west of S045 or show S045A which does not have resource signage at TGP crossing. There is no delineation of W090 in the field confusing where W090 ends or where S045A begins (Report 043-2)

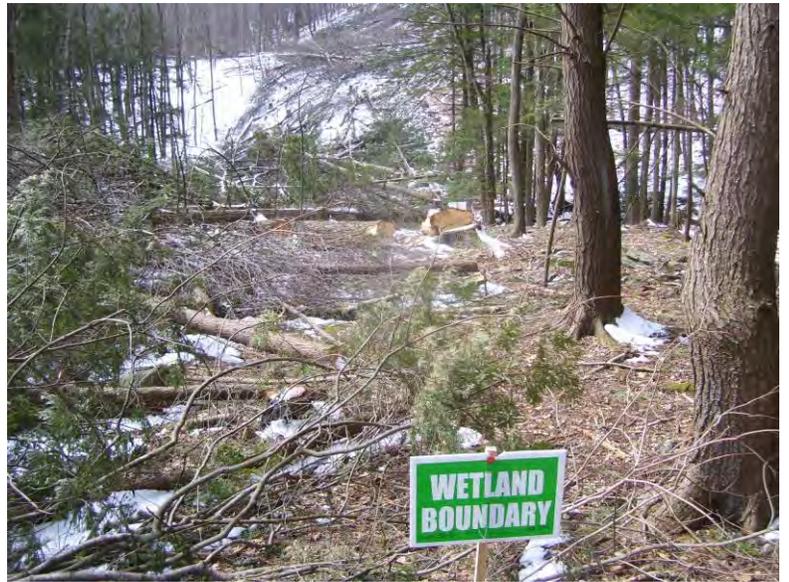
DRN Photo100_4765 looking west from

During the March 22 field visit DRN followed the construction ROW east towards Crawford Branch (S046). W091 is adjacent to W090 and field observations has W091 extending to the east to foot marker 194+00 connecting these associated wetlands and waterbodies for approximately 200’ to the top of west bank S045 at 192+12. Pa Bulletin 12/8/12 has a combined total crossing width of only 61’ permitted for these 4 resources. There are no field delineations for W090/W091 other than resource signage along the northern edge of ROW and no resource signage for S045A. (Report 043-3).

boundary of W091 connecting with W090

- 3) Three features associated with Deep Brook S045 (Exceptional Value stream) appear to be connected in a single crossing width of approximately 200' but much larger than the 61' combined for W090/W091 and S045/S045A with S045A having no resource signage in place.
