Re: *Headquarters Road Bridge – Headquarters Road Bridge as a 4(f) Property*

# The Bridges of Tinicum Township

## BURNT MILL BRIDGE HAER DOCUMENTATION SUMMARY

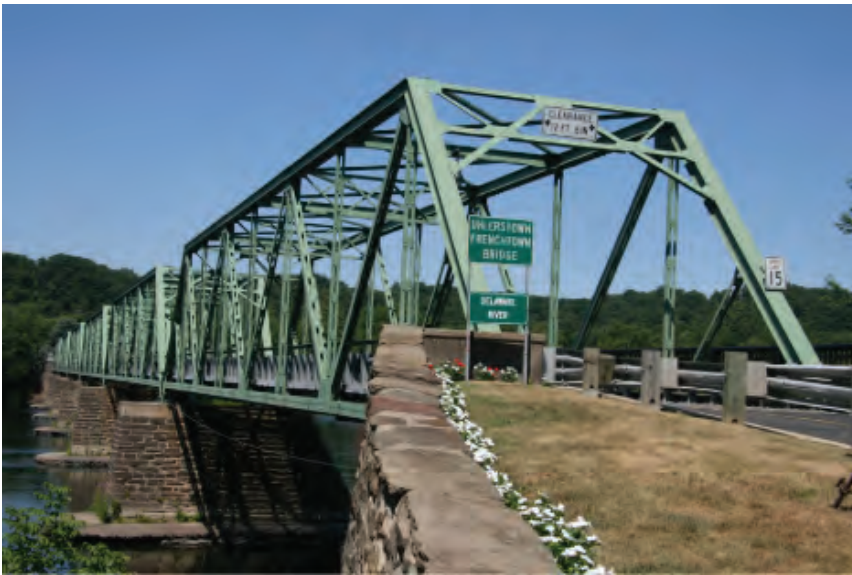
*The Uhlerstown- Frenchtown bridge crosses the Delaware River and is considered National Register eligible.*

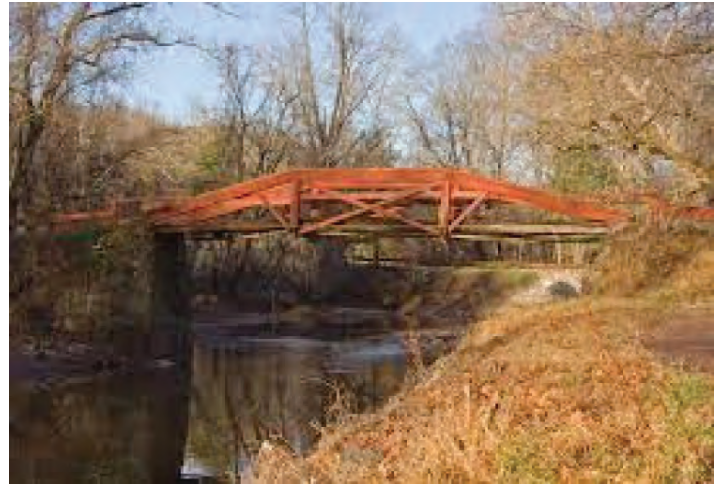
*A representative example of a camel-back canal bridge.*

Bridges crossing the canal have also fared well and the basic design of the bridge sidewalls has been preserved over time. The Delaware and Lehigh Canal National Heritage Corridor features a common camel-back bridge design for road crossings over the canal that despite repairs and rebuilding, have retained their character defining sides forming the camelback profile. In looking at all of the camelback canal bridges along the sixty mile canal, only six fully original camelback bridges still exist. Most are newer beam bridges that replicate the wooden trusses as the side railings. One bridge is of the camelback design, but made entirely of metal pipe. Another replicates the engineering features, with wood and metal components, but is much heavier in appearance, being designed for heavy modern loads. Other types of crossings include metal Pratt pony truss, concrete arch, I-beam, box beam and concrete, pipe and pre-stressed arch culverts.

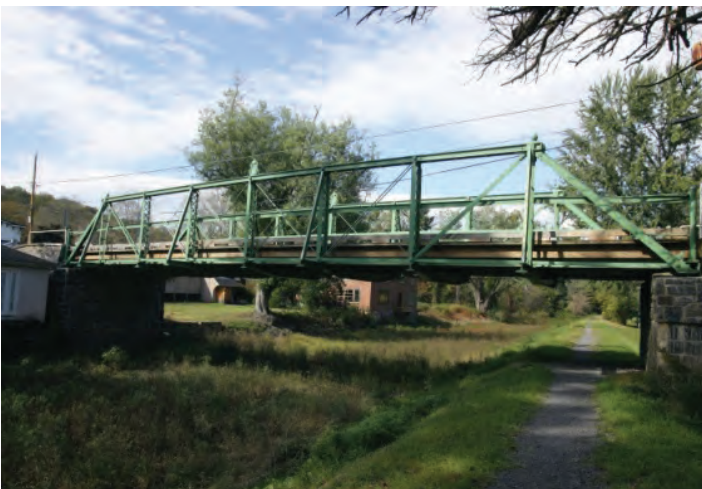
*Pony Truss 1877 bridge crossing the canal—restored.*

The 1877 Pratt Pony Truss bridge over the canal recently underwent disassembly, repair, and restoration. The bridge was cast by the Murray Dougal and Company in Milton, Pennsylvania. The 1948 concrete canal aqueduct in Point Pleasant was replaced recently with a more authentic wooden structure that ensures that the canal flows over the Tohickon Creek.

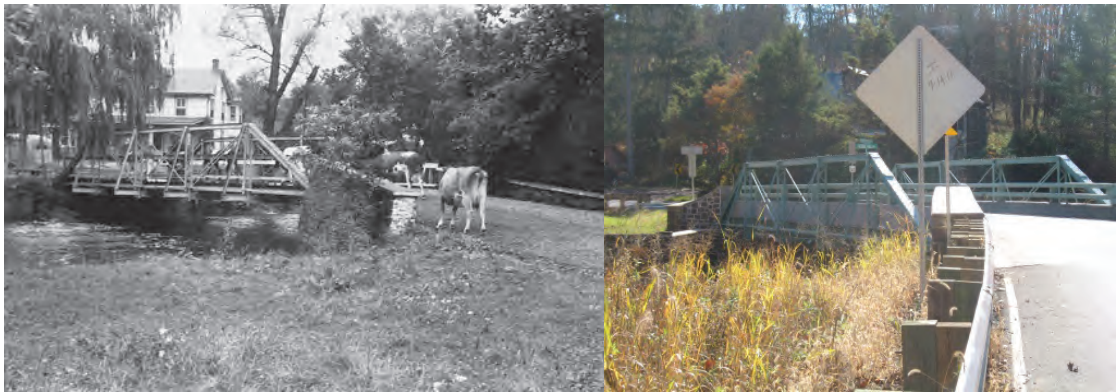
*Although the 1887 bridge was demolished, the one lane width, trusses, abutments and the right of way remained virtually unchanged.*

An 1887 pony truss bridge at Geigel Hill and Sheephole Roads was struck by a truck, closed, and its replacement was held up by public pressure because the Geigel Hill Road Bridge was the only bridge made by Nelson & Buchanan and/or the Pittsburgh Bridge Company that was located within a potential or listed historic district in Pennsylvania, that district being the Ridge Valley Rural Historic district.

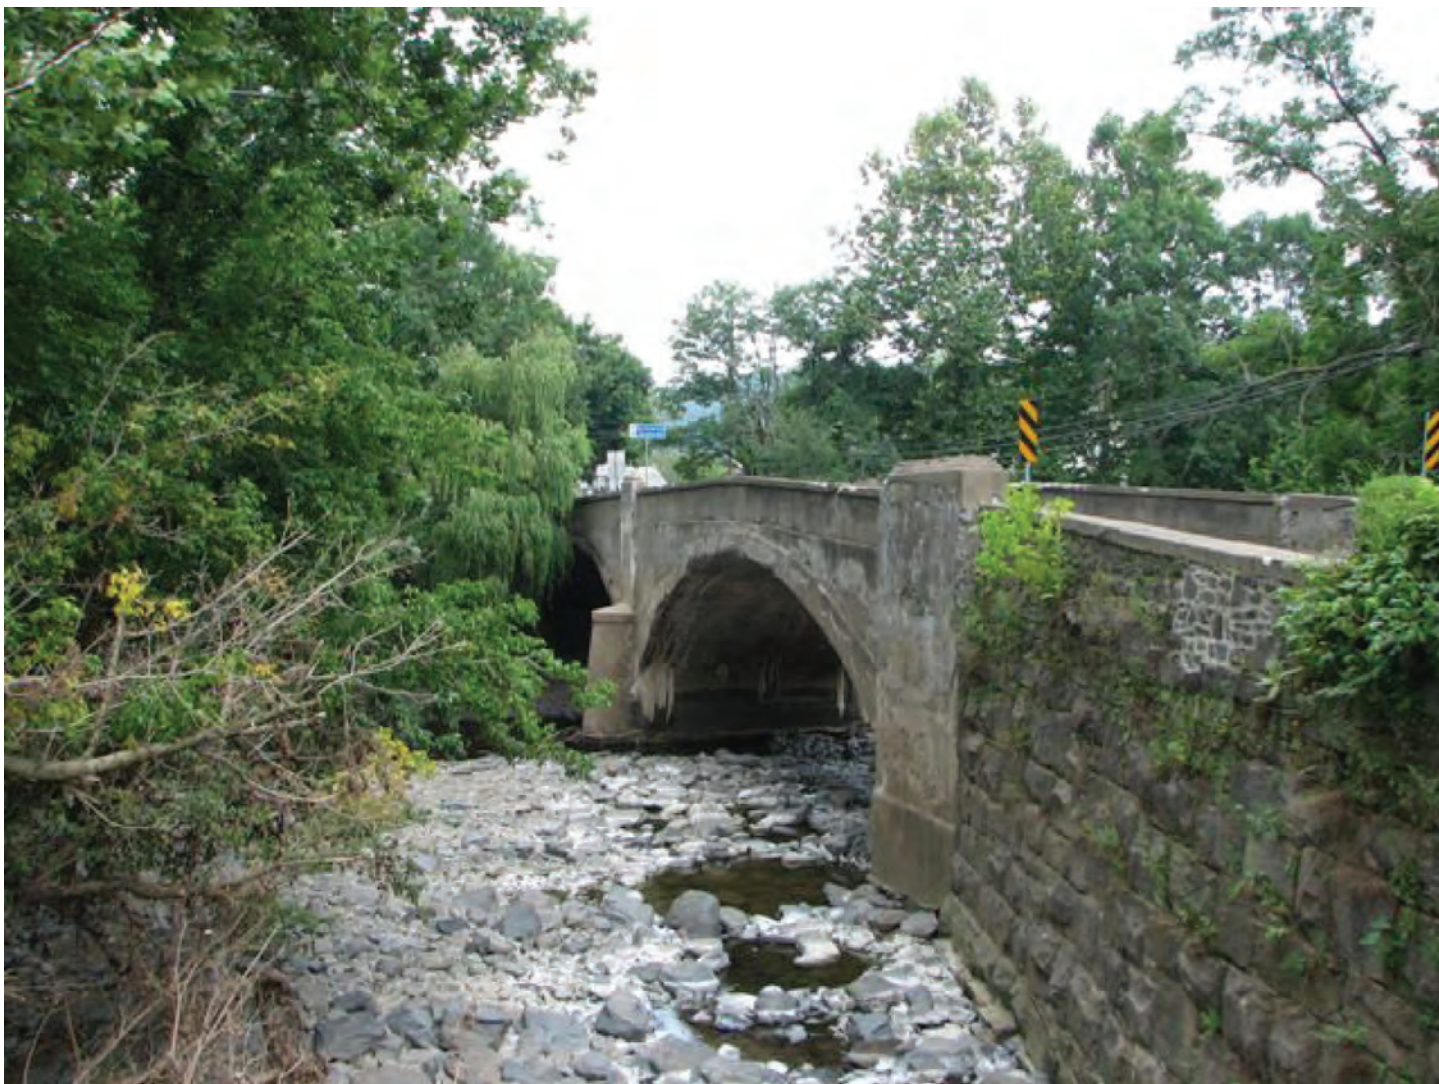
*The 1933 concrete arch bridge in the Point Pleasant Historic District was demolished this spring.*

The Point Pleasant bridge replacement is underway with a temporary crossing being put in place to allow for the demolition of the historic bridge. The removal of this bridge is a significant loss as it is a central feature in the Point Pleasant Historic District. With the powerful Tohickon Creek flowing under its concrete arch, this bridge is a focal point especially from the second floor porch of the Point Pleasant Hotel, a location attracting visitors that came to the area for the quaint architecture and natural beauty seen at this bridge location. That this bridge is not being repaired calls into question the historic designations of the Point Pleasant Historic District and the National Landmark canal designation and how the State honors historic designations. Are these designations not designed to preserve the historic resources of an area? It is especially discouraging for the State to use tax-payer funds to demolish a structure that contributes to a historic district in the most significant part of Tinicum Township.

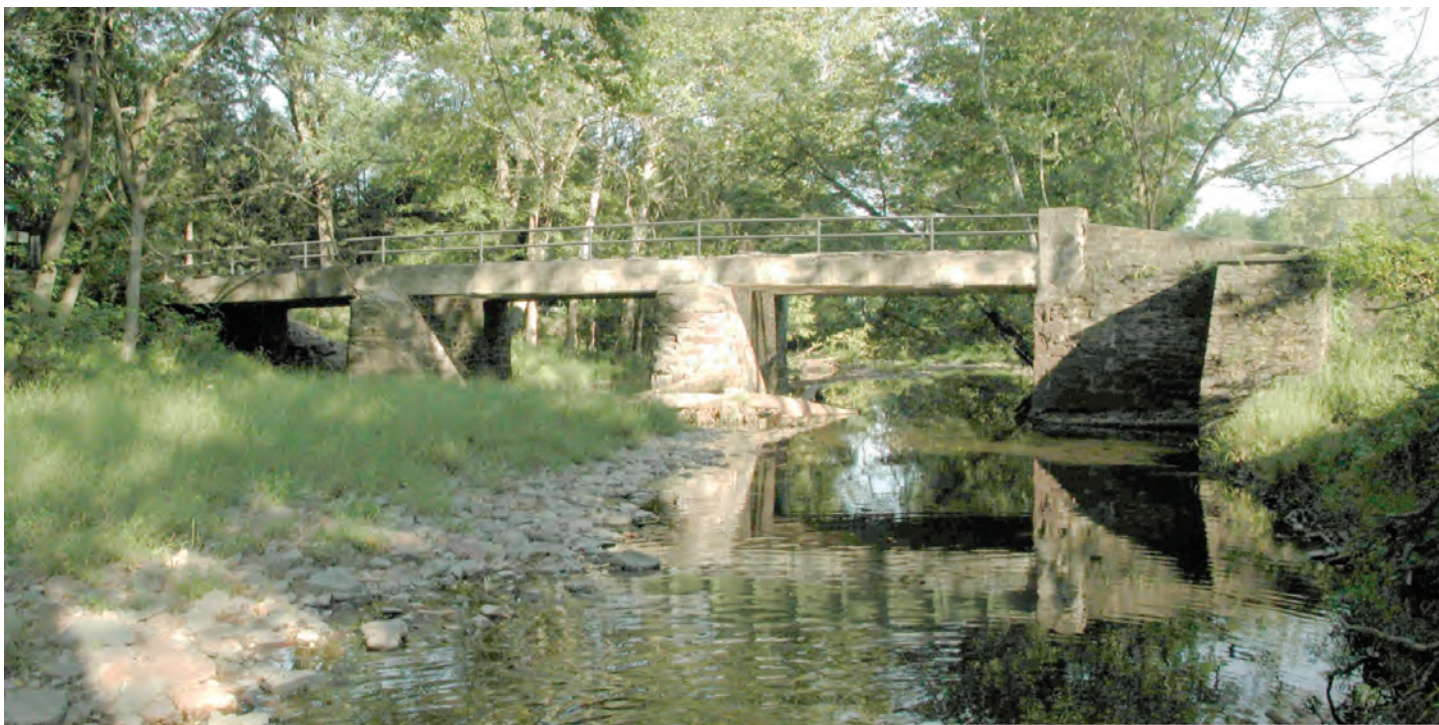
*The 1812 Burnt Mill Bridge (above) and the 1835 Creamery Road Bridge (below) are the last two multi-span stone supported beam bridges left in Bucks County.*

The 1812 Burnt Mill Bridge and the 1835 Creamery Road Bridge are the last two bridges of their type remaining in Bucks County. Is that fact not a reason to repair rather than replace the spans? It is the superstructure of the original bridges that remains since the decks were both originally wooden planks that had to be replaced periodically. The significance of both remains challenged by twentieth century auto era improvements that left both bridges one lane wide with the superstructure intact. Both are monumental with the earlier bridge spanning two supports and the latter stretching 199 feet across seven piers. In the auto age both bridges received concrete decks and pipe railings. The early auto era renovations extended the life of both bridges and are reflective of an older approach of repairing rather than replacing bridges in Pennsylvania. The Burnt Mill Bridge forms a squirrely intersection with Sheephole Road and Headquarters Road that will likely force a bridge realignment if a new two lane bridge is mandated. A new span will have a significant negative effect on the Ridge Valley Historic District.
