HydroQuest

June 12, 2012

RE: **Hydrologic and Environmental Rationale to Bury Gas Pipelines using Horizontal Directional Drilling Technology at Stream and River Crossings**

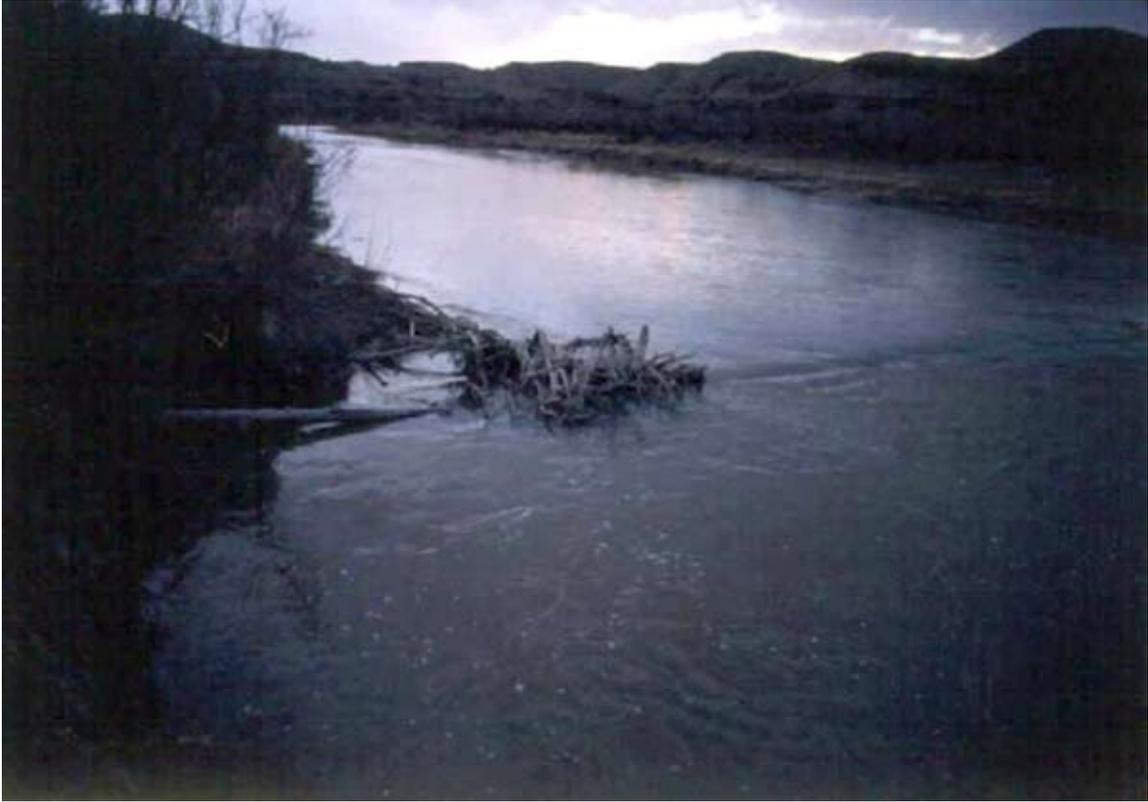
Photo from Fogg and Hadley (2007) of an exposed pipeline crossing the Green River, Utah. Natural gas pipeline breaks during flooding can release condensate toxic to sensitive fish species. Ludwig's Run and the East Branch of Brandywine Creek are a stocked trout fishery.

“In 2002, the U.S. Fish and Wildlife Service raised concerns about the potential for flash floods in ephemeral stream channels to rupture natural-gas pipelines and carry toxic condensates to the Green River, which would have deleterious effects on numerous special-status fish species (Figure 1).”

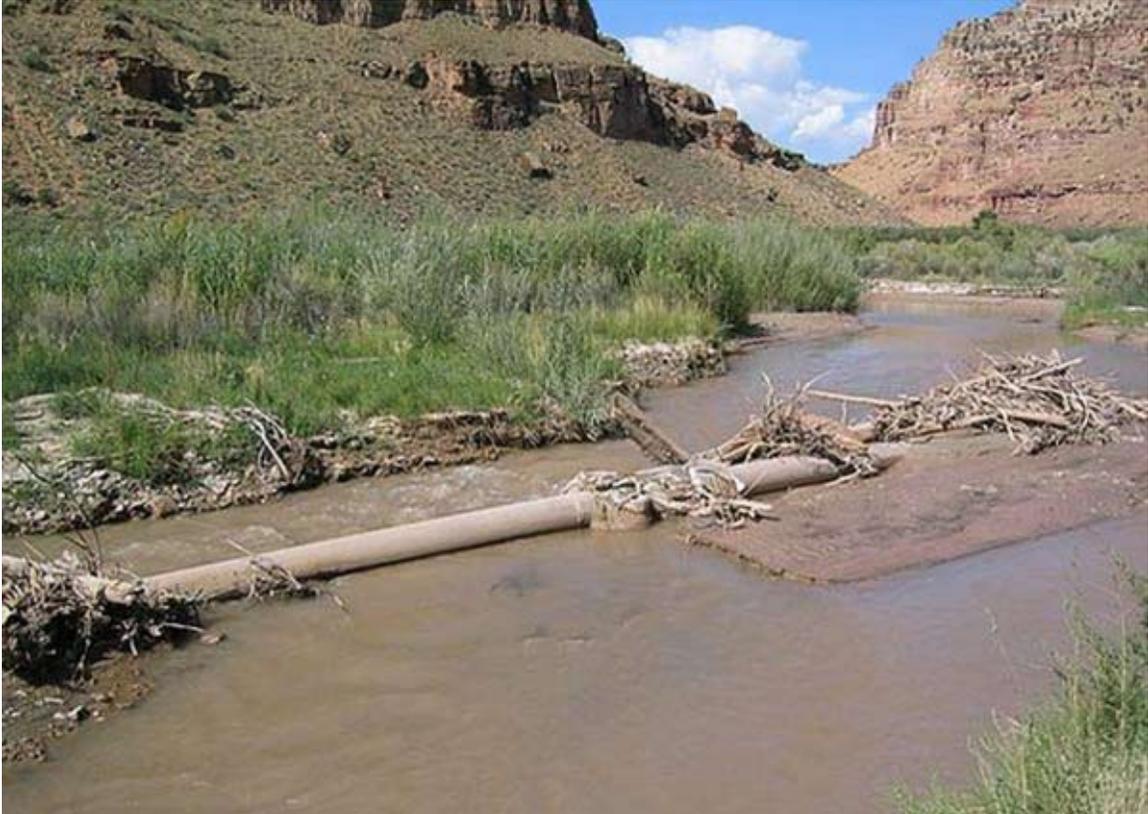
Photo from Fogg and Hadley (2007) of an exposed pipeline crossing an unnamed western US river. Here, lateral migration of a stream channel during high water excavated a section of pipeline under a floodplain that was several feet shallower than at the original stream crossing.

Fogg and Hadley (2007) evaluated hydraulic considerations for pipeline crossings stream channels. Their Figure 10, shown below, depicts lateral migration of a stream channel during high water that excavated a section of pipeline under the floodplain that was several feet shallower than at the original stream crossing. Ludwig's Run has had similar lateral migration of the channel.
