FIELD NOTES

09 1012 0020 2764

District 6-0
Bucks County
By [redacted] Date 11/2/04
Sheet 2 of 4

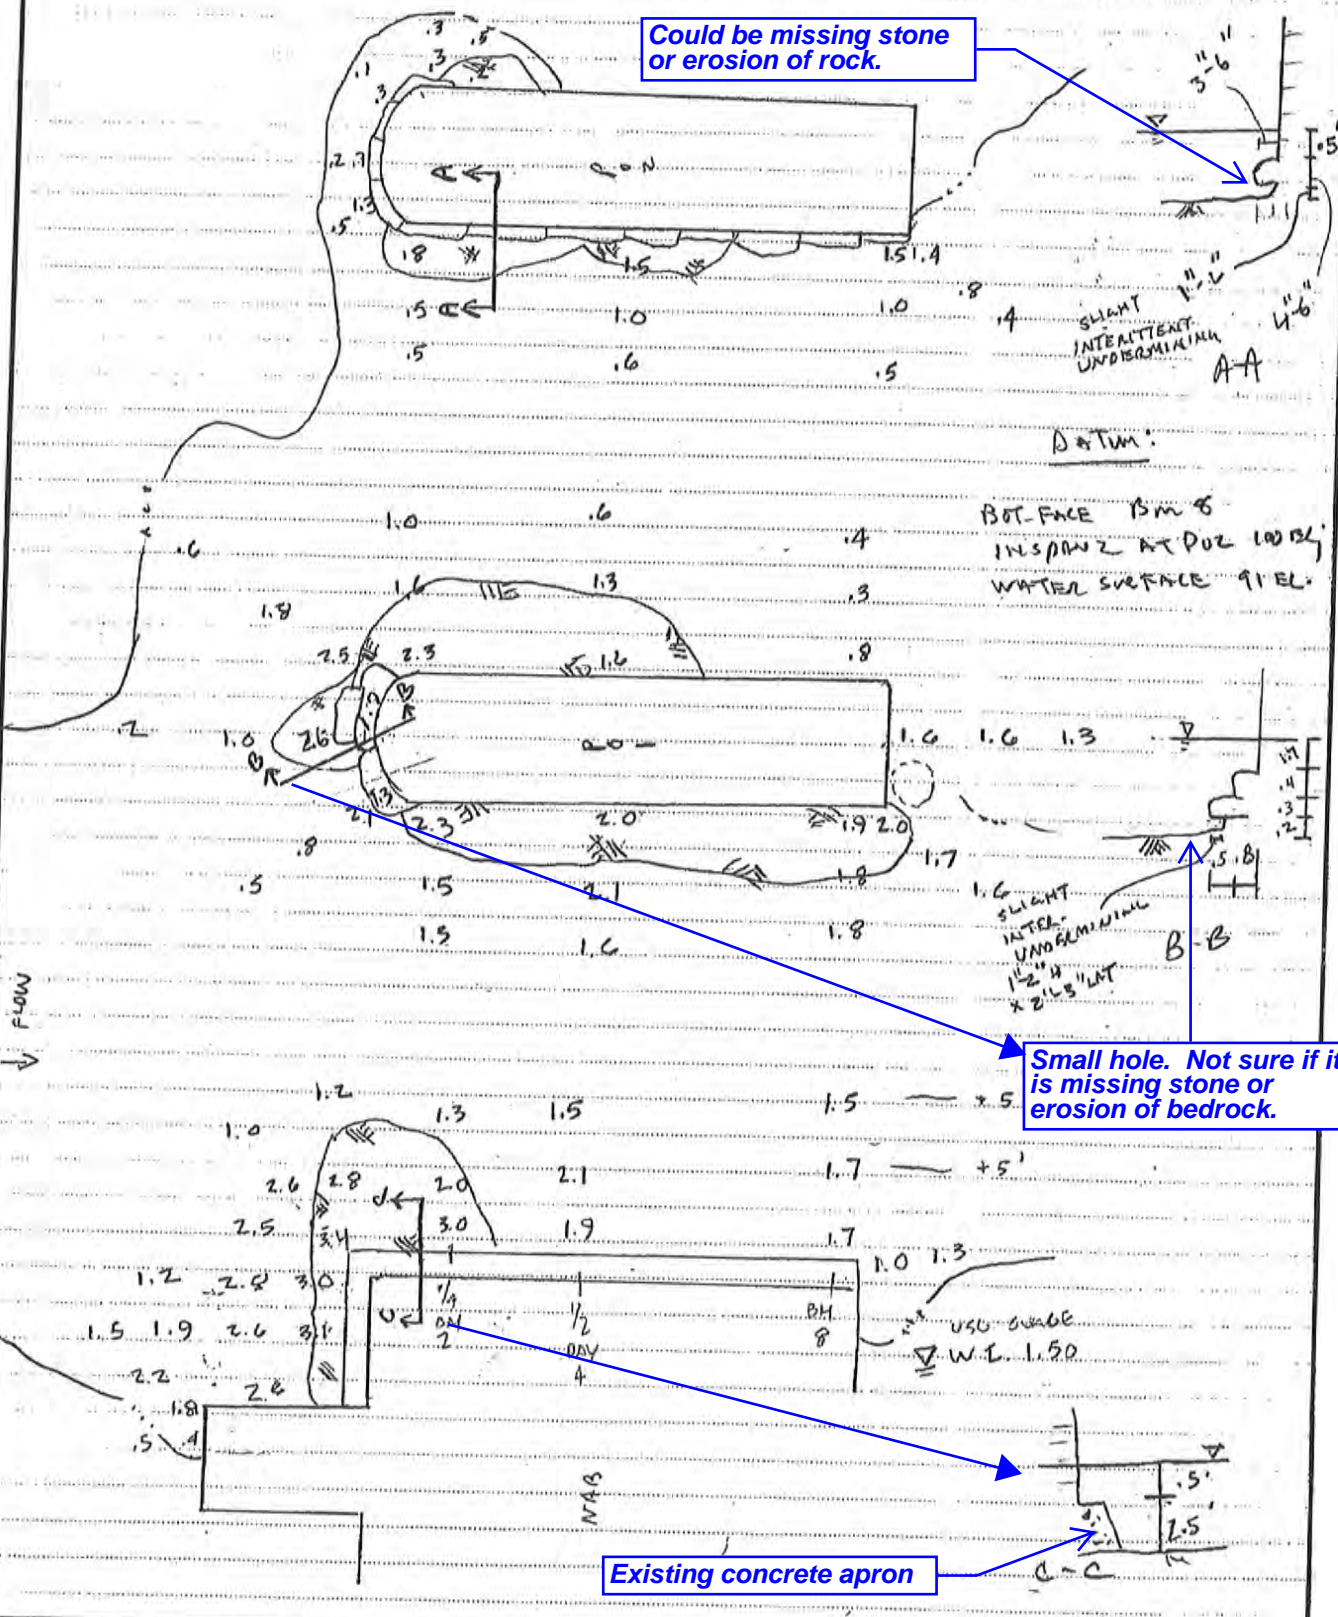
Could be missing stone or erosion of rock.

DATUM:
BOT. FACE Bm 5
1" SPAN 2 AT P.O.Z 100' EL.
WATER SURFACE 91' EL.

Small hole. Not sure if it is missing stone or erosion of bedrock.

Existing concrete apron
