***Re: Headquarters Road Bridge***

# Comments on the PennDOT Determination of Effects Report on the Headquarters Road Bridge

A report prepared for the Delaware Riverkeeper by:

14 December 2015

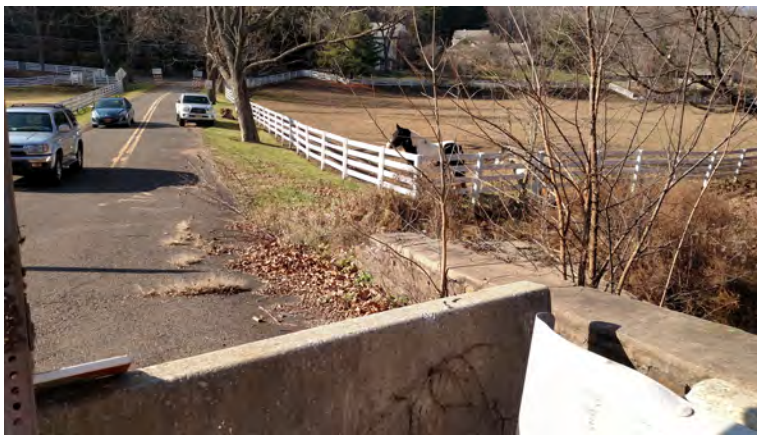
Figure 6  
The fence to the west of the bridge, the apparent site of  
impact in the 6 July 2007 crash

A fourth crash, on 6 July 2007, appears to have been near the bridge. A vehicle driving westbound was reported as having made contact with a fence or wall near the bridge. Based on the limited description and the police sketch (figure 5), the

vehicle probably made contact with the fence on the western end of the bridge (figure 6).

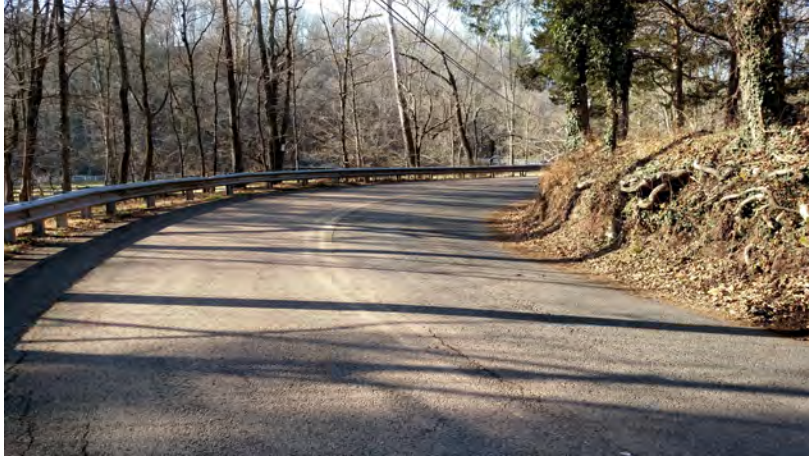
Figure 7  
Westbound view of the curve on Headquarters Road located 250 feet east of the intersection with Sheephole Road, the site of 5 crashes within the reporting period

Of the crashes at the curve, 3 occurred when the road surface was wet and all 5 involved a westbound vehicle crossing the centerline (see figures 7 and 8). These crashes are all well beyond the influence of Headquarters Road Bridge, but do indicate a “hotspot” where PennDOT should consider upgrading such safety measures as signing and striping.

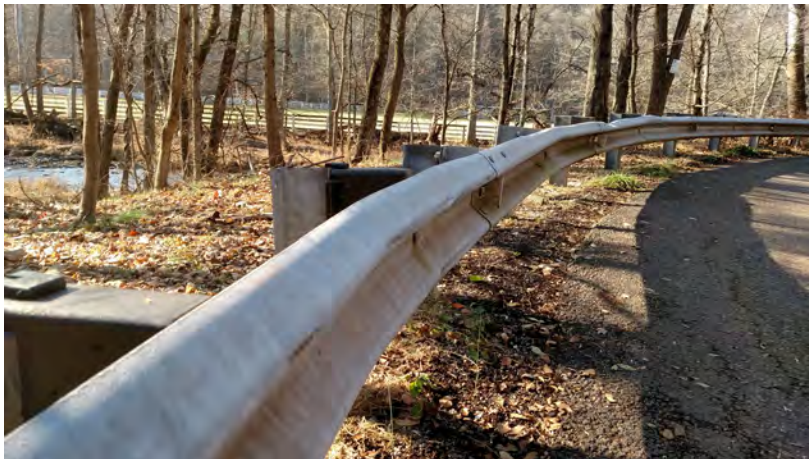
Figure 8  
Guardrail along the Headquarters Road curve, showing signs of multiple impacts
